DRAFT Arborist Report

**Maple and Main
Hayward, CA**

February 2021

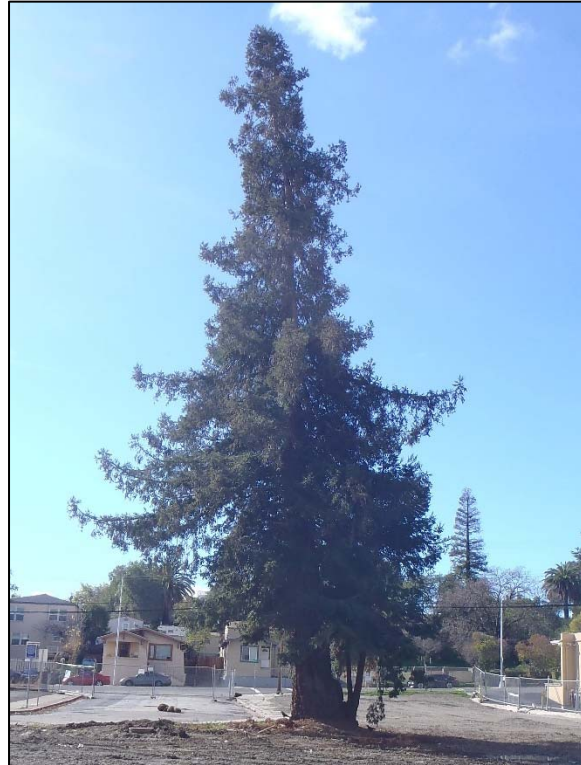
The most common species assessed was coast redwood (5 trees, 24% of the population). The largest diameter coast redwood measured 64" in trunk diameter and was growing on Levine Court (Photo 1). The other coast redwoods were located along the south side of where the Hayward Professional Building once stood (Photo 2). They were in good condition (4 trees) with one tree in fair condition. The redwoods were semi-mature to mature with trunk diameters ranging from 14" to 63".

Photo 1: Looking west at coast redwood #1. It was mature, at 64" in diameter and in fair condition. The tree leaned to the south, with a crook in the upper crown.

Coast redwood #1 is proposed to be preserved in a 20' x 24' planter in a courtyard on the north side of the residential complex. A storm drain would be located at the south end of the planter. I believe the tree will tolerate the proposed changes, provided the following elements of the **Tree Preservation Guidelines** are strictly adhered to throughout the construction process.

7. Have a temporary irrigation system installed around coast redwood #1 (using soaker hoses or pvc laid on the ground and covered with mulch) as soon as possible to supply the tree with water and help it recover from the demolition process and prepare for impacts associated with the construction process.

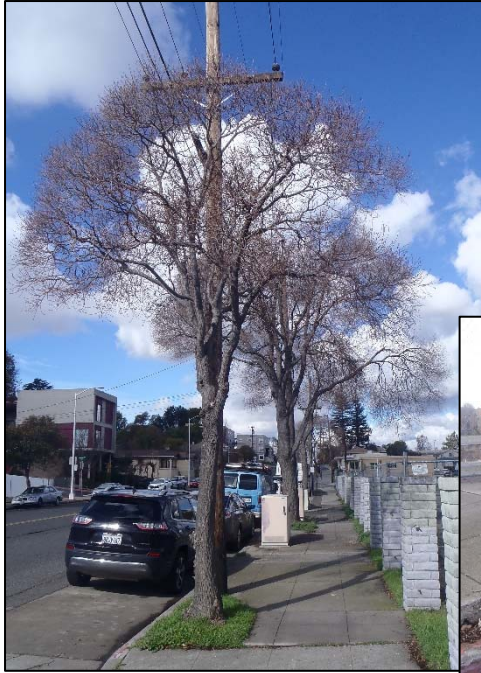
Four (4) Chinese tallow street trees were growing along Main St. (#2-5). Although located under utility lines, it appeared that only #4 had been topped (Photo 2, following page). These trees were semi-mature to mature with trunk diameters ranging from 9" to 21" and in good (3 trees) to fair (1 tree) condition. Several of the Chinese tallows' roots were displacing the sidewalks (Photo 3 inset).

Photo 2 (L): Looking north at street trees #2-5 (background to foreground). These semi-mature to mature Chinese tallows had performed well, remaining relatively small beneath the overhead utilities. However, all had displaced the surrounding sidewalk, curb and gutters from ~1" to 10". Inset shows base of street tree #2, which had lifted the sidewalk by ~8".
