Arborist Consultation Services

July 17, 2023

Arborist Report: 22872 Main Street, Hayward, CA

Project Address: 22872 Main Street
Hayward, CA 94541

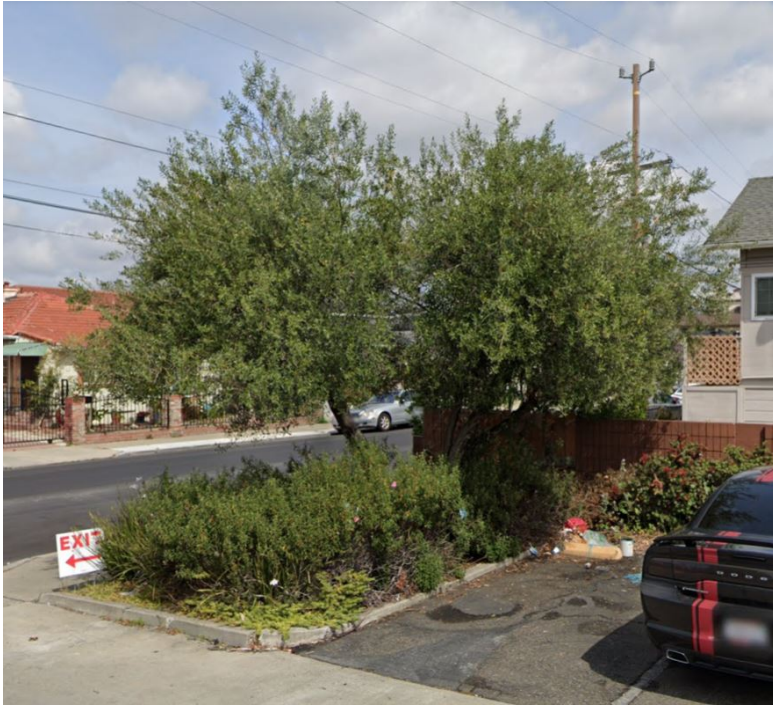
Tree 5 – *Olea europaea* (Olive) in fair condition, structure and form.

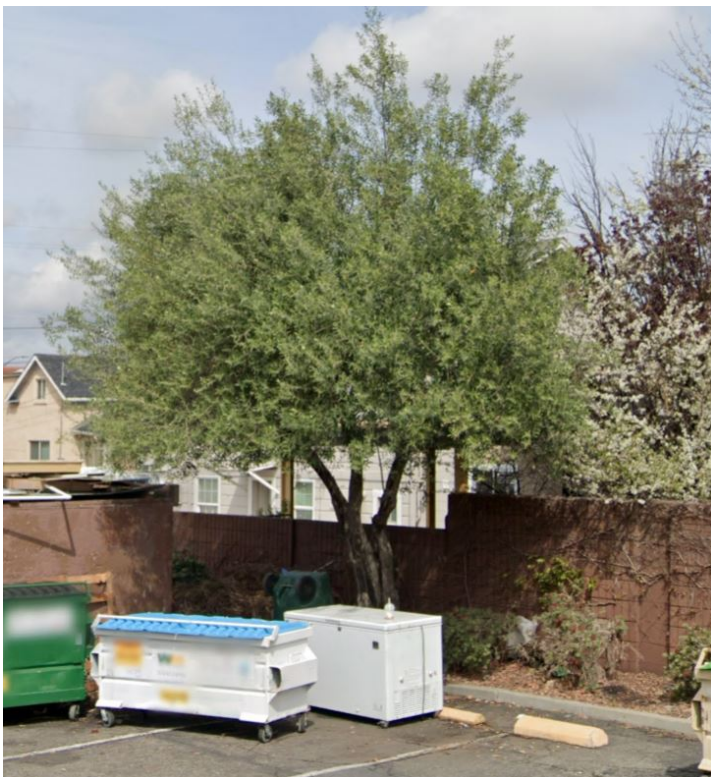
Tree 6, *Olea europaea*, in fair *condition, form, and structure*.
