## **Preliminary Arborist Report**

**24041 Amador Street**  
Hayward, CA 94544

**April 29, 2025**

**Updated July 7, 2025**

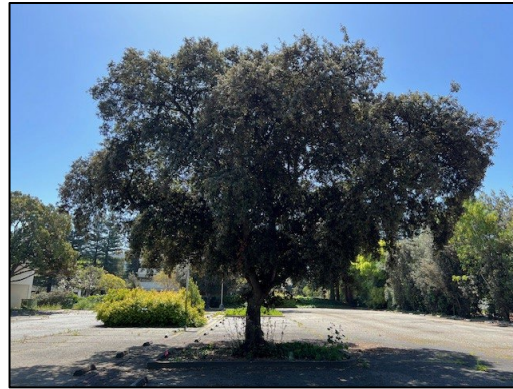
Holly oaks were the most common species with 20 trees. Fourteen (14) were in fair condition with minor structural defects and small branch or twig dieback. Four were in poor condition with larger dead branches and poor structure and form. Holly oak #534 was in good condition with a wide, healthy crown and good form (Photo 1). Holly oak #551 was located off-site, dead and covered in ivy. Trees ranged from young in development to mature, with trunk diameters ranging between 4 – 18 inches, averaging 9 inches.

**Photo 1.** Holly oak #534 was in good condition with a wide, healthy crown.

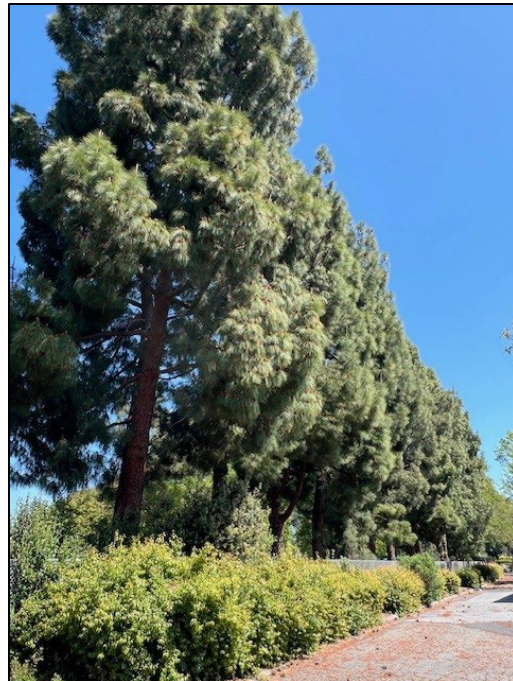
Seventeen (17) Canary Island pines were located off-site to the north between the Centennial Park parking lot and the chain link fence separating the properties (Photo 2). Trees were located approximately 4 - 8 feet north of the fence, with branches overhanging the site by 2 – 10 feet. Pines had typical upright growth habit with good or fair structure and form. Thirteen (13) trees were in fair condition with minor branch dieback and thinning crowns. Pines #564, 565 and 571 were in good condition with large, full crowns and good structure. Pine #563 was dead. Trees were mostly mature in development with trunk diameters ranging between 10 – 41 inches, averaging 22 inches.

**Photo 2.** Canary Island pines #574 – 560 L-R) were growing off-site 4 foot off the fence line.

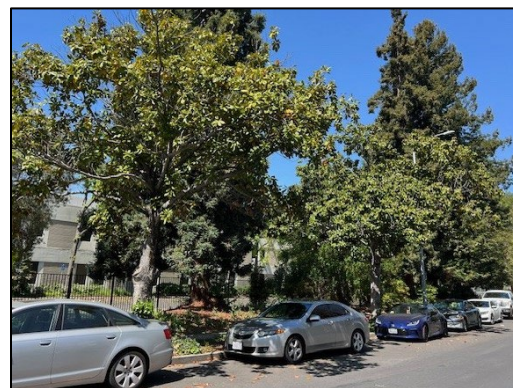
Of the nine southern magnolias, five were in fair condition with asymmetrical crowns and minor branch dieback. Trees growing along the west side of the building were one-sided to the west. Magnolias #520, 525 and 526 were in good condition with wide, full crowns and good or fair form. Magnolia #514 was in poor condition with major branch dieback, and the base was covered in ivy. Trees were semi-mature to mature in development with trunk diameters between 12 – 24 inches, averaging 18 inches. Magnolias #508 and 509 were street trees located on the southeast side of the site (Photo 3).

**Photo 3.** Southern magnolias #508 and 509 were street trees located on the southeast side of the site.

Street trees #508 and 509 should have type II fencing 6' x 6' around each tree well using free-standing chain link to protect the trunks from impacts during construction.

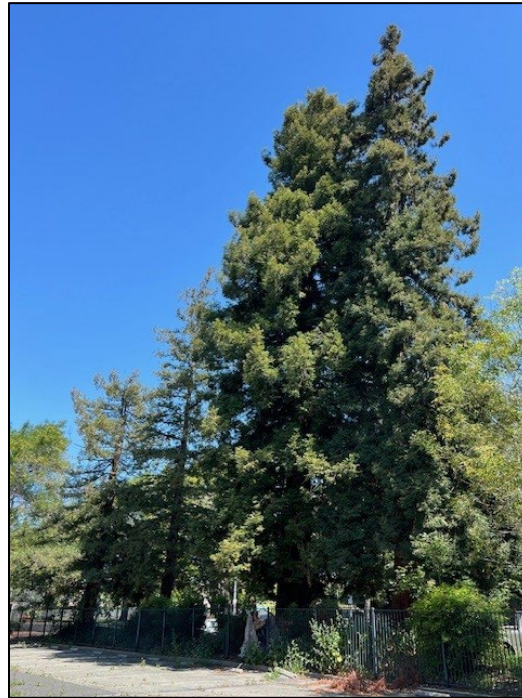
Of the eight coast redwoods, five were in good condition with typical upright form and good foliage color. Redwoods #501, 502 and 558 were in fair condition with thinning crowns, minor browning foliage, and #501 had a broken top at 40 feet. Redwoods #511, 557 and 558 were located off-site to the south with branches overhanging the site 10 – 20 feet. Trees were semi-mature in development with trunk diameters ranging from 25 – 58 inches, averaging 33 inches. Redwood #503 was the largest tree on-site with a 58-inch trunk and a full crown (Photo 4).

**Photo 4.** Coast redwoods #501 – 503 (L-R). Redwood #503 was the largest tree on-site with a 58-inch trunk diameter.

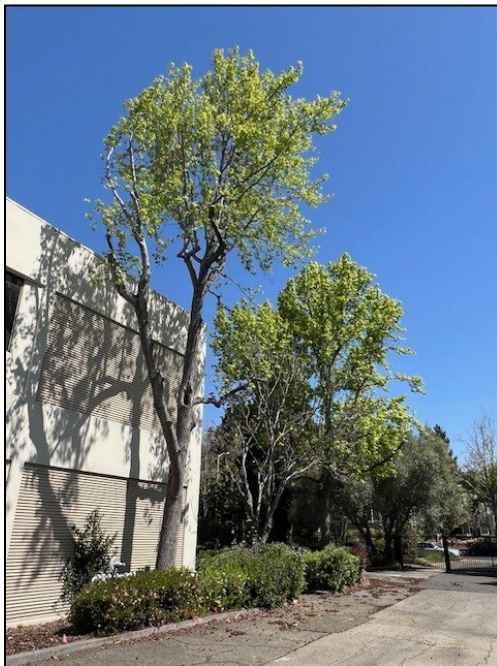
Four of the seven sweetgums were in fair condition with fair structure and form. Most had reduced crowns with epicormic sprouts growing throughout. Sweetgums #515, 523 and 524 were in poor condition with major branch dieback, poor structure and form and a history of poor pruning (Photo 5). Trees were semi-mature in development, with trunk diameters ranging between 12 – 20 inches, averaging 16 inches.

**Photo 5.** Sweetgum #515 was in poor condition with poor structure and form and a history of poor pruning.

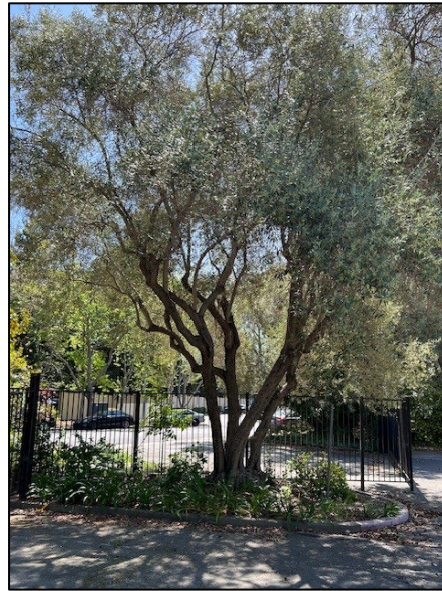
- Three olives were in fair condition with multiple trunk attachments at the base. Ivy covered the lower stems of #510. Olive #512 was previously topped at 15 feet (Photo 6). All trees had epicormic sprouts on their trunks and scaffold branches. Trees were semi-mature in development with combined trunk diameters averaging 28 inches.

**Photo 6.** Olive #512 was previously topped at 15 feet and in fair condition.

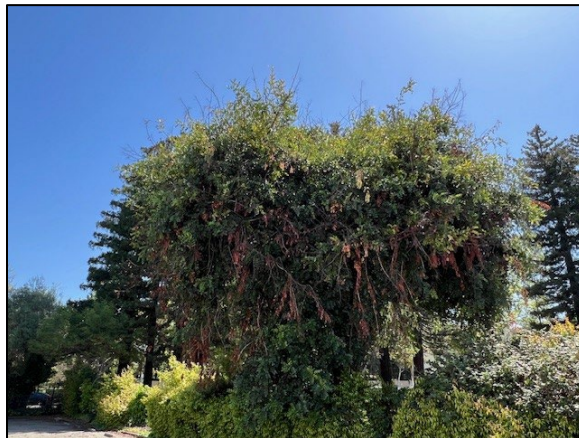
- Carobs #529 and 531 were in fair condition; both were located off-site on the south side of the property. Trees had large, wide crowns with small branch and tip dieback (Photo 7). Trees were located 2-3 feet off the south fence line and branches were overhanging the site by 8-10 feet. Trunk diameters were estimated at 28 and 24 inches, respectively.

**Photo 7.** Off-site carob #531 was in fair condition with small branch and tip dieback.

3. Off-site evergreen ash #559 is located on the northeast side with branches overhanging the project site by 20 feet. Carobs #529 and 531 may also require the reduction of branches over the site. Branches should be pruned back to avoid interfering with construction equipment.
