**Re: Arborist Report**

Proposed **Huntwood Town House** project

28538 Huntwood Avenue

Hayward, California

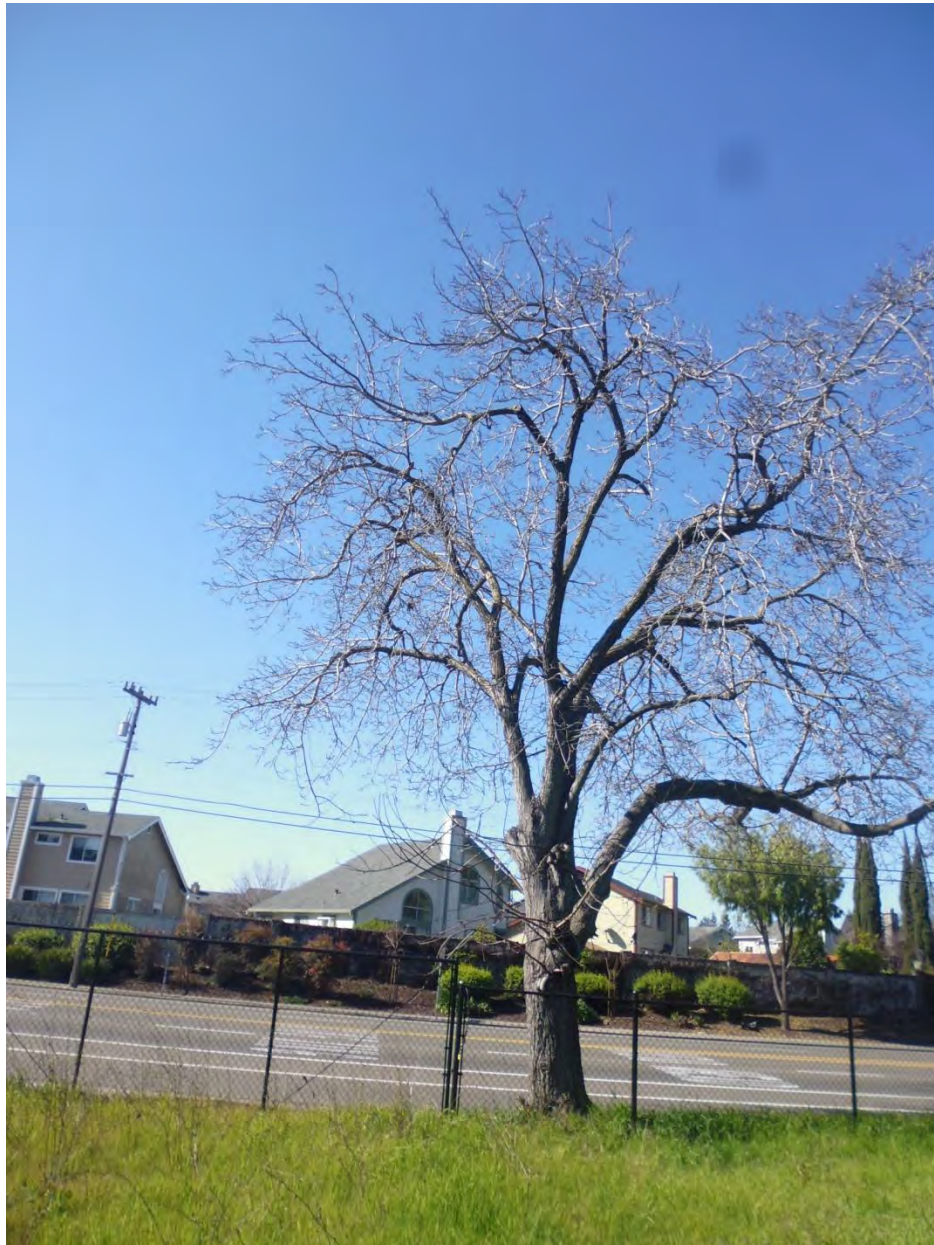
*Juglans nigra* / Black Walnut. 24" caliper DBH. Approximately 35' diameter and 30' height. Fair condition. Some poor branching structure and past pruning. Location at edge of proposed driveway and sidewalk. Not an especially desirable species. To be removed.

Tree No. ET1. Walnut. To be removed. 24” caliper.

Species Rating = 0.3

Condition Rating = 0.7

Location Rating = 0.7

$$V = (1,800 + (69 \times 452) \times 0.3 \times 0.7 \times 0.7$$

$$V = \$4,849.00$$

Tree ET1, Walnut.

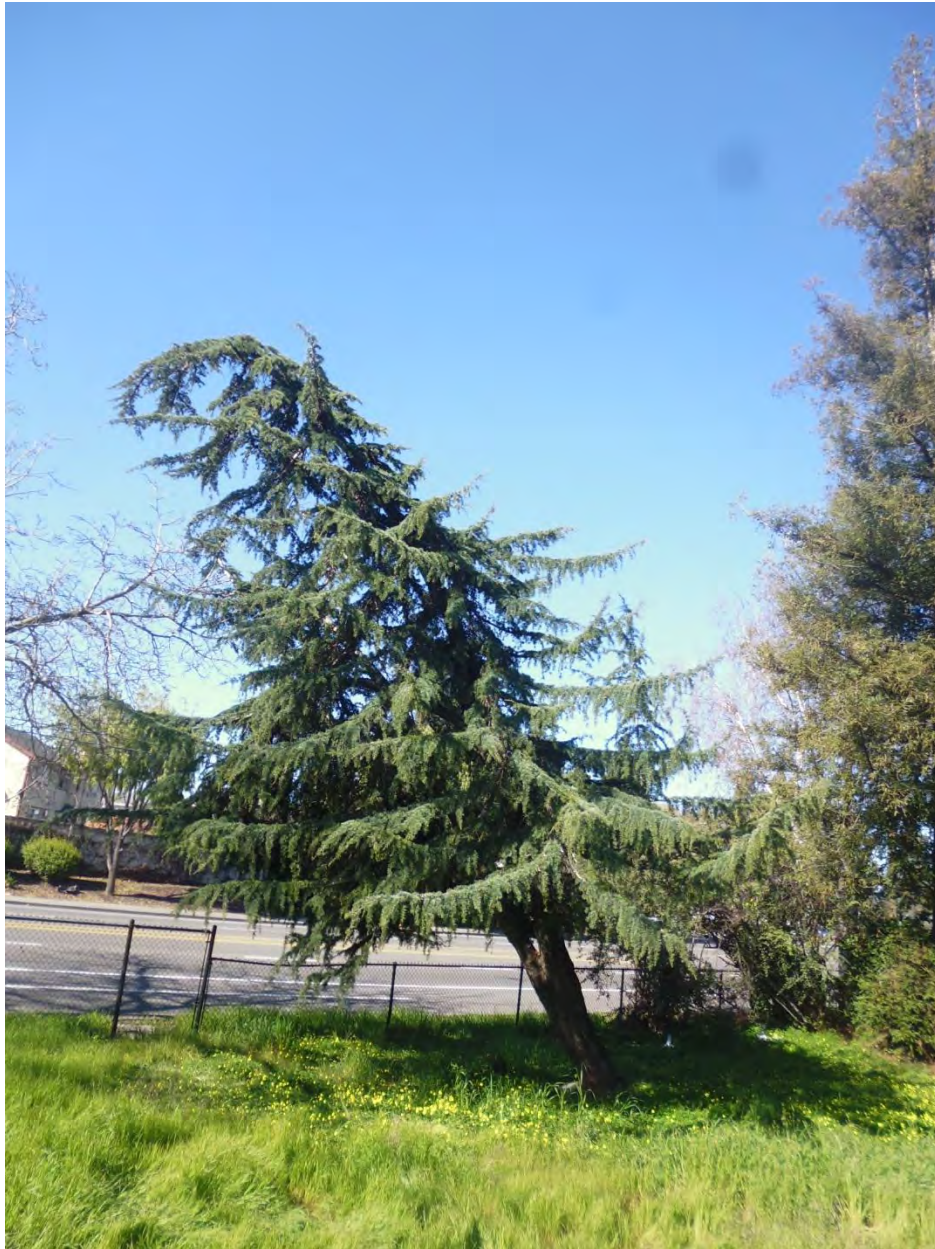
*Cedrus deodora* / Deodar Cedar. 18" caliper DBH. Approximately 20' diameter and 20' height. Fair to poor condition. Severe lean to the tree makes it a falling hazard. Although potentially this tree could be saved, we recommend removal due to hazard potential.

Tree No. ET2. Deodar Cedar. To be removed.

This tree is deemed a hazard. Assigned zero value.

Tree ET2, Deodar Cedar showing lean.

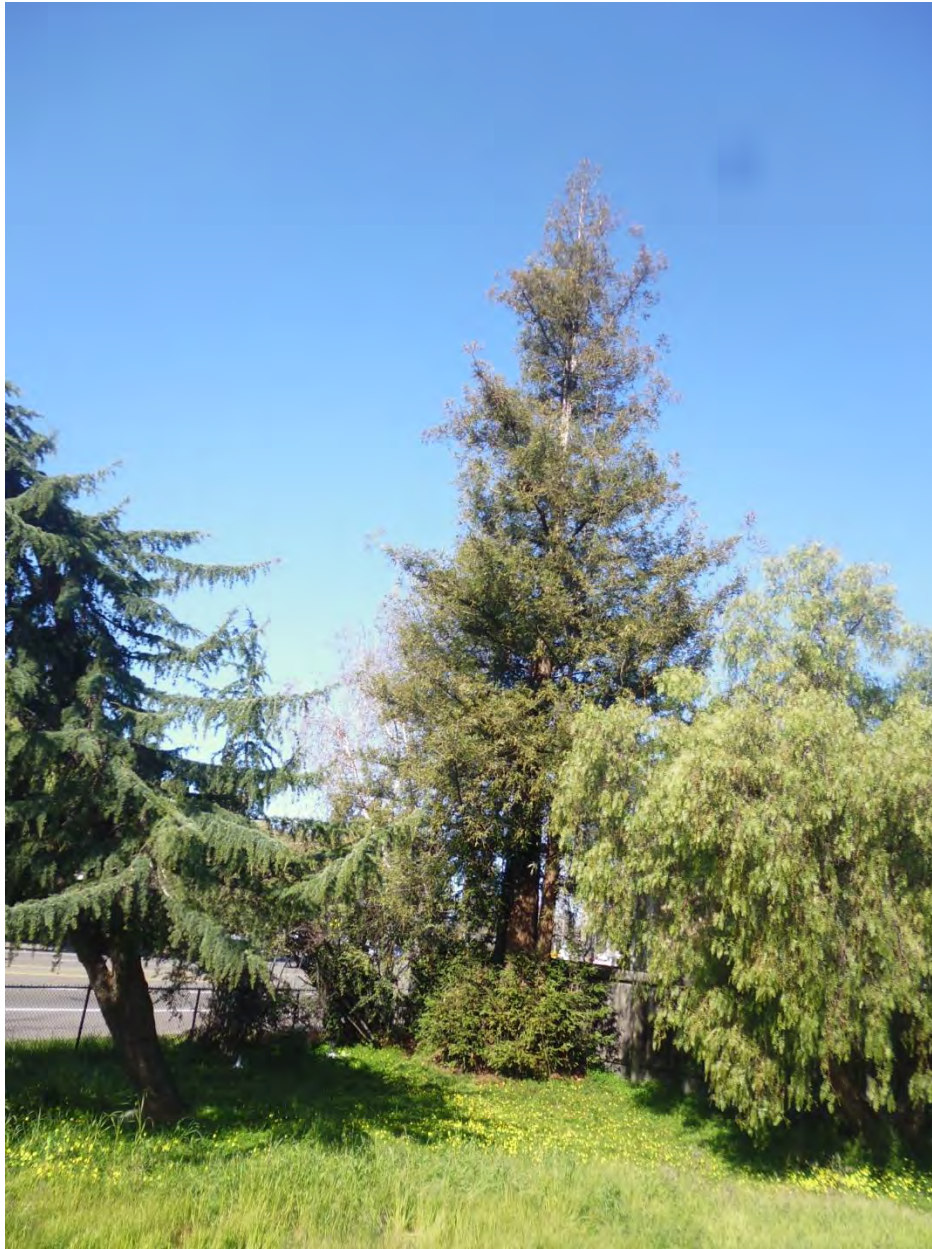
*Sequoia sempervirens* / Coast Redwoods. 24", 12" and 15" caliper DBH. Approximately 20' to 35' height and 20' diameter. This is a close group of Redwoods in fair to poor condition. Very crowded together. We recommend removal of the smaller trees, ET4 and ET5 to allow the larger tree ET3 room to thrive. These trees have been affected by the drought.

Tree No. ET3. Coast Redwood. To remain. 24” caliper.

Trees No. ET4 and ET5. Coast Redwood. To be removed.

Crowding Tree ET3. Assigned zero value.

Trees ET3, ET4, and ET5, Redwoods in center. ET2, Deodar Cedar to left and ET6, California Pepper Tree to right.

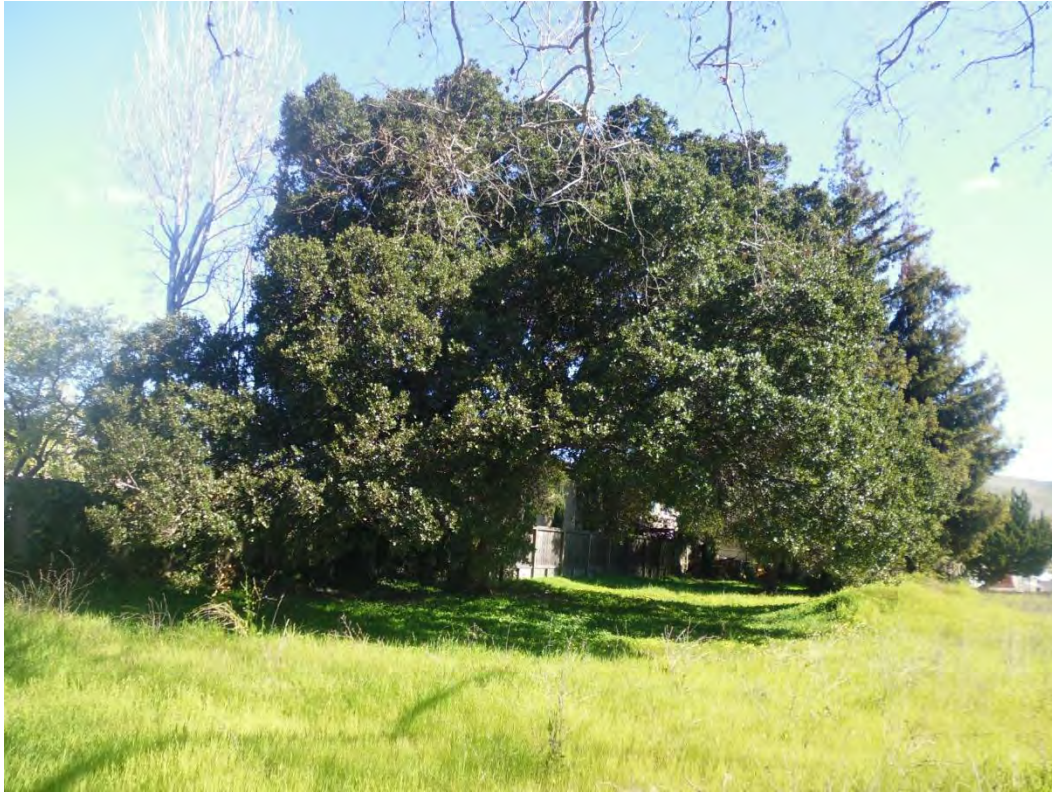
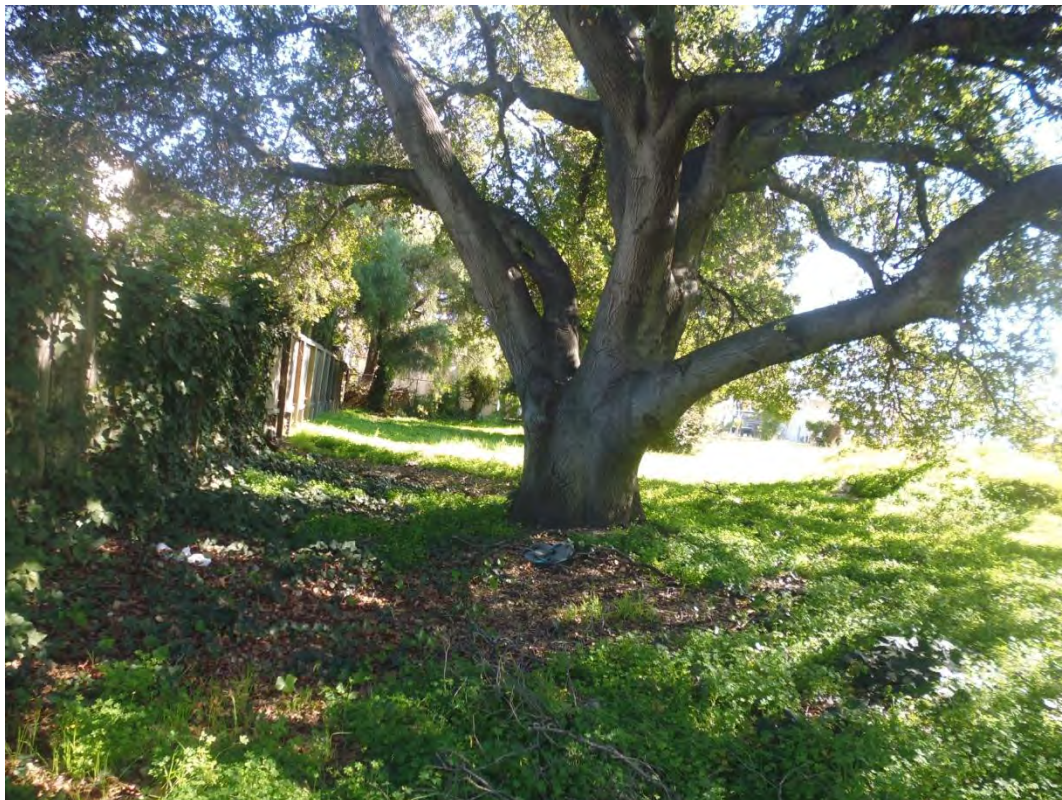
*Quercus agrifolia* / Coast Live Oak. 48" caliper DBH. Approximately 50' spread and 30' height. Fair to good condition. Crown branching nearly to the ground. Native Oak tree of mature age. Fair to good condition. No diseases seen. Somewhat lop-sided due to adjunct development to the north. This would generally be considered a tree species to be saved, but its size, location and the density of proposed development requires its removal.

Tree No. ET8. Coast Live Oak. To remain. 48" caliper.

V=\$40,412.00

Tree ET8. Coast Live Oak.

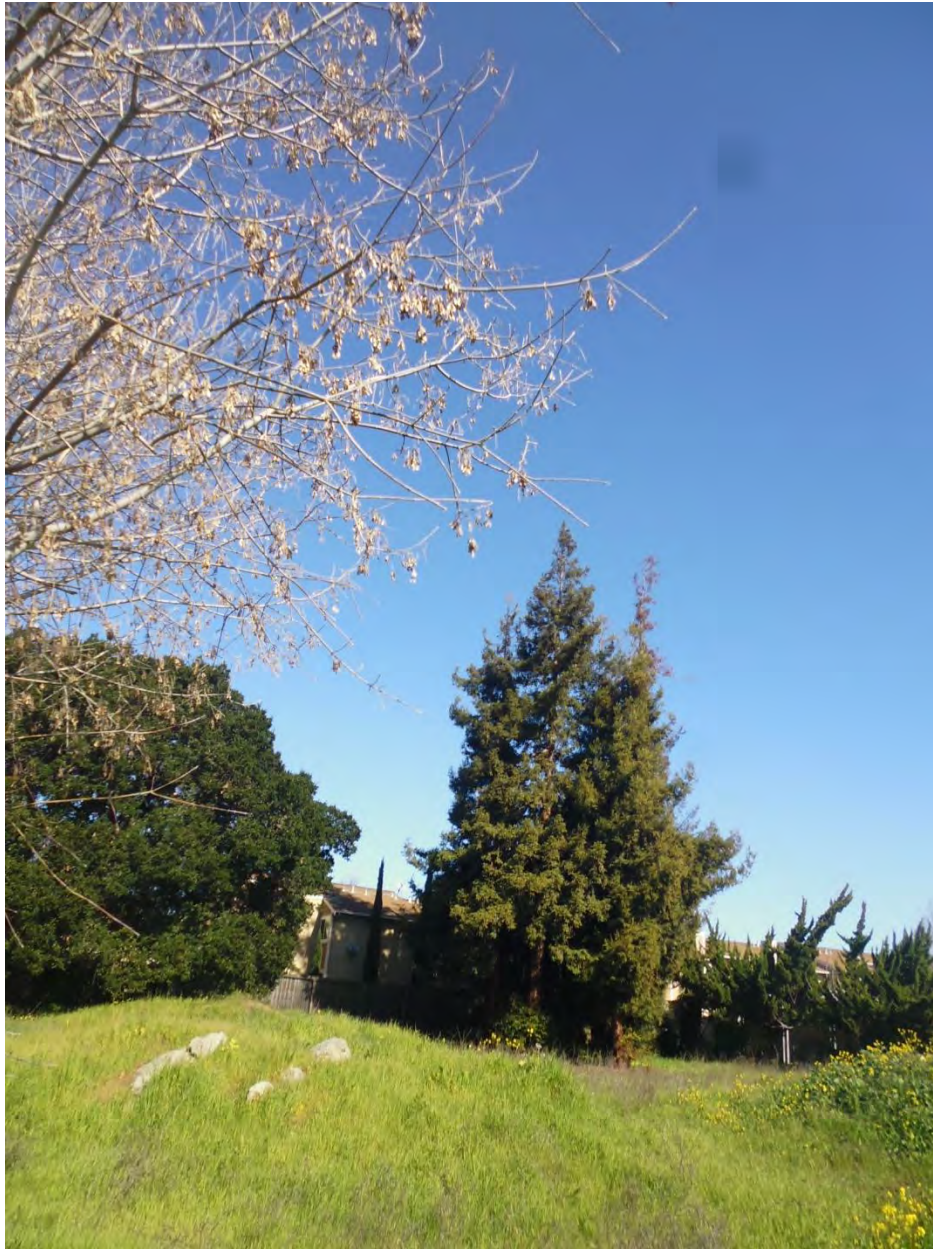
*Sequoia sempervirens* / Coast Redwoods. 16", 24", 20", 18", and 18" caliper DBH. 15'+/- diameters, and 30' to 35' height. A group of fairly closely spaced Redwood trees in fair to poor condition. These trees have clearly been affected by the drought. One had a dead top. To be removed due to location in proposed house.

Trees ET9 to ET13. Group of Redwoods.

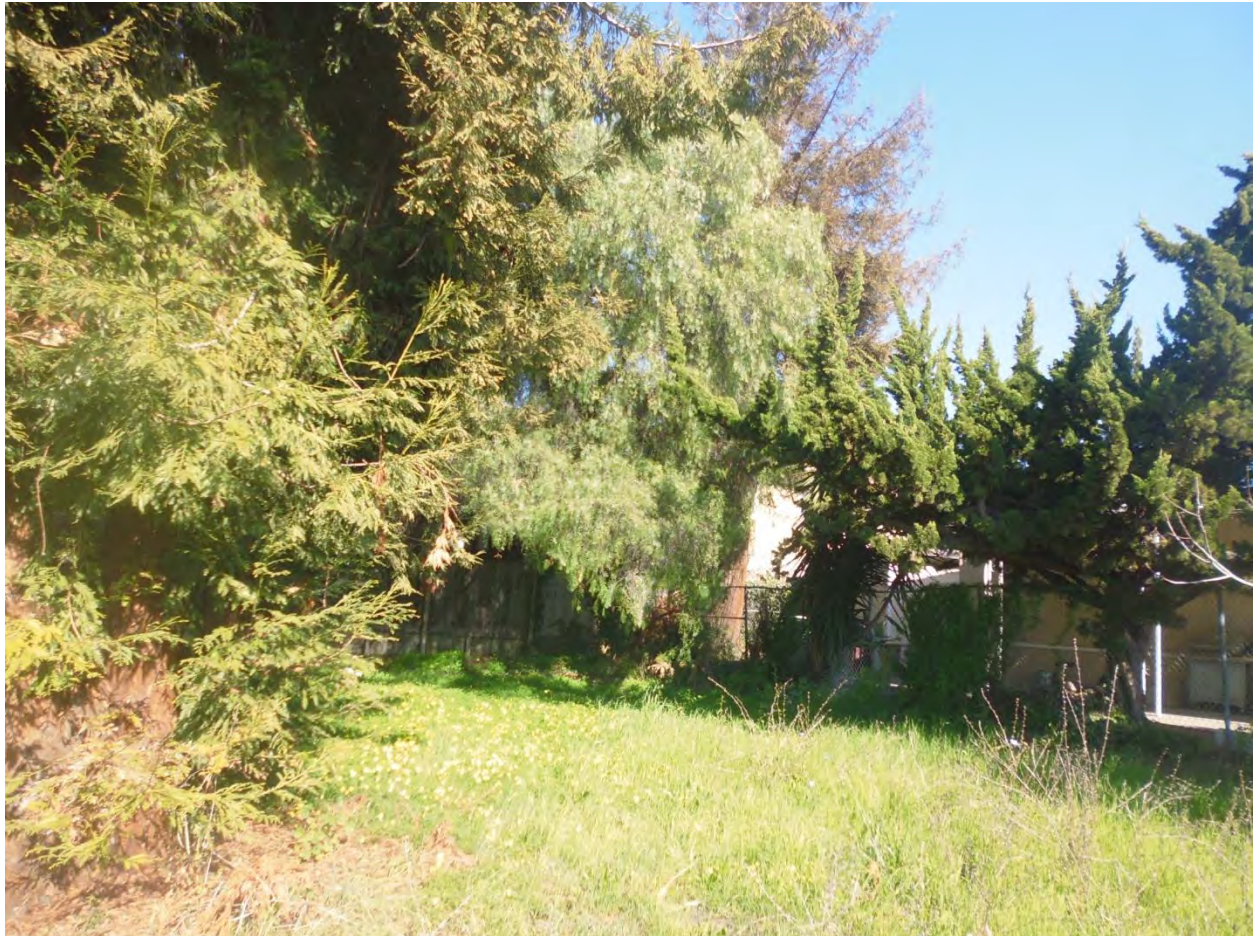
*Schinus molle* / California Pepper Tree. 20" caliper DBH. Approximate spread and height of 15' Poor condition. Crowded in corner of site. A "volunteer" tree. Messy and generally undesirable tree in a poor location. To be removed.

Tree No. ET14. California Pepper Tree. To be removed. 20" caliper.

$V = \$563.00$

Tree ET14. California Pepper Tree. Poor Redwood in rear and adjacent Hollywood Juniper are on adjacent parcel.

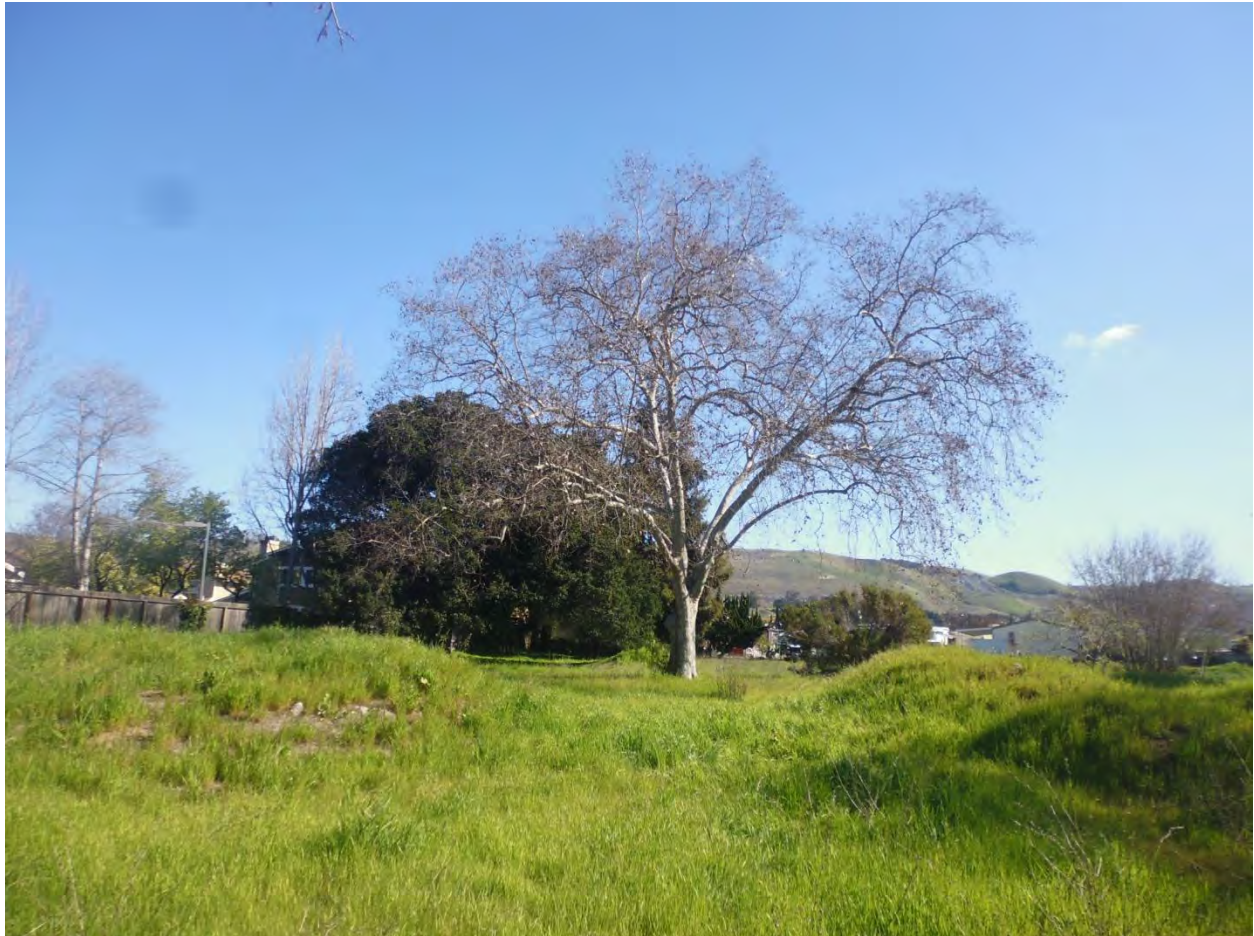
*Platanus acerifolia* / London Plane Tree. 30" caliper DBH. Approximately 40' diameter and 35' 35' height. Fair to good condition. The size and species would generally be considered a tree to be saved, but its size and location in the proposed driveway requires its removal.

Tree No. ET15. London Plane Tree. To be removed. 30" caliper.

$V = \$22,630.00$

Tree ET15. London Plan Tree.

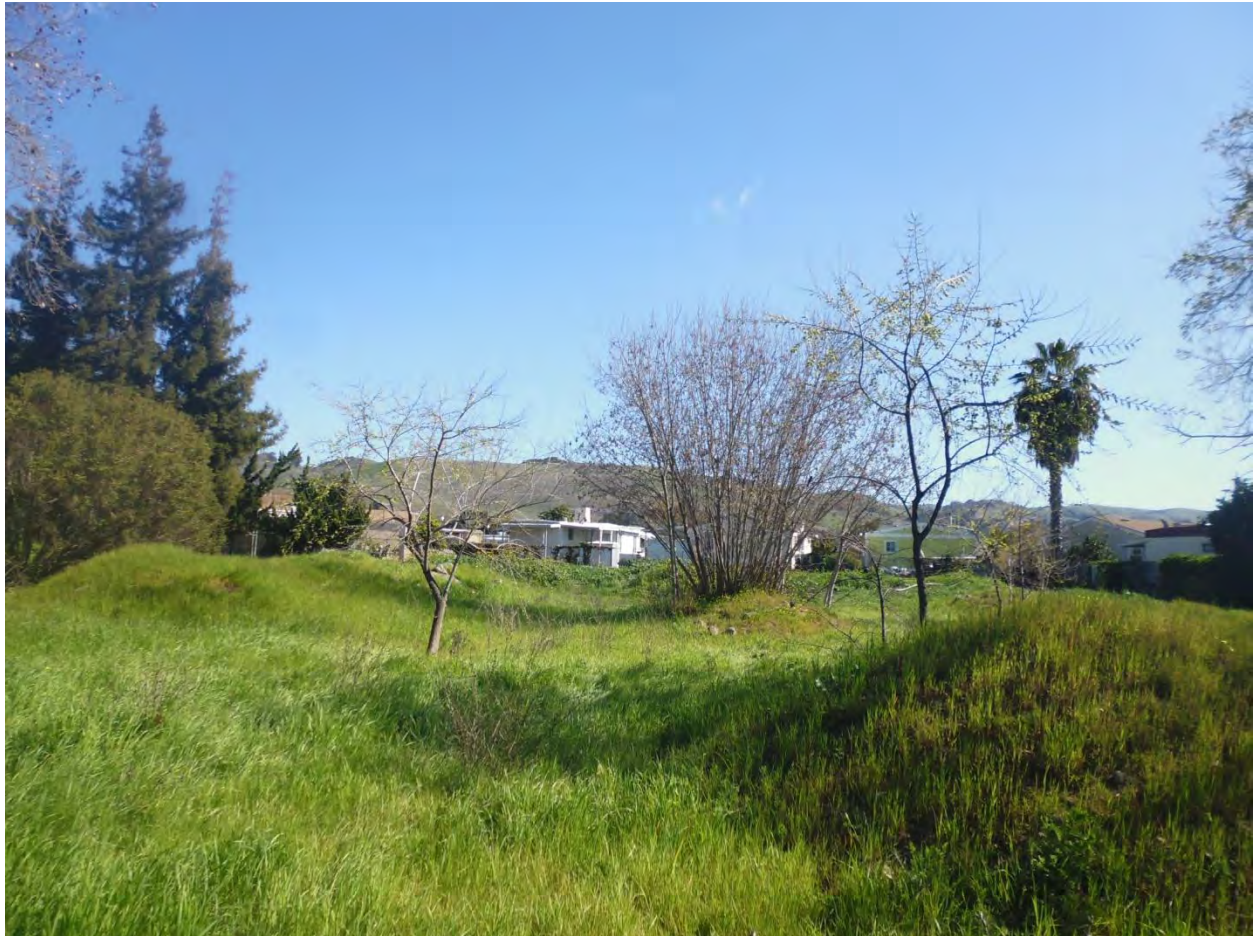
*Ulmus spp.* / Elm. A group of small stump sprouts in poor condition. To be removed.

Tree No. ET17. Elms. To be removed.

Undesirable stump sprouts. Assigned zero value.

Trees ET17, Elm cluster in center. Palm to right is on adjacent property.

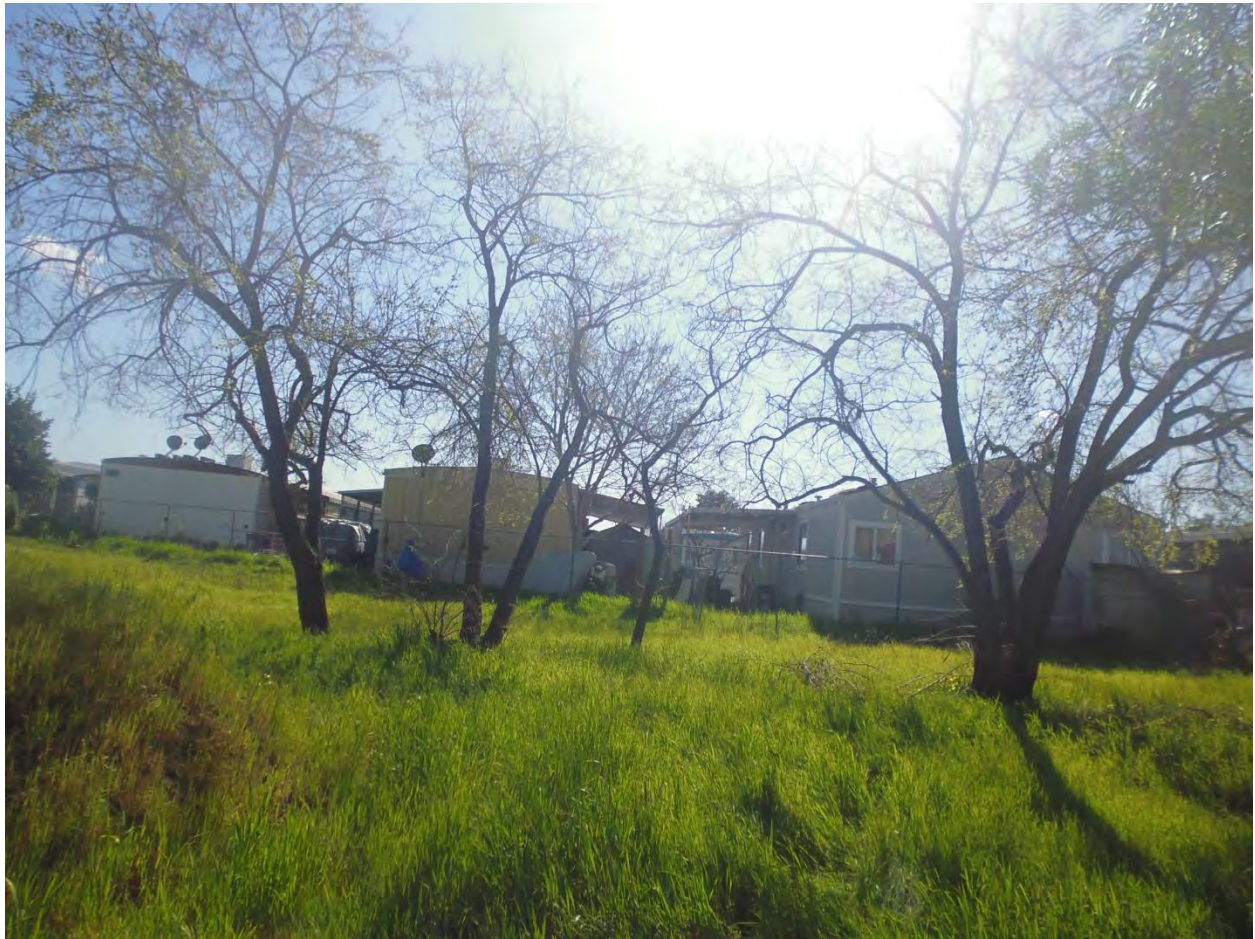
*Acer negundo* / Box Elder. Multi-trunked. Poor condition. Undesirable species to be removed.

Tree No. ET18. Box Elder. To be removed.

Undesirable species. Assigned zero value.

Trees ET18, Box Elder group.

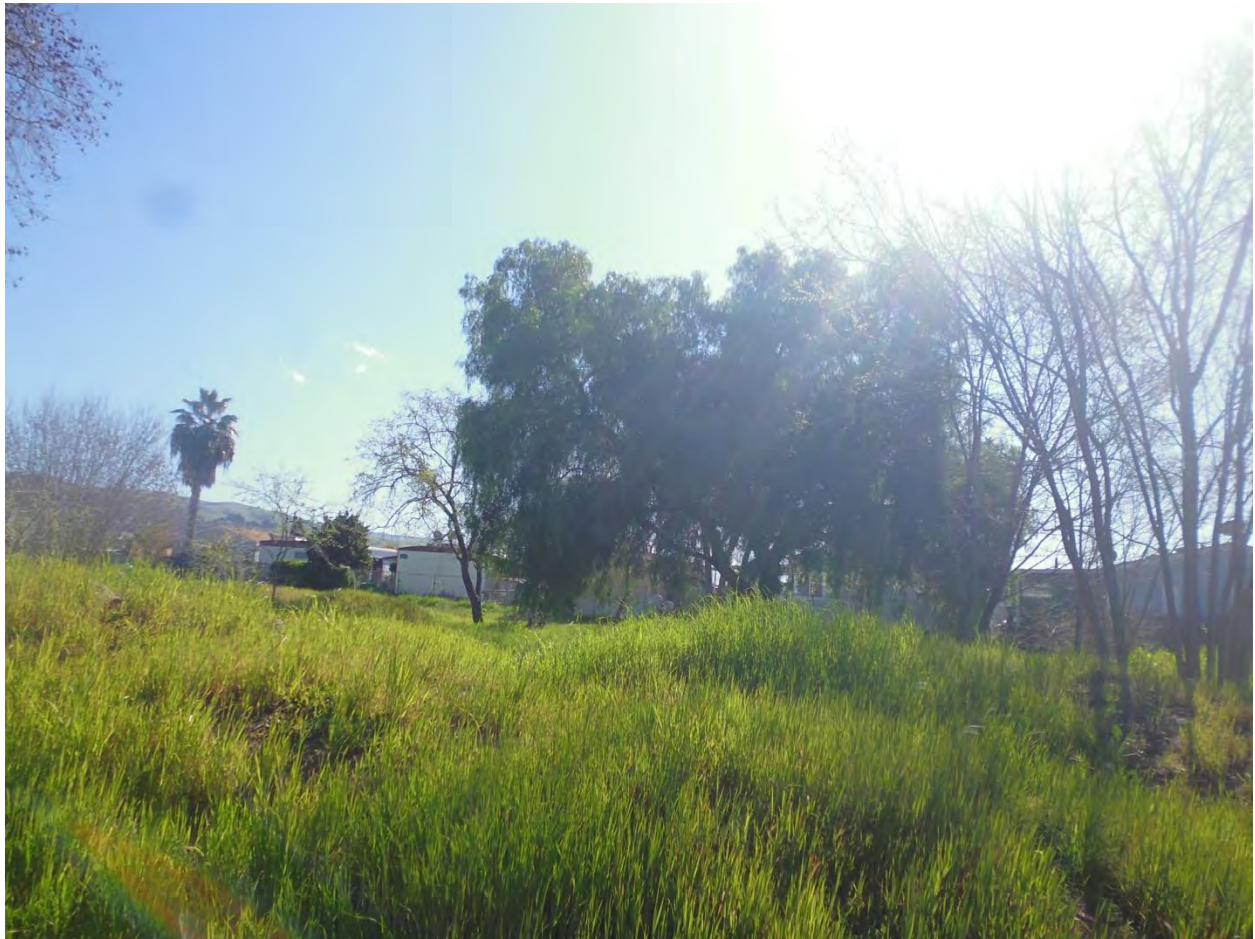
*Schinus molle* / California Pepper Tree. 14" caliper DBH. Approximately 30' spread and 25' height. Fair to poor condition. To be removed due to location in proposed house.

Tree No. ET19. California Pepper Tree. To be removed. 14" caliper.

$V = \$447.00$

Tree ET19, California Pepper Tree in center.

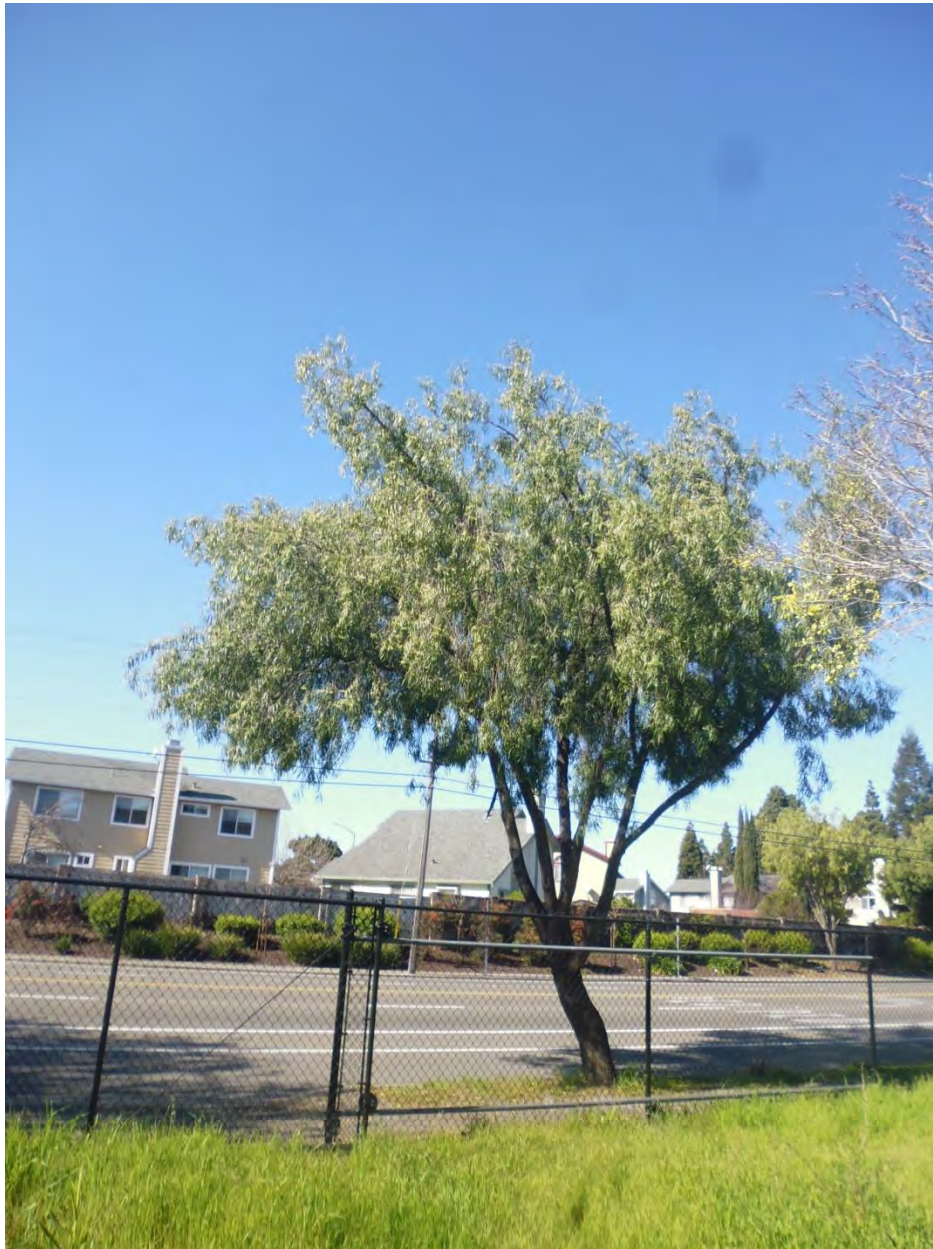
*Geijera parvifolia* / Australian Willow. 12" caliper DBH. Approximately 15' spread and height. Fair condition. Street tree. To remain.

Tree No. ET20. Australian Willow. To remain. 12" caliper.

$V = \$4,299.00$

Tree ET20, Australian Willow. Street Tree.

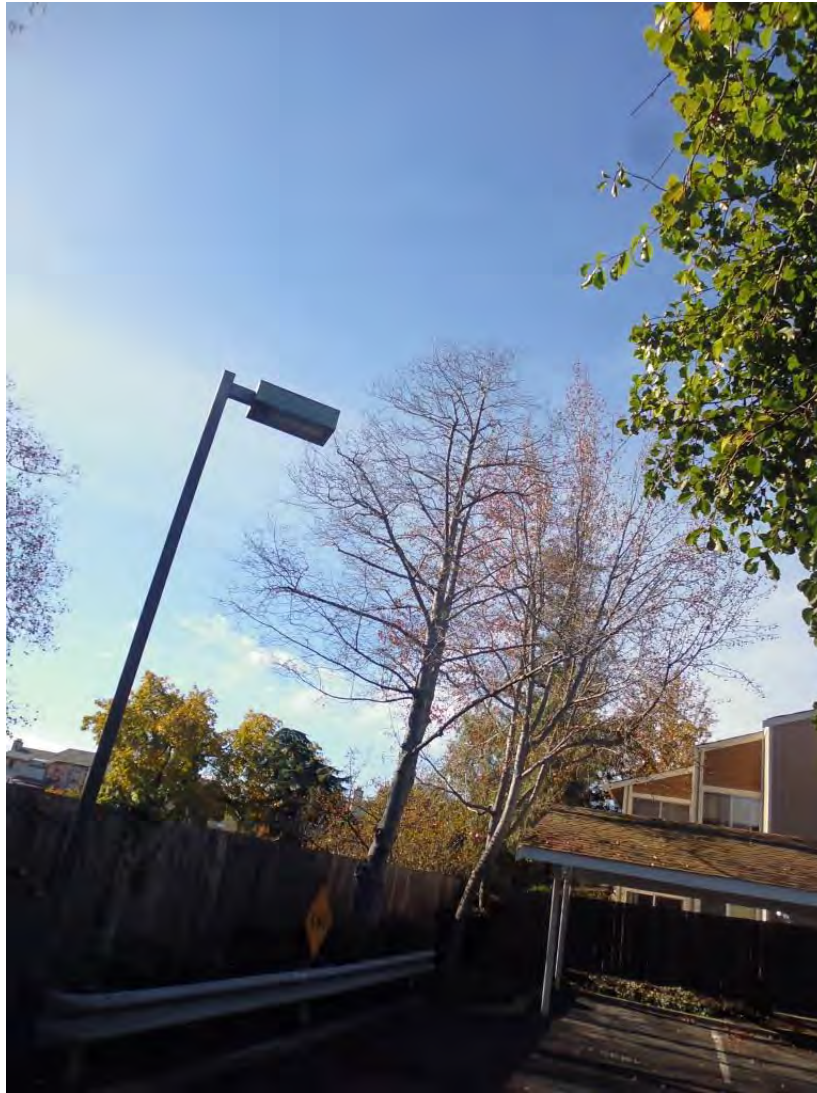
*Liquidamber Styraciflua* / American Sweet Gum. 9" caliper DBH. Approximately 12' spread and 30' height. Fair to good condition. Trees ET21, ET22, ET23, ET24 and ET25 are in narrow planters and beginning to damage the nearby curbs and paving.

*Liquidamber Styraciflua* / American Sweet Gum. 7" caliper DBH. Approximately 12' spread and 30' height. Fair to good condition.

*Populus alba* / White Poplar. 14" caliper DBH. Approximately 15' spread and 25' height. Fair to poor condition. Split trunk.

Off-site trees ET21, ET22 and ET23, Liquidambers and Poplar.

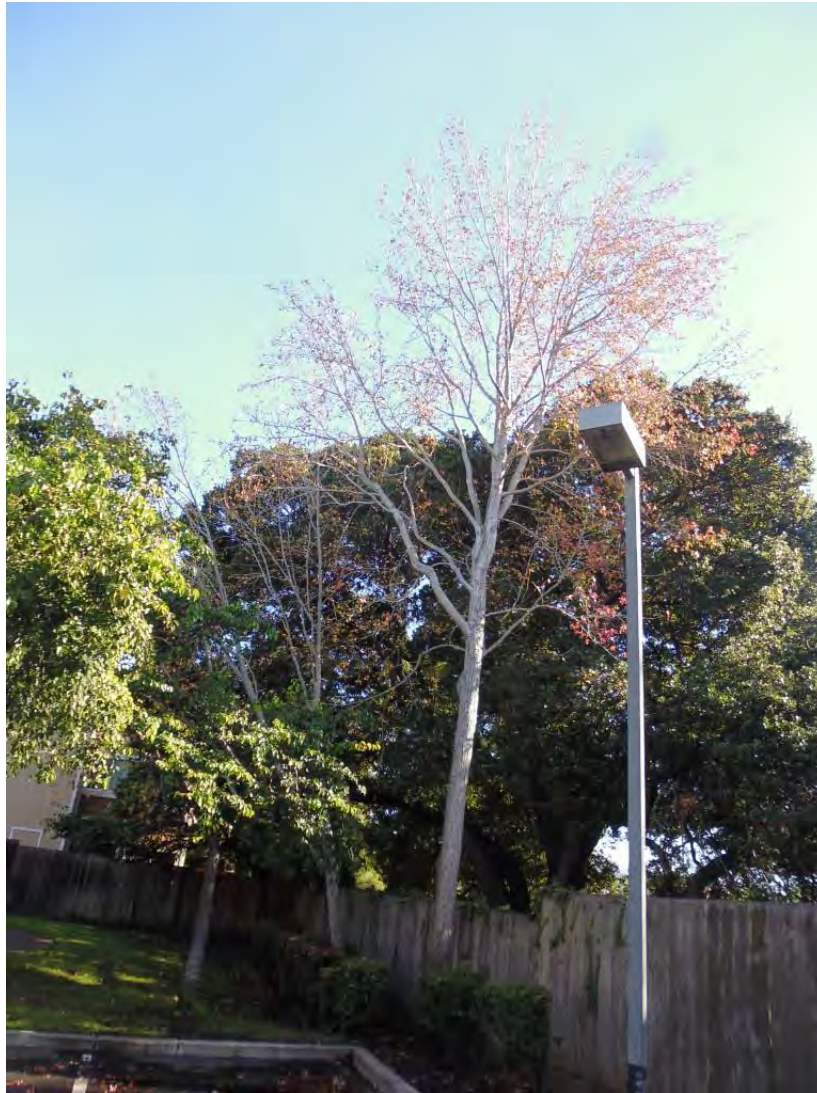
*Liquidamber Styraciflua* / American Sweet Gum. 12" caliper DBH. Approximately 12' spread and 30' height. Fair to good condition.

*Liquidamber Styraciflua* / American Sweet Gum. 8" caliper DBH. Approximately 12' spread and 25' height. Fair to good condition. Crowding the large adjacent on-site Oak tree, ET8. Leans away from Oak.

Off-site trees ET24 and ET25. Liquidambers.

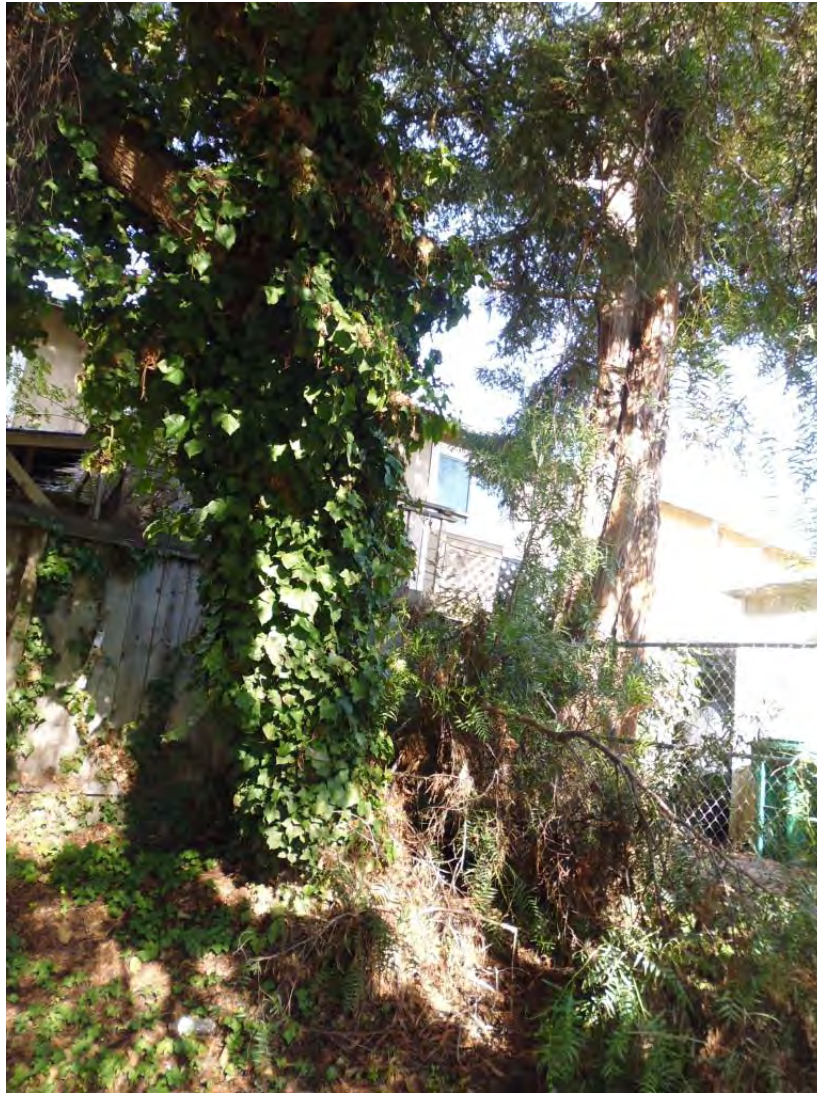
*Sequoia sempervirens* / Coast Redwood. 24" caliper DBH. Approximately 15' spread and 30' height. Poor condition. Not maintained. Vines on trunk. Partially dying crown.

No. ET26. Coast Redwood. 24" caliper.

$V=\$2,375.00$

Off-site tree ET26, Redwood. On right past fence.

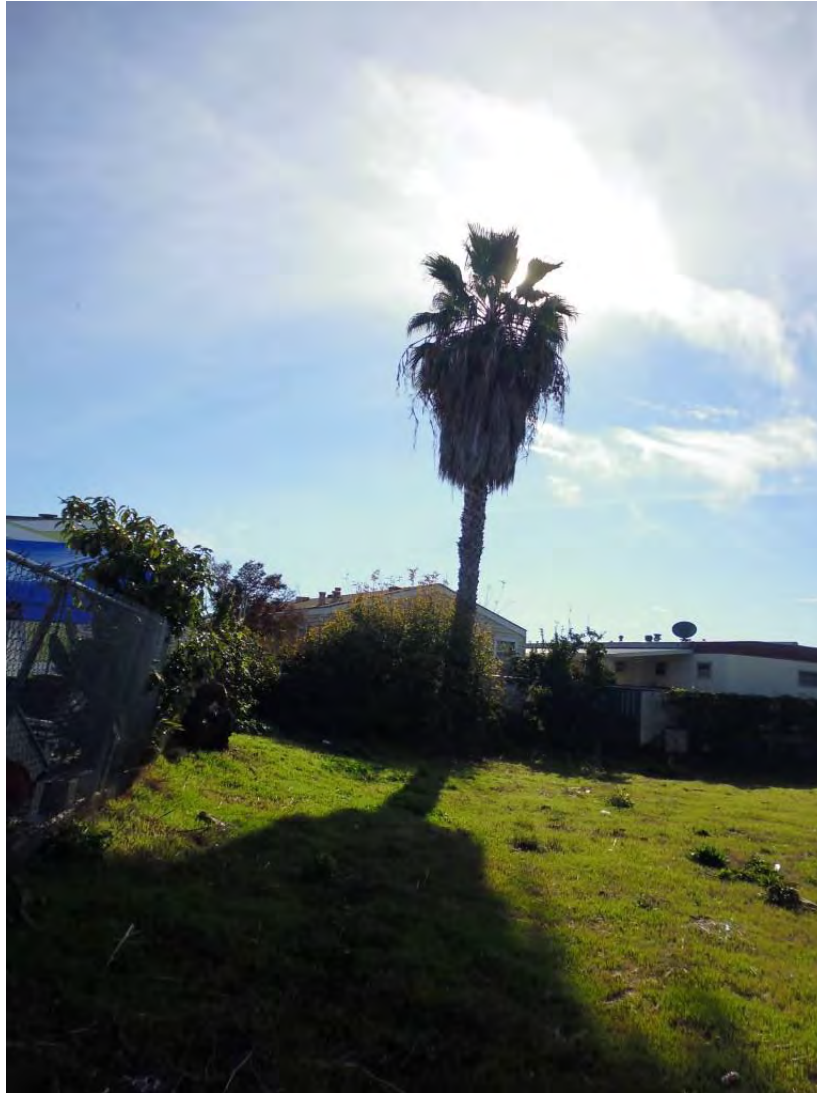
*Washingtonia robusta* / Mexican Fan Palm. 18" caliper DBH. Approximately 10' spread and 25' height. Good condition. Caliper not comparable to other trees due to growth pattern of palm trees.

Tree No. ET27. Mexican Fan Palm. 18" caliper.

Available in the nursery trade. Value=\$500.00

Off-site Tree ET27. Mexican Fan Palm.
