| <b>DOCKETED</b> | |
|---|---|
| <b>Document Title:</b> | Calpine Russell City Steam Turbine Generator Event Investigation Report - Redacted |

# Investigation Report

## Calpine Russell City Steam Turbine/Generator Event

Calpine Corporation - Russell City Energy Center

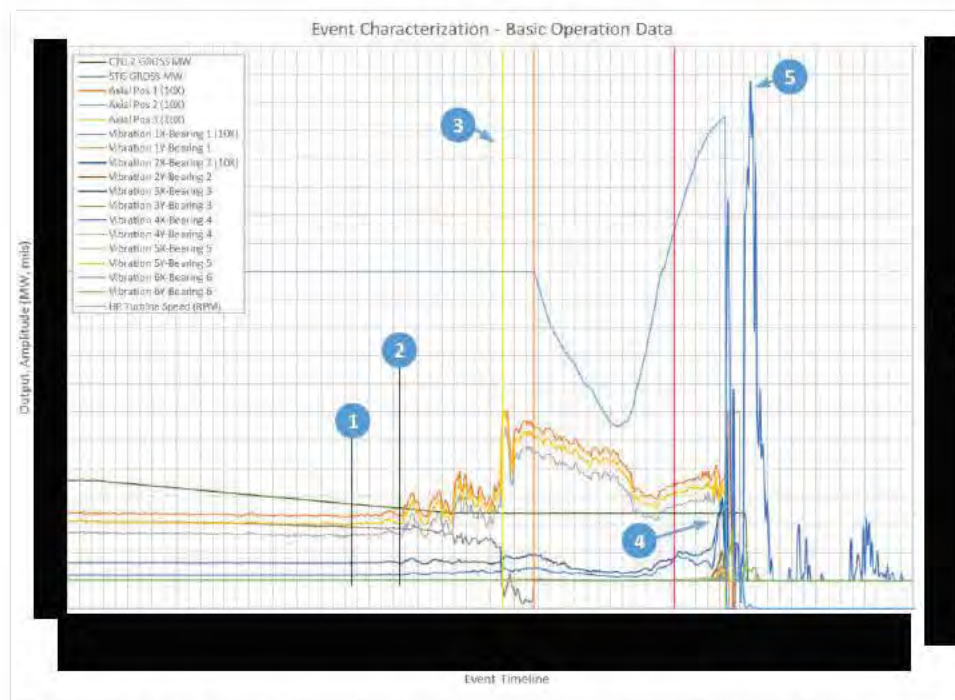
**Figure 5-2 - Event Characterization - Basic Operation Data (Continued)**

Minor trends (1) are visible beginning at [REDACTED] in **Figure 5-2** with the axial position probes and radial bearing 1X and 2X appearing inconsistent with prior operation, although these would likely not raise concern until a more significant (2) step change occurs at [REDACTED] within the axial position probes. The second (2) step change is consistent with STG load fluctuations identified in **Figure 5-1**.

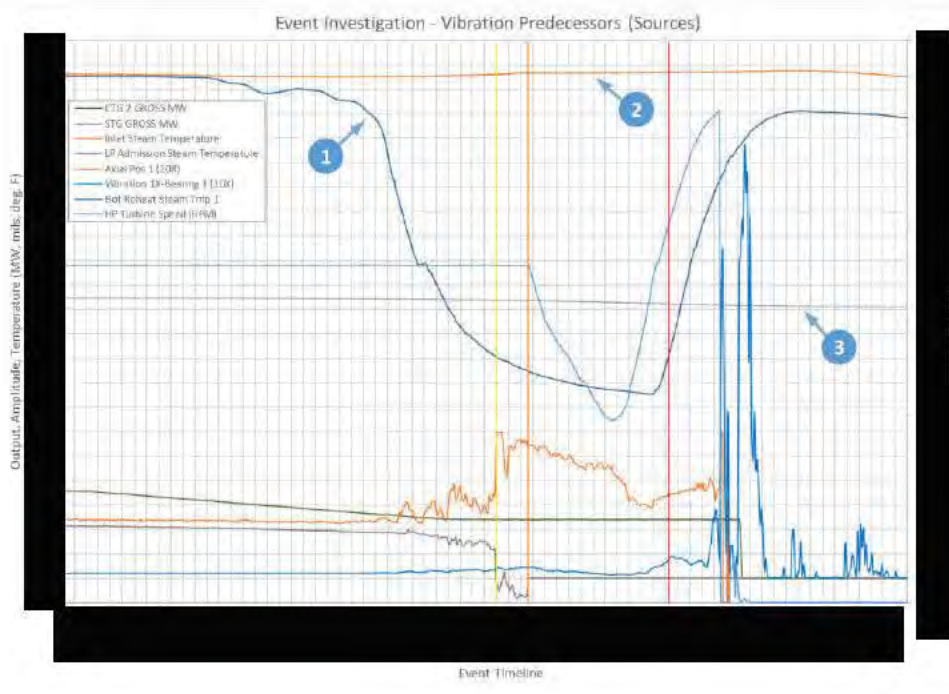
Figure 5-3 - Event Investigation - Vibration Predecessors

Based on the operational data review of STG speed, power output and vibrations, it has been identified that the overspeed event was substantially initiated by a water induction event. Review of HP, IP and LP inlet temperatures was utilized to isolate the turbine section that initially experienced this water induction. The IP section showed a significant reduction in temperature prior to the event and corresponding with the initial minor vibration trends identified in Figure 5-2. As shown in Figure 5-3, HP steam (2) inlet temperature and (3) LP admission steam temperature remained steady throughout the event, however, the (1) HRH steam entering through the right of the IP turbine showed a rapid reduction in temperature consistent with the induction of liquid water vs. steam.

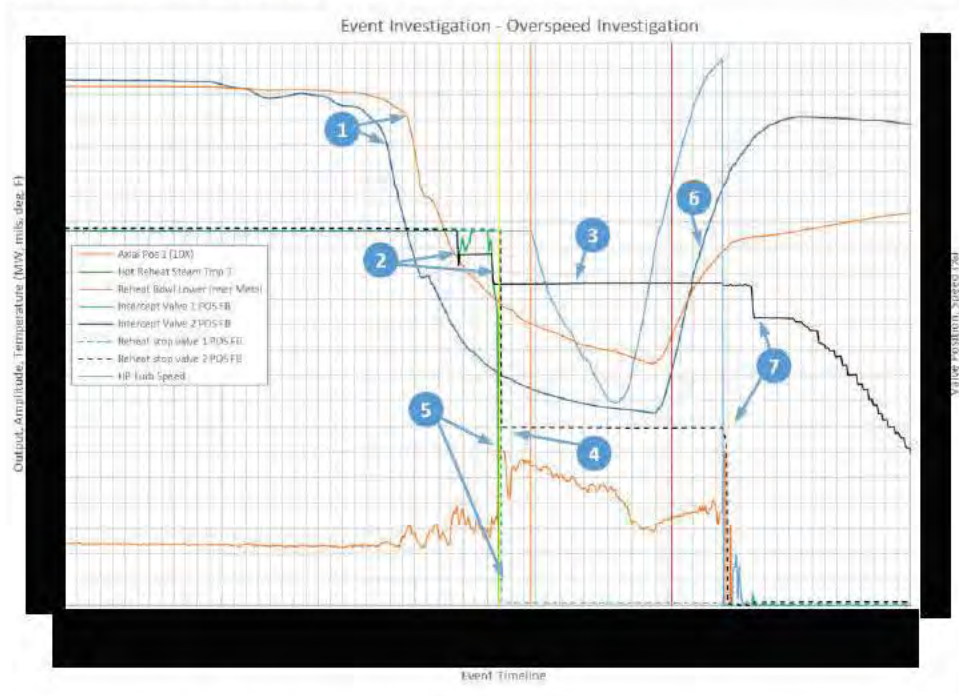
**Figure 5-4 - Event Investigation - Overspeed Investigation**

**Figure 5-4** shows that (1) both the right HRH pipe beneath the STG and the right IP lower bowl temperatures were rapidly reduced from operating temperatures of approximately [REDACTED] to less than [REDACTED] when (2) both CRV IVs began to throttle in response to shutdown activities as described in **Section 4.4**. At this time, the right HRH pipe and IP lower bowl showed the presence of water versus the left HRH pipe and IP lower bowl, providing explanation as to why the IV #2 was (3) unable to close in response to flow throttling and RSV #2 in response to the trip command to (4) close all stop valves. At the time of the steam turbine trip, the left IP lower bowl temperature had begun to drop below [REDACTED] indicating a much smaller volume of water had entered through the left HRH pipe, allowing (5) IV #1 and RSV #1 to throttle and close as commanded.

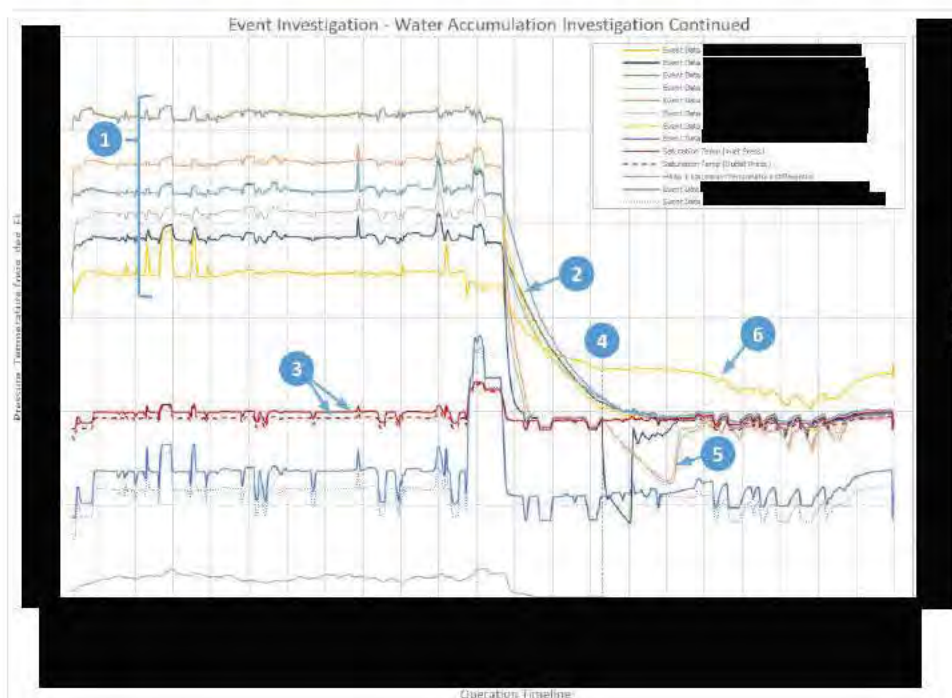
**Figure 5-10 - Water Accumulation Investigation Temperature Plot**

Temperature traces (1) show representative temperatures through the RH circuit including the inlet, 3 harps, and outlet; these traces show that the RH steam was steadily increasing in temperature when HRSG #1 was in service. These temperatures (2) decline after HRSG #1 is taken out of service. RH harp 1 drain ( ) temperatures, followed by harp 3 drain ( ) temperatures, decline first, followed by drops in temperature at the upper region thermocouples.

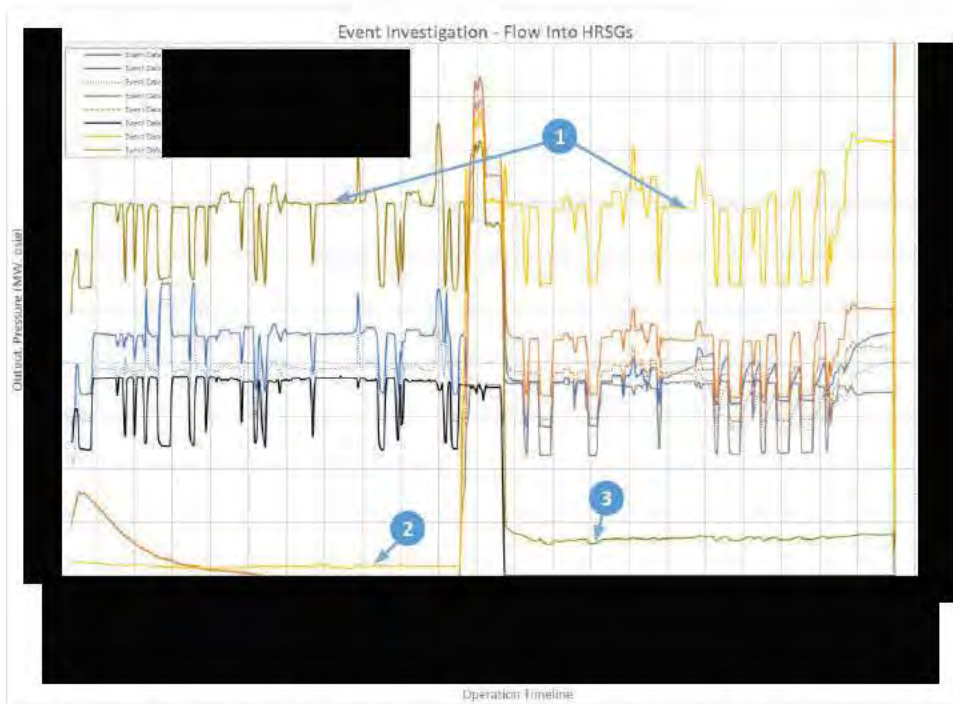
**Figure 5-12 - Event Investigation Flow into HRSGs**

The CRH Flow Balance Flowmeter is in-line downstream of the HRSG CRH SV, CRH flow balance valve and HP bypass piping. As shown in **Figure 5-12**, (1) both HRSG #1 and HRSG

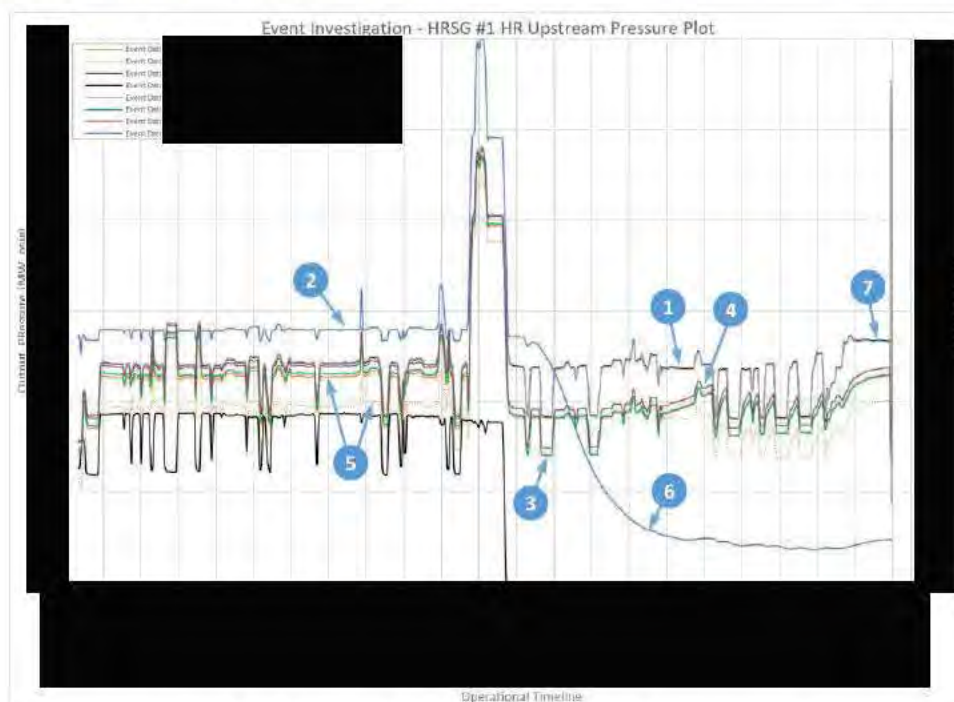
Plotted in **Figure 5-13**, the pressures upstream of HRSG #1 are shown for the (1) CRH pipe upstream of the CRH SV, (2) HP bypass system (plotted on the secondary Y scale), (3) CRH flow meter, (4) IP superheater, and both the (5) RH inlet and outlet. Initially, after the shutdown of block 1, the HP bypass system remained at approximately [REDACTED]. However, after approximately [REDACTED], the (6) pressure bleeds off to less than [REDACTED]. Throughout the majority of block 2's operation, both CRH pipes remain at approximately [REDACTED] sig with the exception of the [REDACTED] prior to the event where the pressure (7) increases to approximately [REDACTED] without a load increase on CT 2.

- Flow from the CRH piping through HRSG #1 CRH SV
  - The (1) CRH pipe upstream of the CRH SV remains at a higher pressure than the (3) CRH pipe leading to the RH system throughout the duration of operation.
  - The CRH upstream pressure fluctuates with operation of block 2 and pressures downstream of the CRH SV follow these fluctuations. This pressure association appears to indicate flow across the CRH SV.

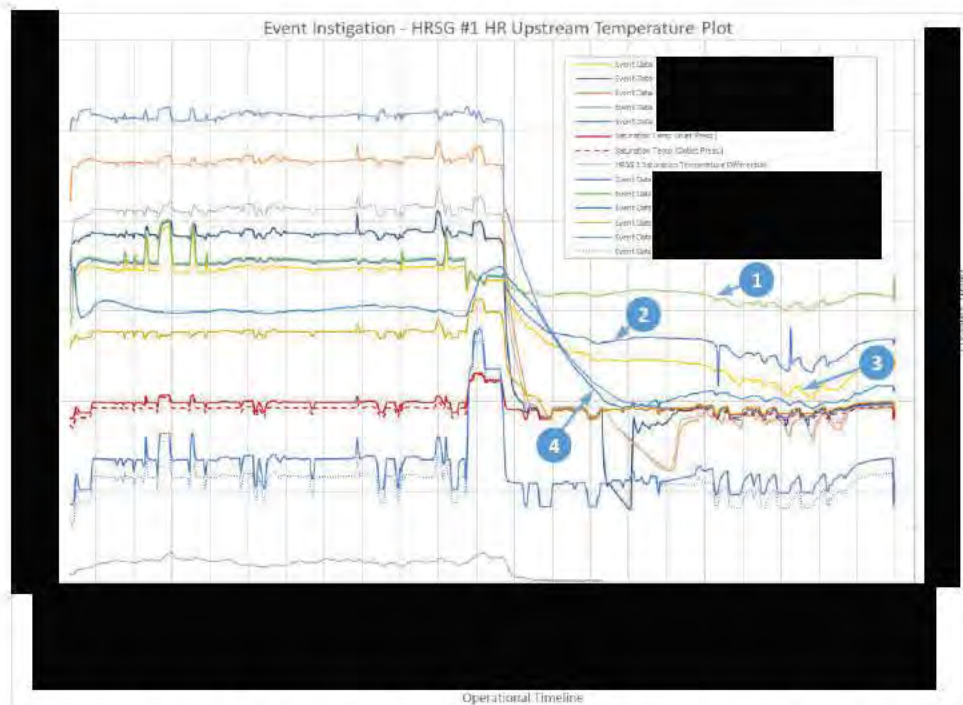
**Figure 5-14 - HRSG #1 HR Upstream Temperature Plot**

- Based on the low supply pressure from the IP superheater and the {Figure 5-14 (3)} temperatures within the IP superheater piping, it is unlikely that this contributes any significant steam flow or pressurization of the HRSG #1 RH.
