Preliminary Arborist Report

24041 Amador Street Hayward, CA 94544

PREPARED FOR: City Ventures 1185 Old Mason Street San Francisco, CA 94123

April 29, 2025

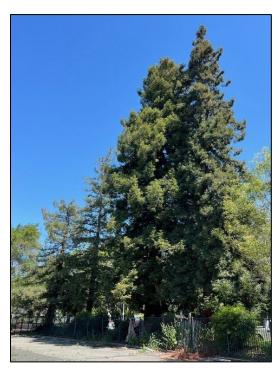
Photo 4. Coast redwoods #501 – 503 (L-R). Redwood #503 was the largest tree on-site with a 58-inch trunk diameter.

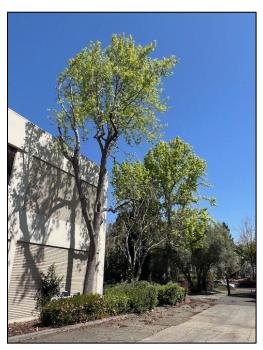
Photo 5. Sweetgum #515 was in poor condition with poor structure and form and a history of poor pruning.
