## Preliminary Arborist Report

**24041 Amador Street**  
Hayward, CA 94544

**April 29, 2025**

**Updated July 7, 2025**

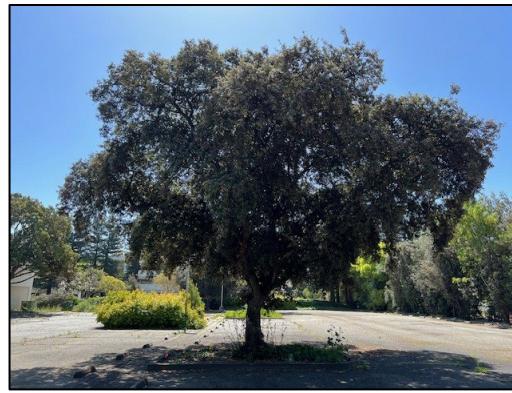
**Photo 1.** Holly oak #534 was in good condition with a wide, healthy crown.

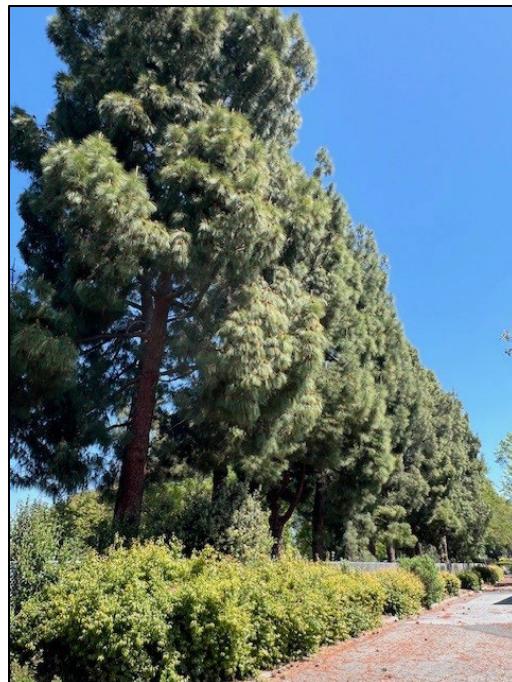
Seventeen (17) Canary Island pines were located off-site to the north between the Centennial Park parking lot and the chain link fence separating the properties (Photo 2). Trees were located approximately 4 - 8 feet north of the fence, with branches overhanging the site by 2 – 10 feet. Pines had typical upright growth habit with good or fair structure and form. Thirteen (13) trees were in fair condition with minor branch dieback and thinning crowns. Pines #564, 565 and 571 were in good condition with large, full crowns and good structure. Pine #563 was dead. Trees were mostly mature in development with trunk diameters ranging between 10 – 41 inches, averaging 22 inches.

**Photo 2.** Canary Island pines #574 – 560 (L-R) were growing off-site 4 foot off the fence line.

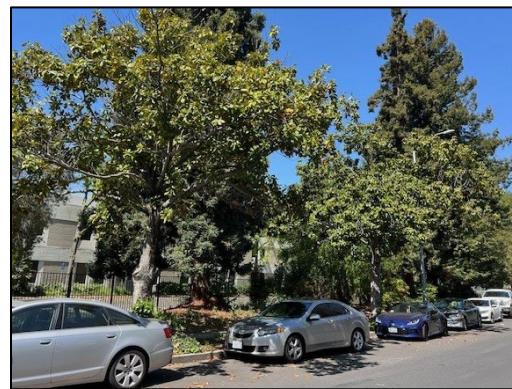
**Photo 3.** Southern magnolias #508 and 509 were street trees located on the southeast side of the site.

Street trees #508 and 509 should have type II fencing 6' x 6' around each tree well using free-standing chain link to protect the trunks from impacts during construction.

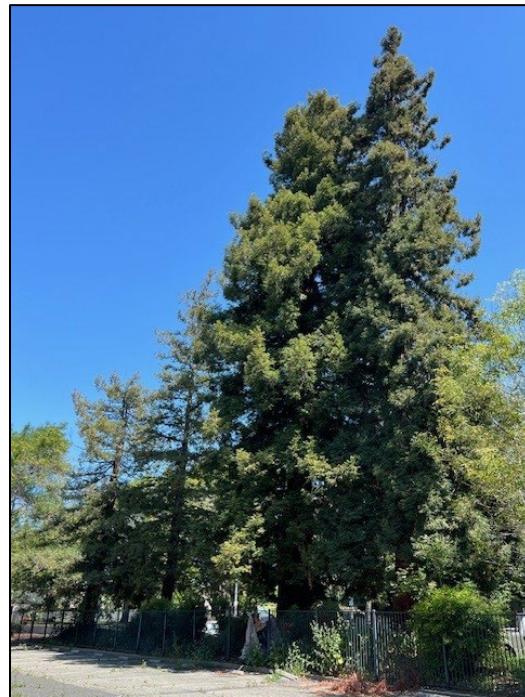
Of the eight coast redwoods, five were in good condition with typical upright form and good foliage color. Redwoods #501, 502 and 558 were in fair condition with thinning crowns, minor browning foliage, and #501 had a broken top at 40 feet. Redwoods #511, 557 and 558 were located off-site to the south with branches overhanging the site 10 – 20 feet. Trees were semi-mature in development with trunk diameters ranging from 25 – 58 inches, averaging 33 inches. Redwood #503 was the largest tree on-site with a 58-inch trunk and a full crown (Photo 4).

**Photo 4.** Coast redwoods #501 – 503 (L-R). Redwood #503 was the largest tree on-site with a 58-inch trunk diameter.

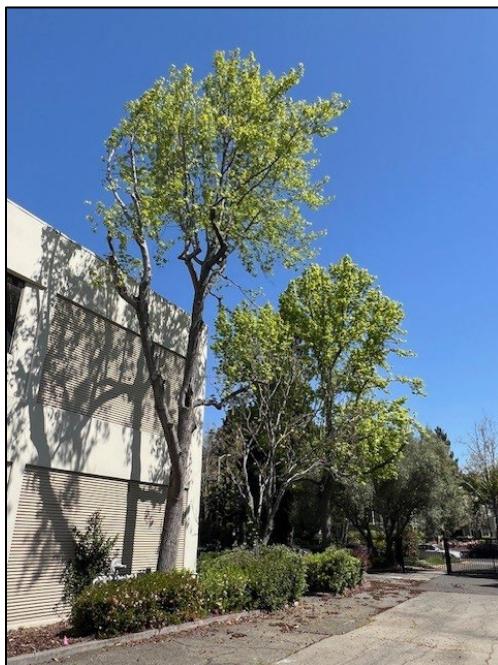
Four of the seven sweetgums were in fair condition with fair structure and form. Most had reduced crowns with epicormic sprouts growing throughout. Sweetgums #515, 523 and 524 were in poor condition with major branch dieback, poor structure and form and a history of poor pruning (Photo 5). Trees were semi-mature in development, with trunk diameters ranging between 12 – 20 inches, averaging 16 inches.

**Photo 5.** Sweetgum #515 was in poor condition with poor structure and form and a history of poor pruning.

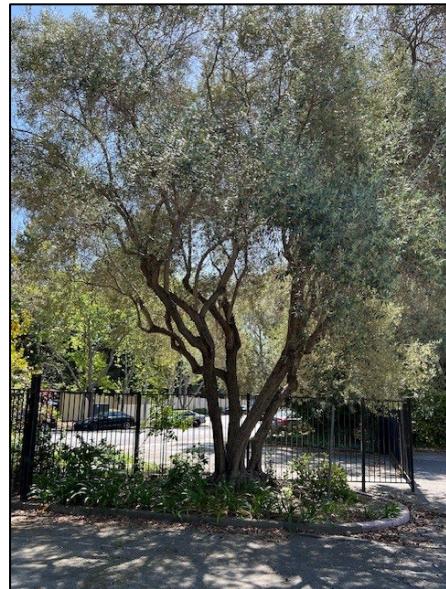
**Photo 6.** Olive #512 was previously topped at 15 feet and in fair condition.

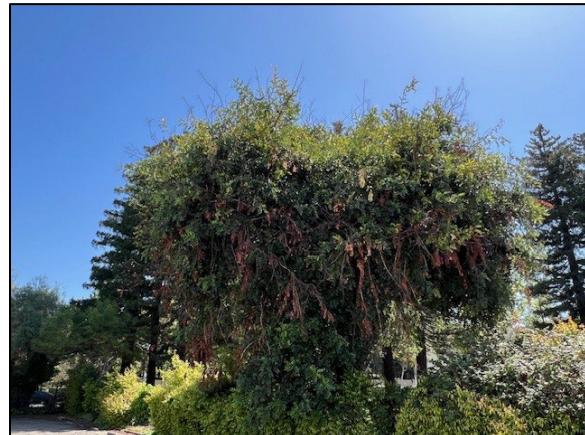
- Carobs #529 and 531 were in fair condition; both were located off-site on the south side of the property. Trees had large, wide crowns with small branch and tip dieback (Photo 7). Trees were located 2-3 feet off the south fence line and branches were overhanging the site by 8-10 feet. Trunk diameters were estimated at 28 and 24 inches, respectively.

**Photo 7.** Off-site carob #531 was in fair condition with small branch and tip dieback.

3. Off-site evergreen ash #559 is located on the northeast side with branches overhanging the project site by 20 feet. Carobs #529 and 531 may also require the reduction of branches over the site. Branches should be pruned back to avoid interfering with construction equipment.
