RE: Alquist-Priolo Earthquake Fault Report and Geotechnical Investigation Report
Maple & Main Mixed-Use Development - Hayward, California
SFB Project No.: 911-1

Maple & Main, 911-1.002

**GEOTECHNICAL FEASIBILITY INVESTIGATION
AND FAULT RUPTURE HAZARD ASSESSMENT
22330 MAIN STREET
HAYWARD, CALIFORNIA
*SFB PROJECT NO. 648-1***

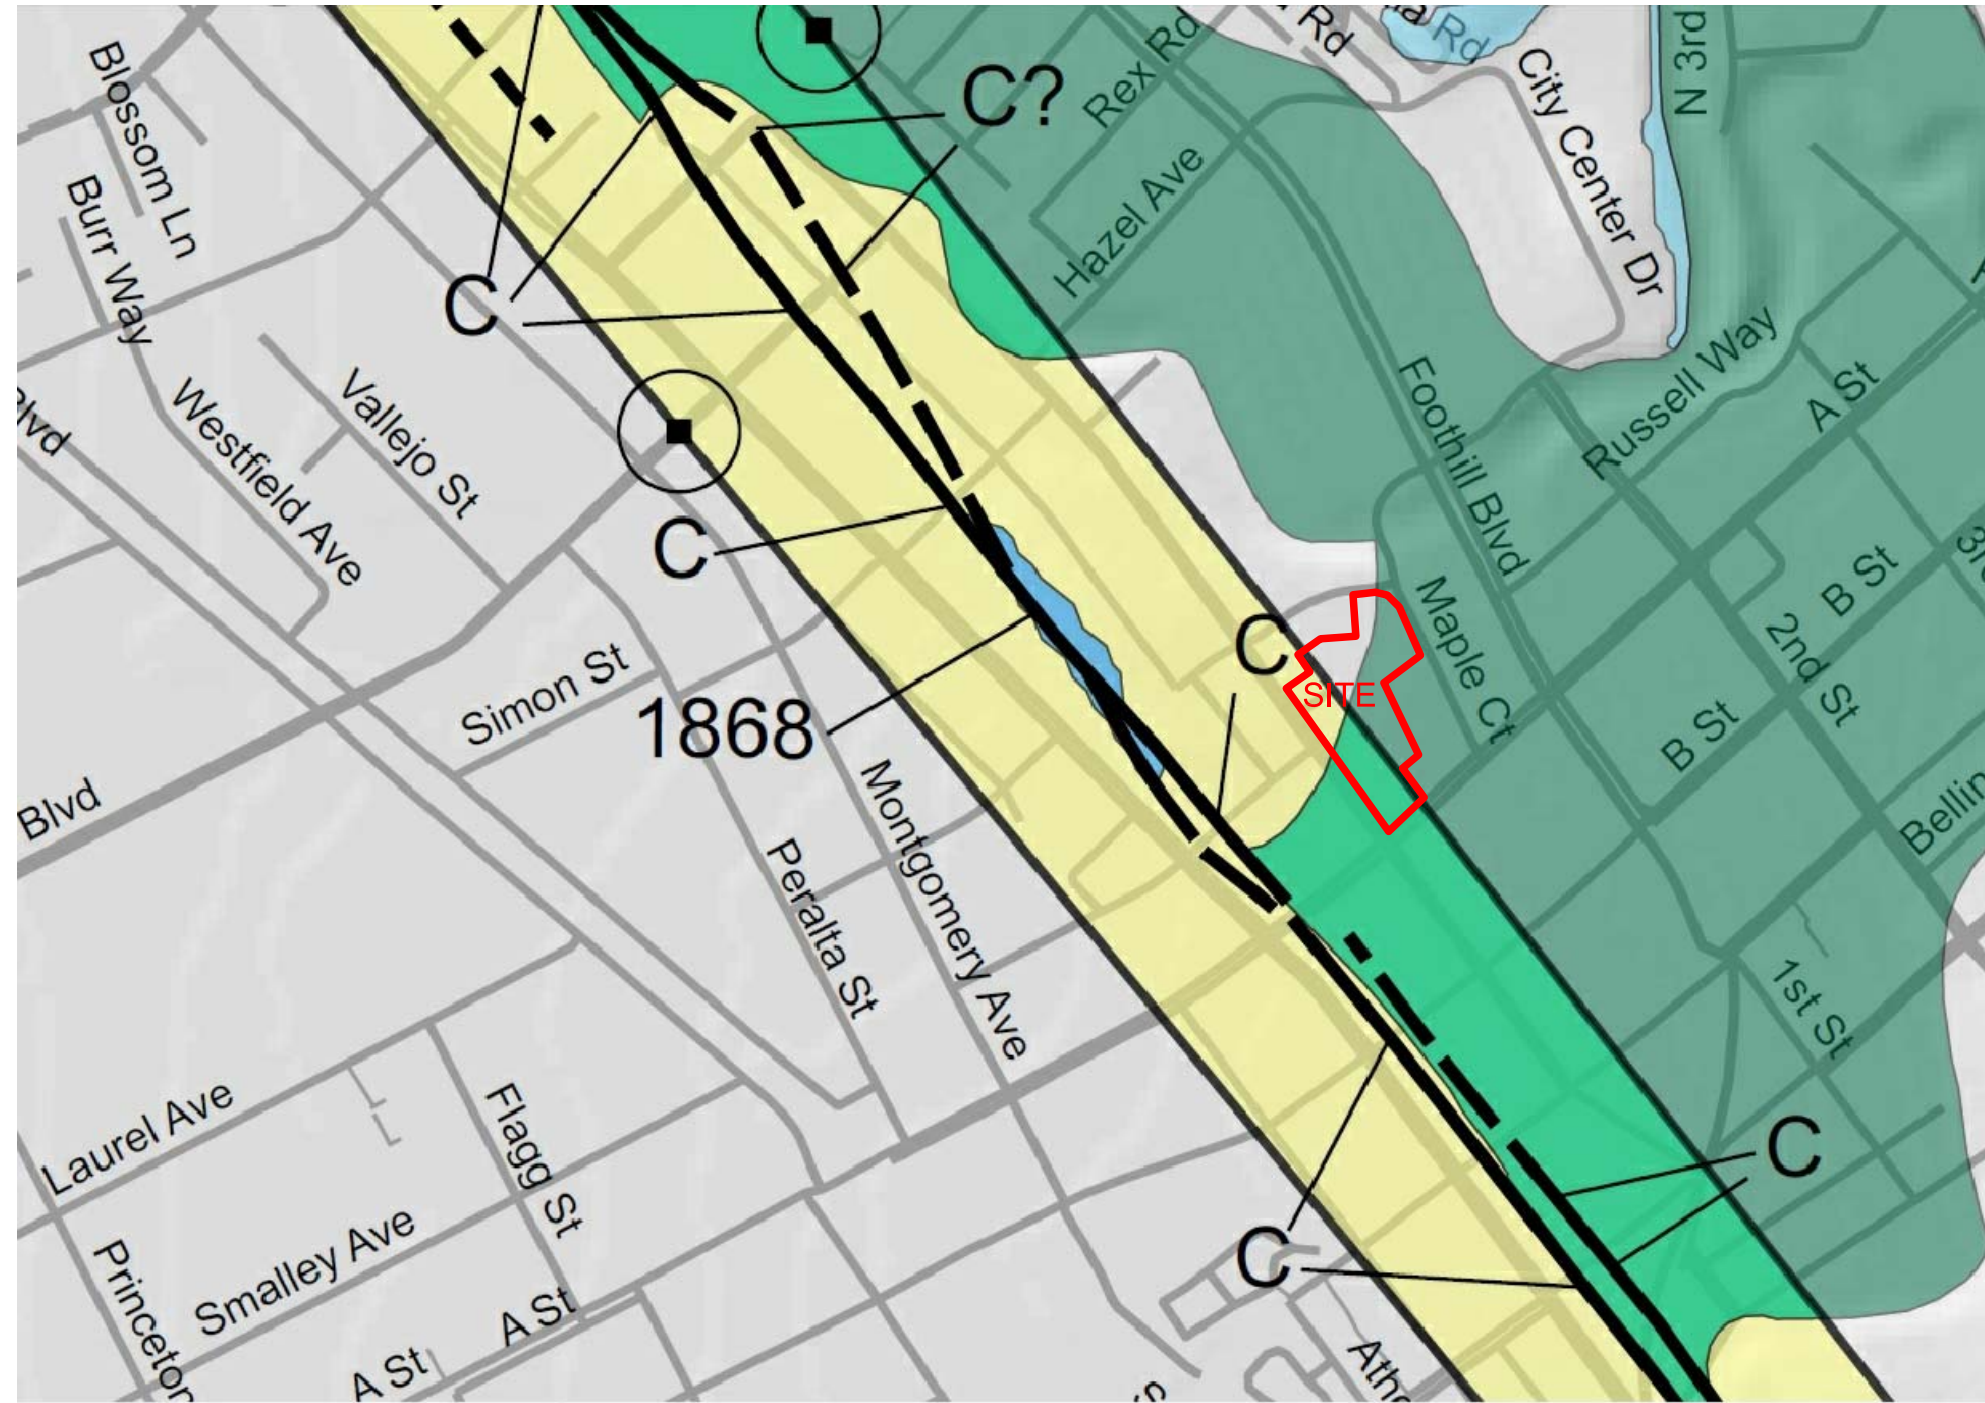
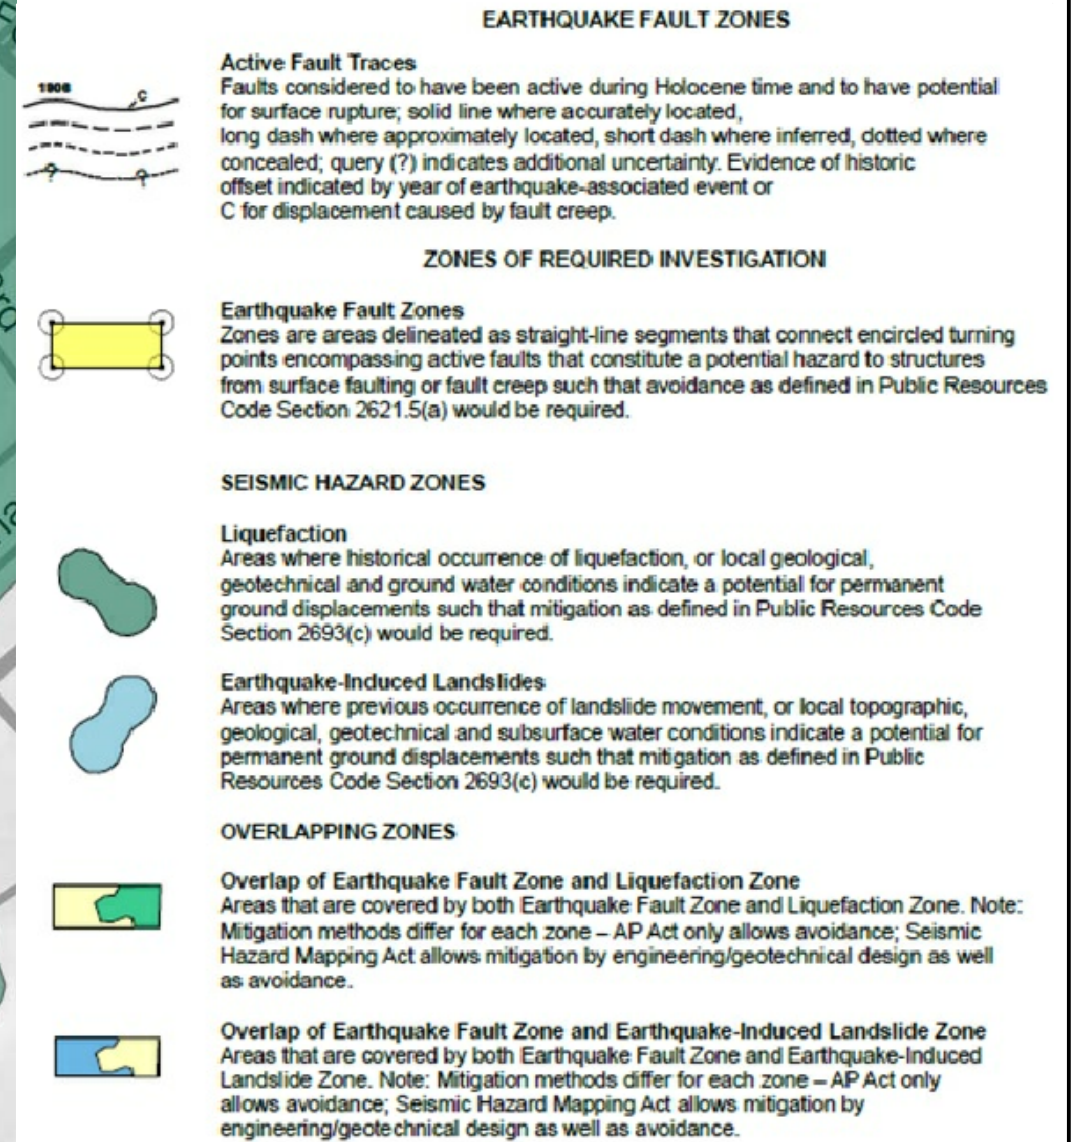
As shown on Figure 4, the approximately southwestern half of the site is located within a State of California, Alquist-Priolo Earthquake Fault Zone as delineated by the California Geological Survey (CGS) for the Hayward fault. The Hayward fault shows evidence of historic ground rupture and on-going fault creep. This fault zone is based on the information and conclusions contained in the CGS Fault Evaluation Report FER-103 (Hart, 1981). CGS Note 49 (2002), *Guidelines for Evaluating the Hazard of Surface Fault Rupture*, was followed during our fault rupture hazard evaluation.

Figure 4 also shows that the approximately eastern half of the site is located within a seismic hazards zone. This zone was established to delineate areas where historical occurrence of liquefaction has occurred, or local geological, geotechnical and groundwater conditions indicate a potential for permanent ground displacements such that mitigation measures would be required.

having liquefaction susceptibility^{2,3}. According to the Seismic Hazard Zones Map of the Hayward Quadrangle (see Figure 4), part of the site is located in a seismic hazard zone due to liquefaction as designated by the State of California. As shown on Figure 7, liquefaction related ground damage has been historically reported in the vicinity of the site.

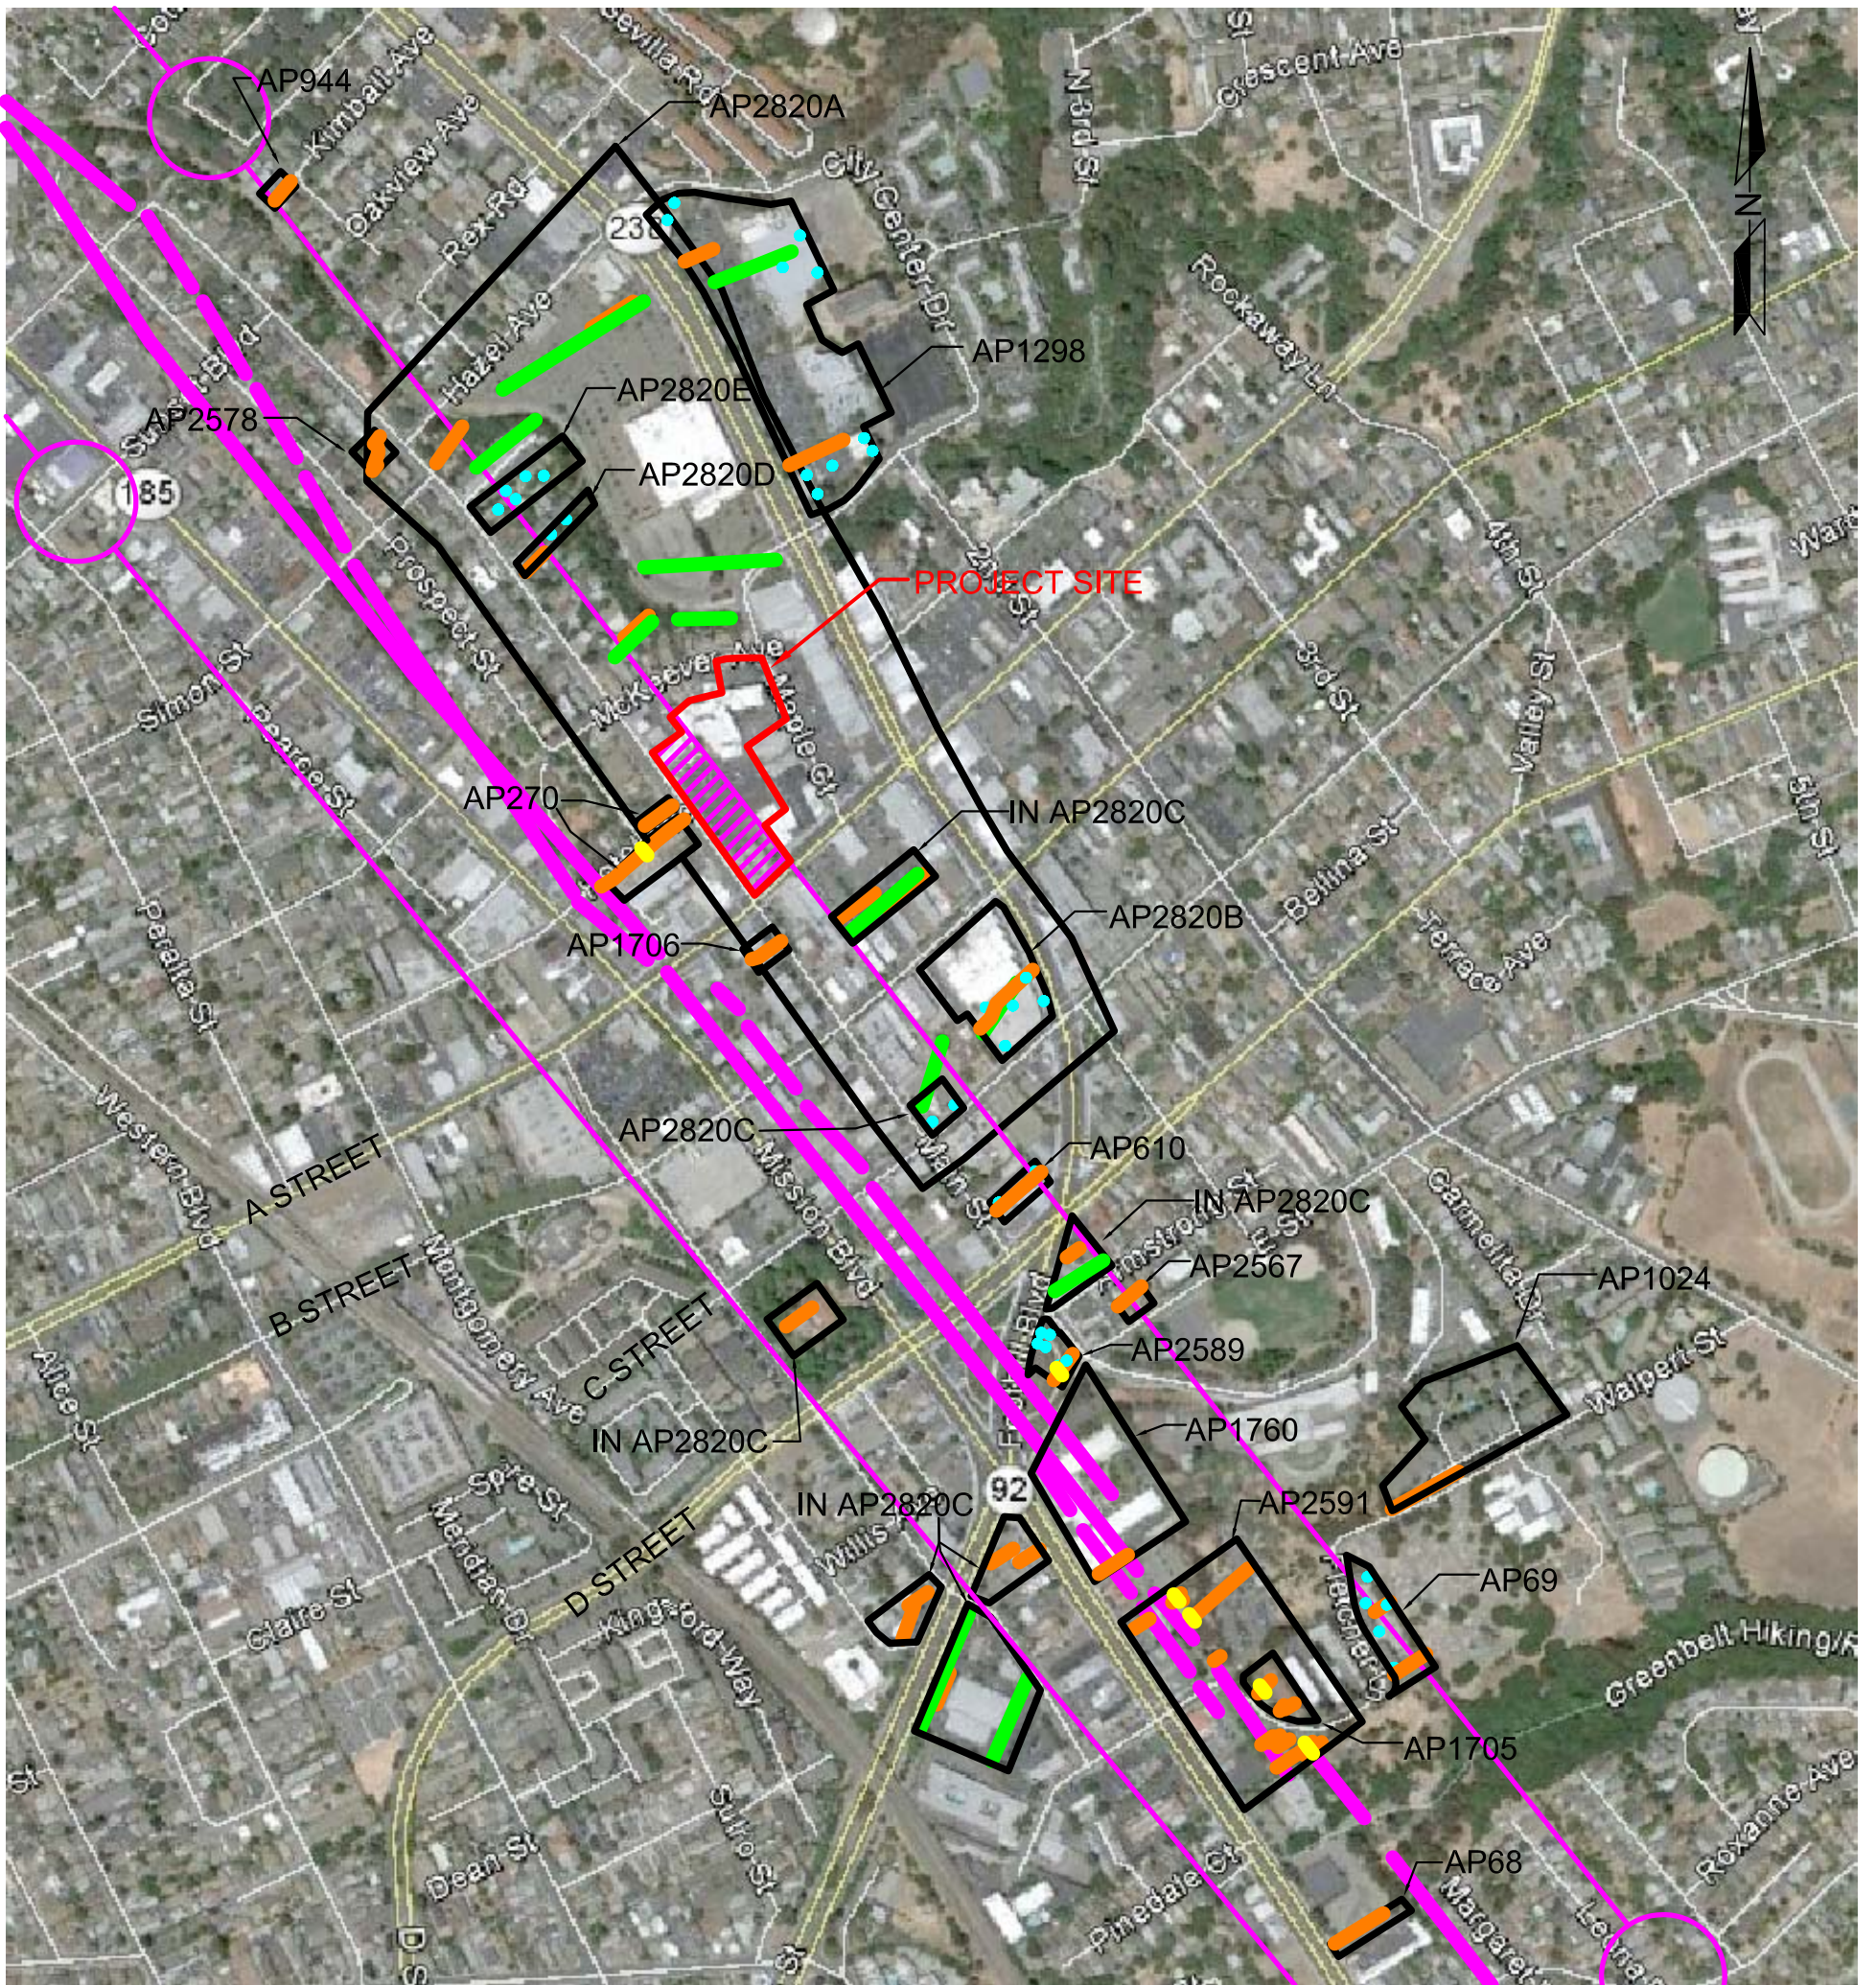
DATE		1600 Willow Pass Court Concord, CA 94520 Tel 925.688.1001 Fax 925.688.1005 www.SFandB.com	REGIONAL FAULT STUDY MAP	FIGURE
November 2014			22330 MAIN STREET	5
PROJECT NO.			Hayward, California	
648-1

The Hayward fault is also characterized by active surface fault creep. Offsets and cracking of surficial improvement, such as curbs, gutters, roads, and walls, can be found in several areas along the main trace of the Hayward fault. Figure 4 shows solid fault lines with the designation “C” which indicate where fault creep has been observed. Creep monitoring stations have been used by the U.S. Geological survey for many years. Lienkaemper (2006) shows recently active traces of the Hayward fault on his maps, with creep data being a primary source of information.

We have observed surface fault creep in similar locations as delineated by Lienkaemper (2006). We did not observe any fault related features onsite or surrounding the site.

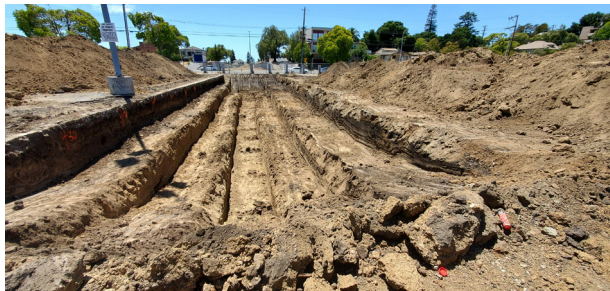
View of Trench T-1 looking toward Main Street.

Kevin Ryan, CEG, logged the southernmost trench wall, and the log and findings are presented in Appendix A of the updated **SFB** report (**Item 1**). The results reveal no evidence of faulting within the continuous geologic stratigraphy of the trenched area. A reconnaissance of the Main Street area did not detect any evidence of fault creep or fault-related distress in the street or adjacent vicinity, including a paved parking lot covering much of the project site. They conclude that surface fault rupture should not be a detriment to the project.
