December 11, 2024 (revised September 4, 2025)

This revised arborist report addresses the proposed townhomes project at 1101 Walpert Dr, Hayward. **Notable changes to the report are highlighted in red**; minor content or wording changes were not specifically highlighted. For this report, I used the following references:

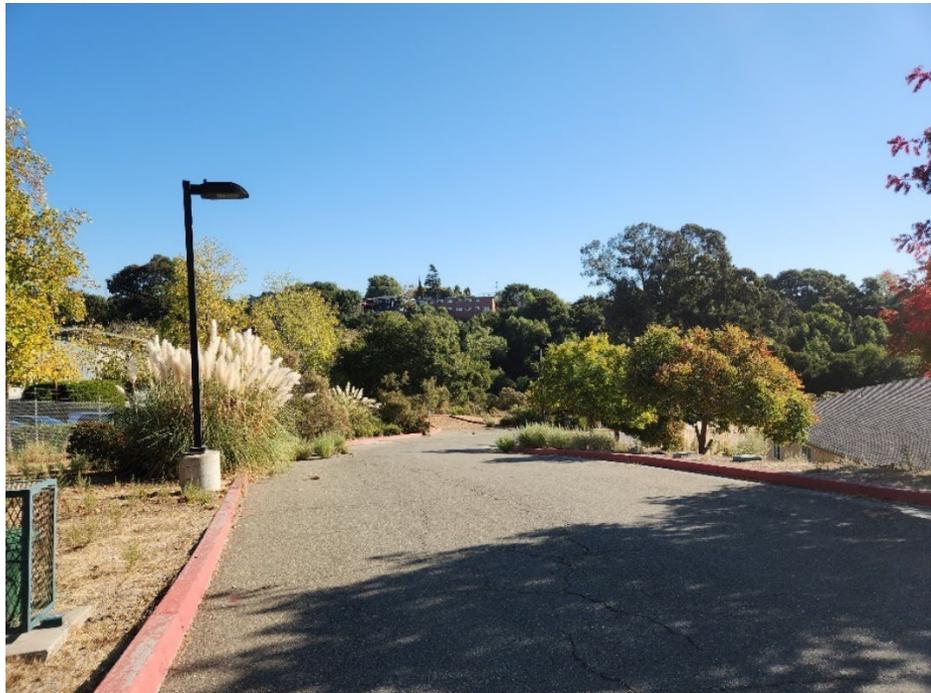
Figure 1. Photo taken facing south to the larger parcel; the tallest tree right of the center is growing on the creek bank.

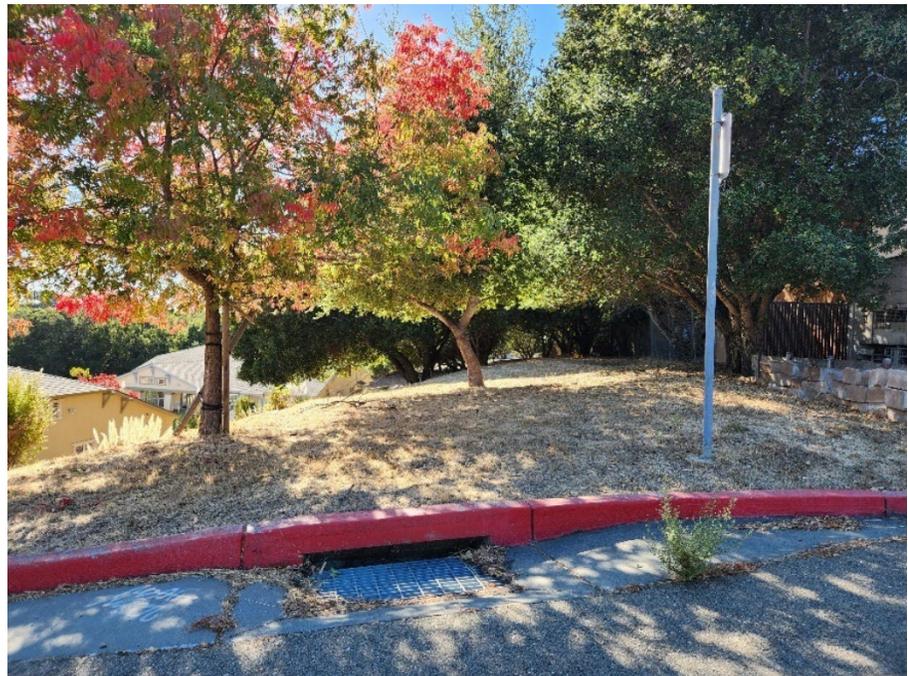
Figure 2. The central oak grove is visible in the background, at the border between the north and south parcels. Several oaks will be removed due to new retaining walls and accessibility ramps; others may be affected by landscaping within the area.

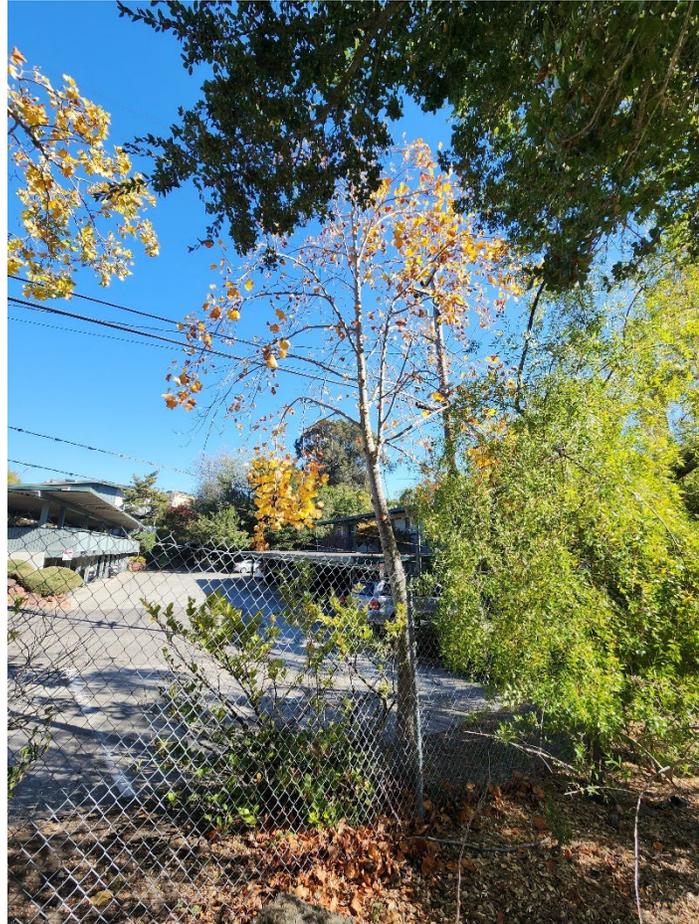
Figure 3. Tulip tree #80 grows on the apartment's side of the fence. Its stunted and sparse canopy is likely due to insufficient water. Parking spaces extend within 2' of its trunk on the apartment side.

- The project arborist shall be on-site during grading or excavation by trees #79, 80, 82, 83, 85-87 & 98 (8 trees). If root loss is significant and there is no flexibility in working around roots, the tree(s) may need to be removed.

- Trees #79, 85, 87 & 98 are considered protected.
 - Trees #79, 80, 82, 83, 85-87 & 98 are co-owned or off-site and require the neighbors' approval for removal.

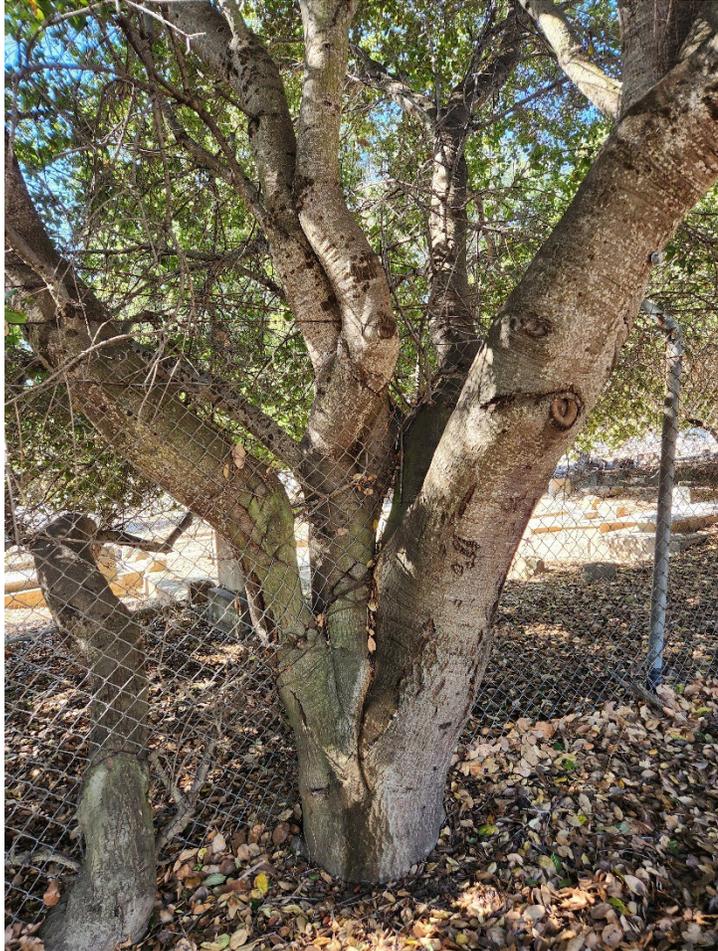
been cut down before but could not be completely eliminated because of the fence. They have since regrown with multiple trunks, which are all embedded in the fence (Figure 4). I expect this issue to recur as long as the fences exist, and there may be structural or health complications in the future. Additionally, the west perimeter trees are very crowded. Their overall forms and structures are affected, since the less-dominant trees are forced to lean out from under the larger trees to reach sunlight.

Figure 4. Tree #65 is an example of the trees growing along the west property line. Its trunk grew at the fence, which has now been embedded into the wood. The small tree at the left of the photo is forced to grow in an odd way to reach sunlight.

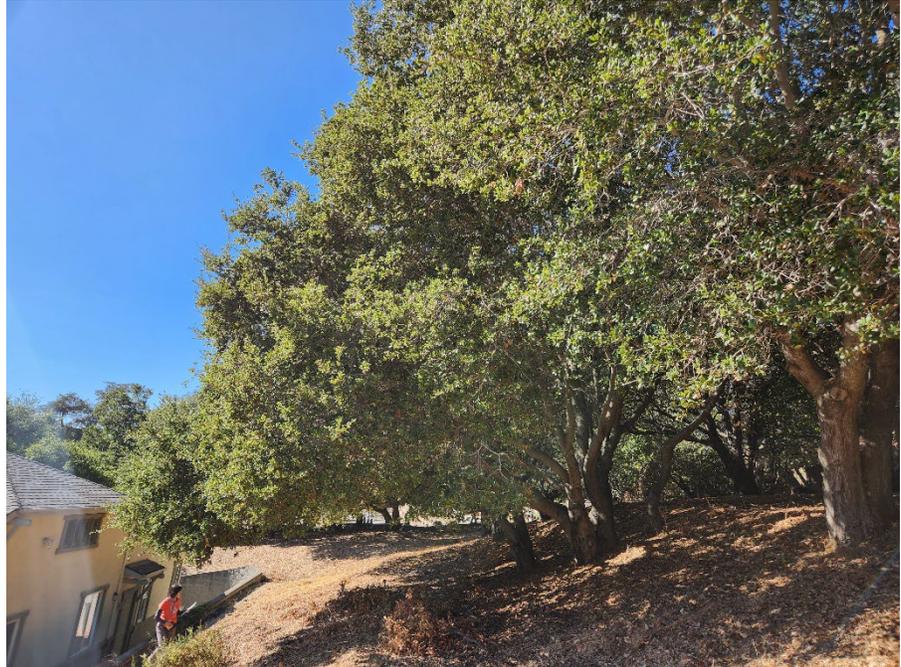
Figure 5. Oaks #53-55 (center) and #51 (right) are part of the oak grove. #51 is in the accessibility switchback and must be removed; the others may be affected by landscaping improvements but the plan was not yet available.

Several tall retaining walls were already constructed on the south parcel – one separating the buildings from the oak grove (Figure 5), and another supporting the fire turnaround portion of the driveway by trees #73 & 74. **The southernmost retaining wall was shifted north, which creates enough distance from oak #73 that it can be preserved (though other trees affected by retaining walls will still be removed). This change means that an additional protected tree can be preserved.**
