Arborist Consultation Services

July 17, 2023

Arborist Report: 22872 Main Street, Hayward, CA

Project Address: 22872 Main Street  
Hayward, CA 94541

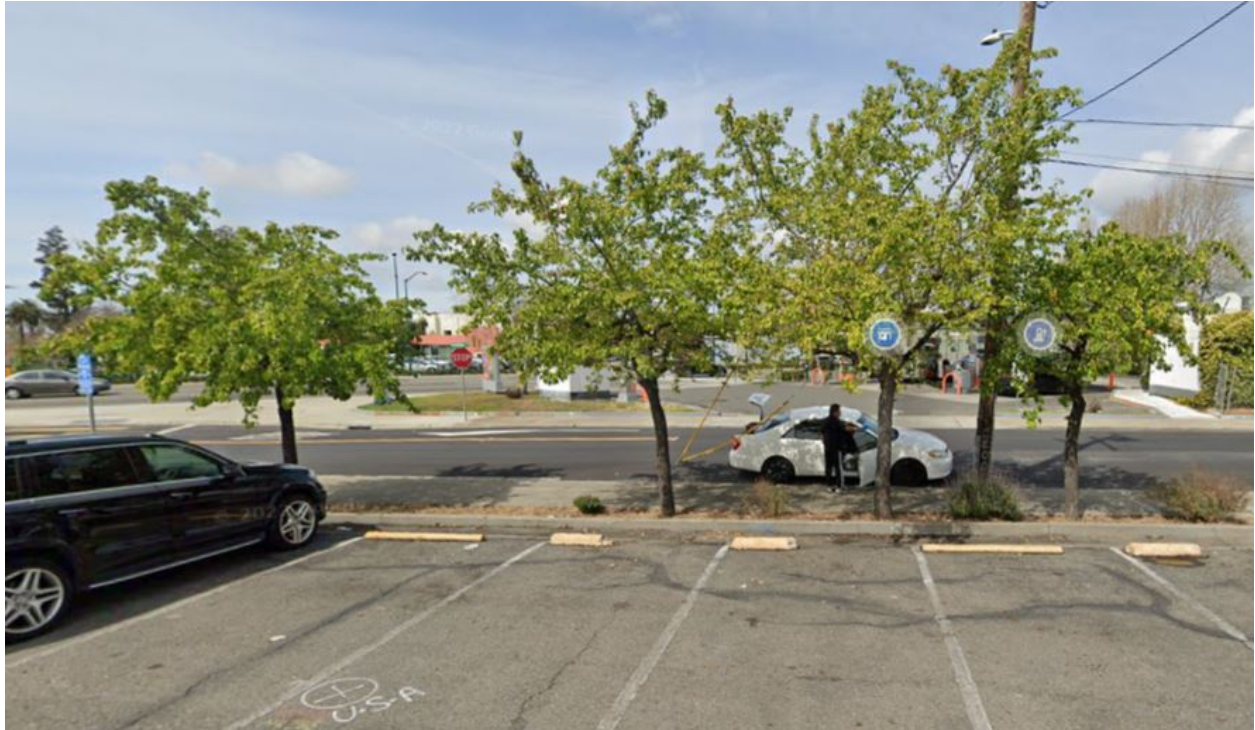
Trees 1 to 4, from left to right. *Pyrus kawakamii* in fair *condition, form, and structure*. Planted in narrow planter.

| Tree # | Name | DBH | Approx Height | Structure | Form | Overhall Condition/Vigor | Suitability/Notes | Assessed Value |
|---|---|---|---|---|---|---|---|---|
| 1 | Pyrus kawakamii | 8" | 15-20' | 3 | 3 | 3 - Fair, small planter | Tree has been removed | \$ 482.00 |
| 2 | Pyrus kawakamii | 8" | 15-20' | 3 | 3 | 3 - Fair, small planter | Tree has been removed | \$ 482.00 |
| 3 | Pyrus kawakamii | 8" | 15-20' | 3 | 3 | 3 - Fair, small planter | Tree has been removed | \$ 482.00 |
| 4 | Pyrus kawakamii | 8" | 15-20' | 3 | 3 | 3 - Fair, small planter | Tree has been removed | \$ 482.00 |

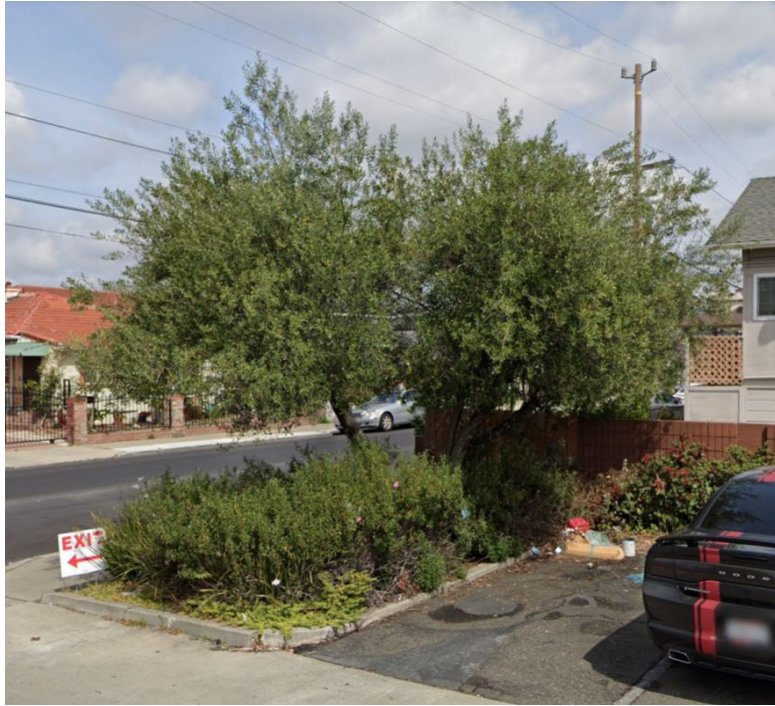
Tree 5 – *Olea europaea* (Olive) in fair condition, structure and form.

| Tree # | Name | DBH | Approx Height | Structure | Form | Overhall Condition/Vigor | Suitability/Notes | Assessed Value |
|---|---|---|---|---|---|---|---|---|
| 5 | Olea europea | 8" + 8" + 8" | 15-20' | 3 | 3 | 3 - Fair to good | Tree has been removed | \$ 694.82 |

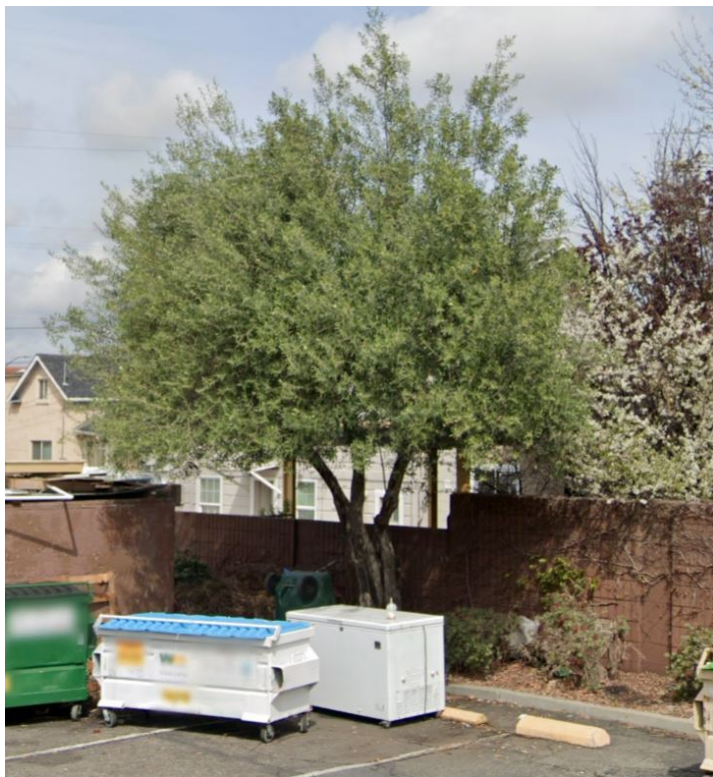
Tree 6, *Olea europaea*, in fair *condition, form, and structure*.

| Tree # | Name | DBH | Approx Height | Structure | Form | Overhall Condition/Vigor | Suitability/Notes | Assessed Value |
|---|---|---|---|---|---|---|---|---|
| 6 | Olea europea | 8" + 8" + 8" | 15-20' | 3 | 3 | 3 - Fair to good | Tree has been removed | \$ 694.82 |

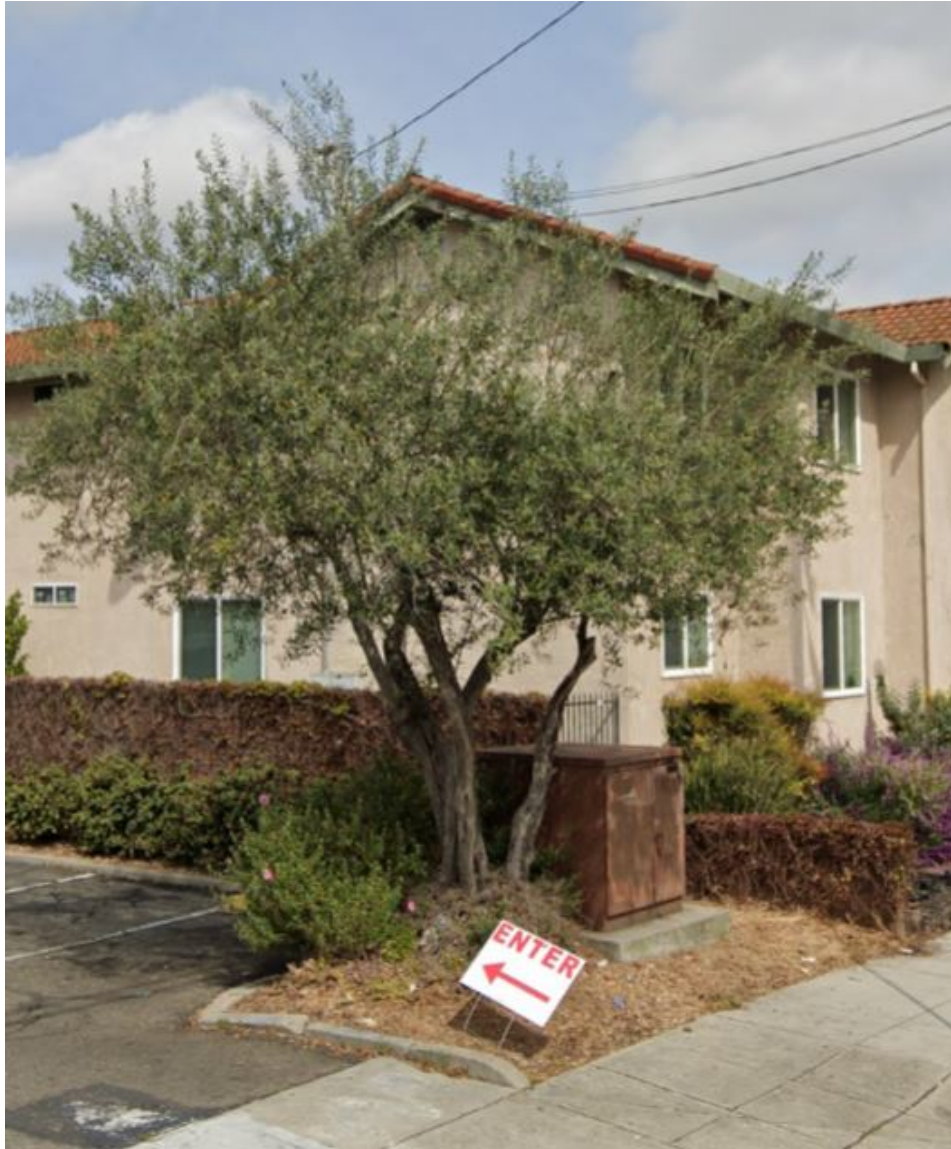
Tree 7, *Olea europaea* with fair *structure* and *form*. Fair to poor *condition* likely due to proximity to utility box.

| Tree # | Name | DBH | Approx Height | Structure | Form | Overhall Condition/Vigor | Suitability/Notes | Assessed Value |
|---|---|---|---|---|---|---|---|---|
| 7 | Olea europea | 8" + 8" + 8"+8" | 15-20' | 3 | 3 | 2 - Fair to poor | Tree has been removed | \$ 468.00 |
