Earth Focus Geological Services, Inc.

January 15, 2018
Project No: F17-01515

Subject: Fault Rupture Hazard Evaluation
Hayward Segment of the Hayward Fault Zone
Proposed New Multi-Unit Residential Development
25036 to 25096 Carlos Bee Boulevard, APN: 445-170-39-13
Hayward, California

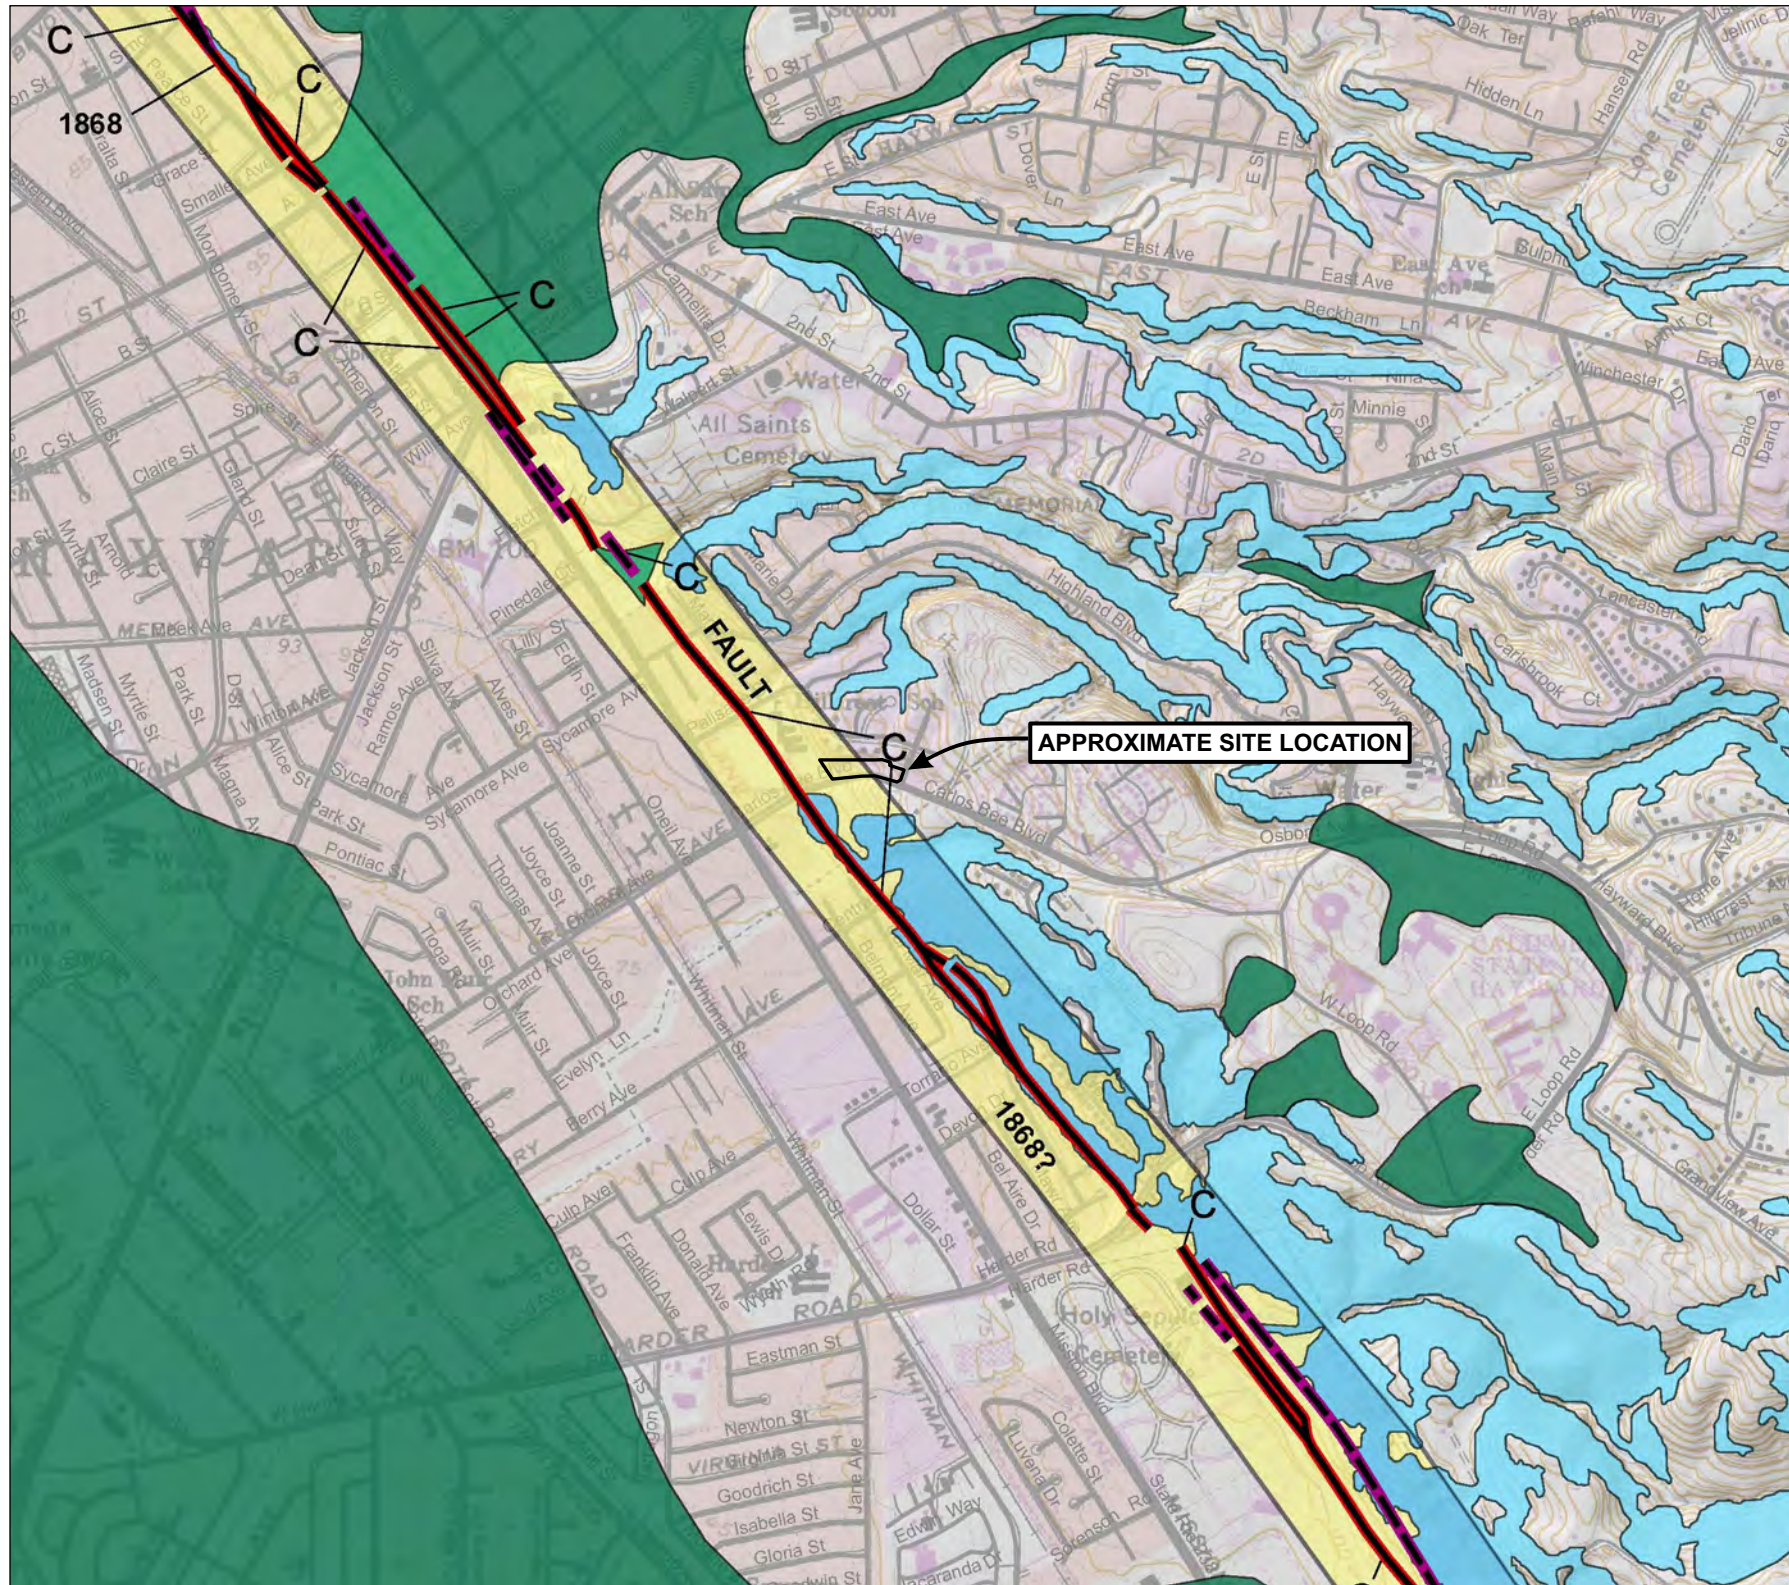
Figure 2

The west portion of the project site is within the Earthquake Fault Zone for the Hayward fault as established by the State of California for active faults (Hart and Bryant, 1997). The nearest trace of the Hayward fault zone as shown on the latest official map by the State of California (State Geologist, 2012) is approximately 300 feet to the west of the west property boundary (see Figure 2). An older version of the official State of California map as well as other fault maps published by the U.S. Geological Survey locate an additional fault trace within very close proximity to the west property boundary (Radbruch, 1967; Radbruch-Hall, 1974; and State Geologist, 1974).

The project site is closest to the Hayward Segment of the southern Hayward fault. Several traces of the Hayward fault zone have been mapped both to the east and west of the site (Dibblee, 1980 and 2005; Graymer and others, 1996; Herd, 1978; Lienkaemper, 1992; Radbruch, 1967; Radbruch-Hall, 1974; Robinson, 1956; and State Geologist, 1974 and 2012). The active creeping trace and likely the most prominent trace of the Hayward fault in the vicinity of the site is located approximately 300 feet to the west of the west property boundary (Lienkaemper, 1992; and State Geologist, 2012). There is evidence to suggest that another less prominent trace of the Hayward fault zone is located closer to the site. This other fault trace has been approximately located in backhoe trenches near the west property boundary by a private consulting firm working on the former Hillcrest School site in the late 1970s (Woodward-Clyde Consultants, 1978). This secondary fault trace appears on a previous version of the State of California official map of the Earthquake Fault Zone (State Geologist, 1974), but not on the most current map as shown on Figure 2.

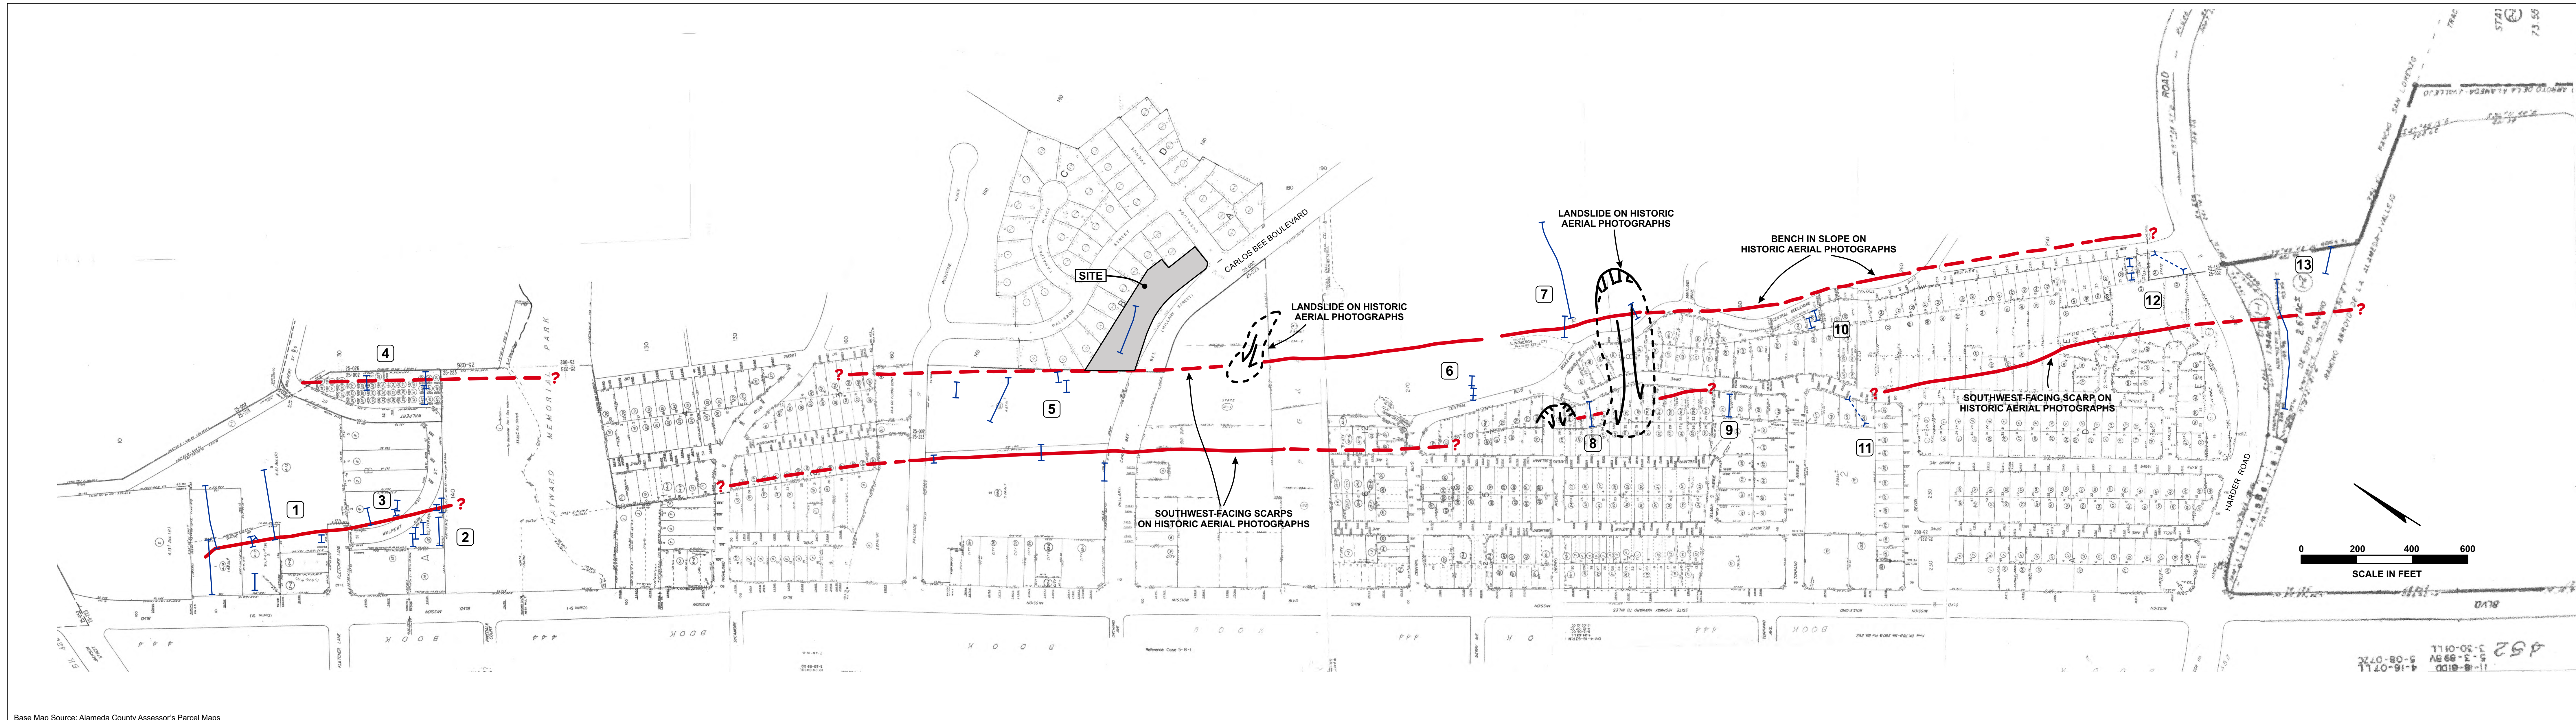
Plate 2 – Trench Log

The trench excavation exposed a significant amount of artificial fill underlain by native soils. The native soils or colluvium was resting on top of sedimentary bedrock. No obvious signs of active faulting were identified within the bedrock exposures in the trench. Seepage was encountered as the excavation penetrated the bedrock. A copy of our graphic log from the trench is reproduced as Plate 2. Below is a brief summary of our observations and interpretations of the trench exposure with horizontal station references.

Native Colluvial Soils (Qcol): We observed a discontinuous layer of colluvium underneath the fill materials, resting on bedrock, throughout most of the length of the exploratory trench from Station 0 + 33 to Station 1 + 55. These native soils generally consisted of sandy clay with some minor soil development and associated clay films between grains. Where present in the trench, the layer ranged in thickness from a few inches to over 3.5 feet. We observed that some of the native soils had been removed prior to the placement of fill that accounted for the discontinuous nature of the deposit. This was highlighted on the trench log at Stations 0 + 60 and 1 + 17.

Knoxville Formation (JKk): The trench penetrated continuous sedimentary bedrock from Station 0 + 50 to Station 1 + 75. The bedrock at the east end of the trench generally consisted of siltstone with shaley interbeds. Sandstone became the dominant bedrock type in the west portion of the trench. The exposed bedrock was well cemented, well indurated, and severely fractured. The bedrock encountered in the trench was consistent with published descriptions of the Knoxville Formation of Jurassic to Cretaceous age (Dibblee, 1980 and 2005; Ellen and Wentworth, 1995; Graymer and others, 1996; and Robinson, 1956). Ground water was encountered within the bottom of the trench flowing through the bedrock fractures.

We did not identify any shear zones or other structural fabrics that would suggest active faulting had occurred within the exposed length of the bedrock in the trench from Station 0 + 50 to Station 1 + 75. At Station 0 + 50, the sandstone bedrock descended into the trench bottom. Rising ground water prevented deeper excavation in this area. The overlying colluvial layer extended further to the west to Station 0 + 33 before disappearing into the trench bottom.

From our geologic interpretations and analysis of soil and rock exposures logged in the exploratory excavation, we conclude that no active faults pass through the exploratory trench excavation from Stations 0 + 50 to 1 + 75 where bedrock was exposed as shown on Plate 2. The depth of the bedrock below the existing ground surface between Station 0 + 00 and Station 0 + 50, the thickness of the overlying fill materials, and the rising ground water condition in the west portion of our exploratory trench made it unsafe to explore the underlying bedrock at this end of the trench.

We are unable to determine whether or not active fault traces may be present within the project site west or downhill of Station 0 + 50 from the exploratory trench and therefore, we have established a No Residential Construction Zone within the west portion of the project site as depicted on Figure 3. One of the fourteen proposed residential structures encroaches into this
