| <b>DOCKETED</b> | |
|---|---|
| <b>Document Title:</b> | CEC Staff Report - Russell City Energy Center May 2021 Incident Root Cause Gap Analysis |

# **Russell City Energy Center May 2021 Incident: Root Cause Gap Analysis**

**April 2022 | CEC-700-2022-004**

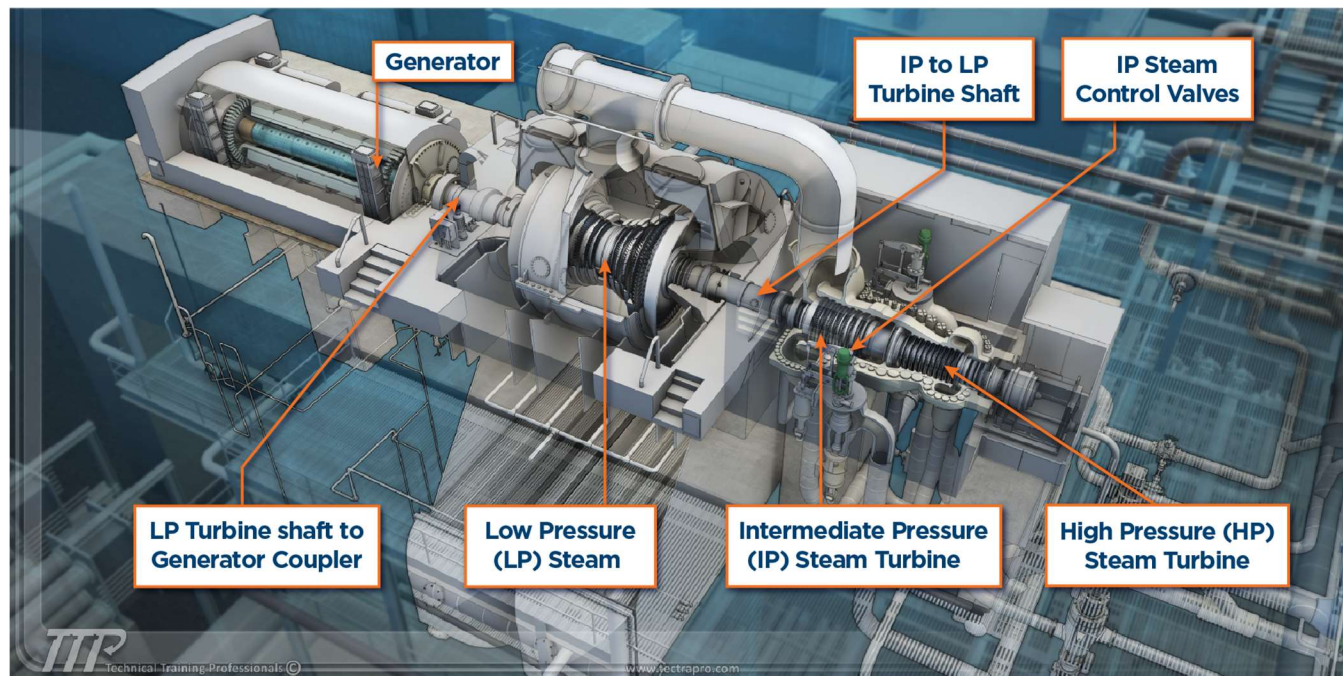
**Figure 2.1: Steam Turbine Generator**

During the initial onsite inspection, the CEC staff observed that the STG shaft was fractured at the exit point of the intermediate pressure (IP) section to the low-pressure section, and the shaft was ejected from the STG. The CEC staff examined the turbine shaft that entered the low-pressure (LP) section and found that the shaft was twisted. The metal casing of the LP section had separated, breaking bolts in the process.

The black charring and soot in the area around the casing were clear evidence that there was a fire at the exit of the LP section to the steam turbine's generator. The LP section casing was severely damaged from the overspeed event. The drive shaft connecting the LP section to the generator was fractured at each end and had been thrown from the enclosure.

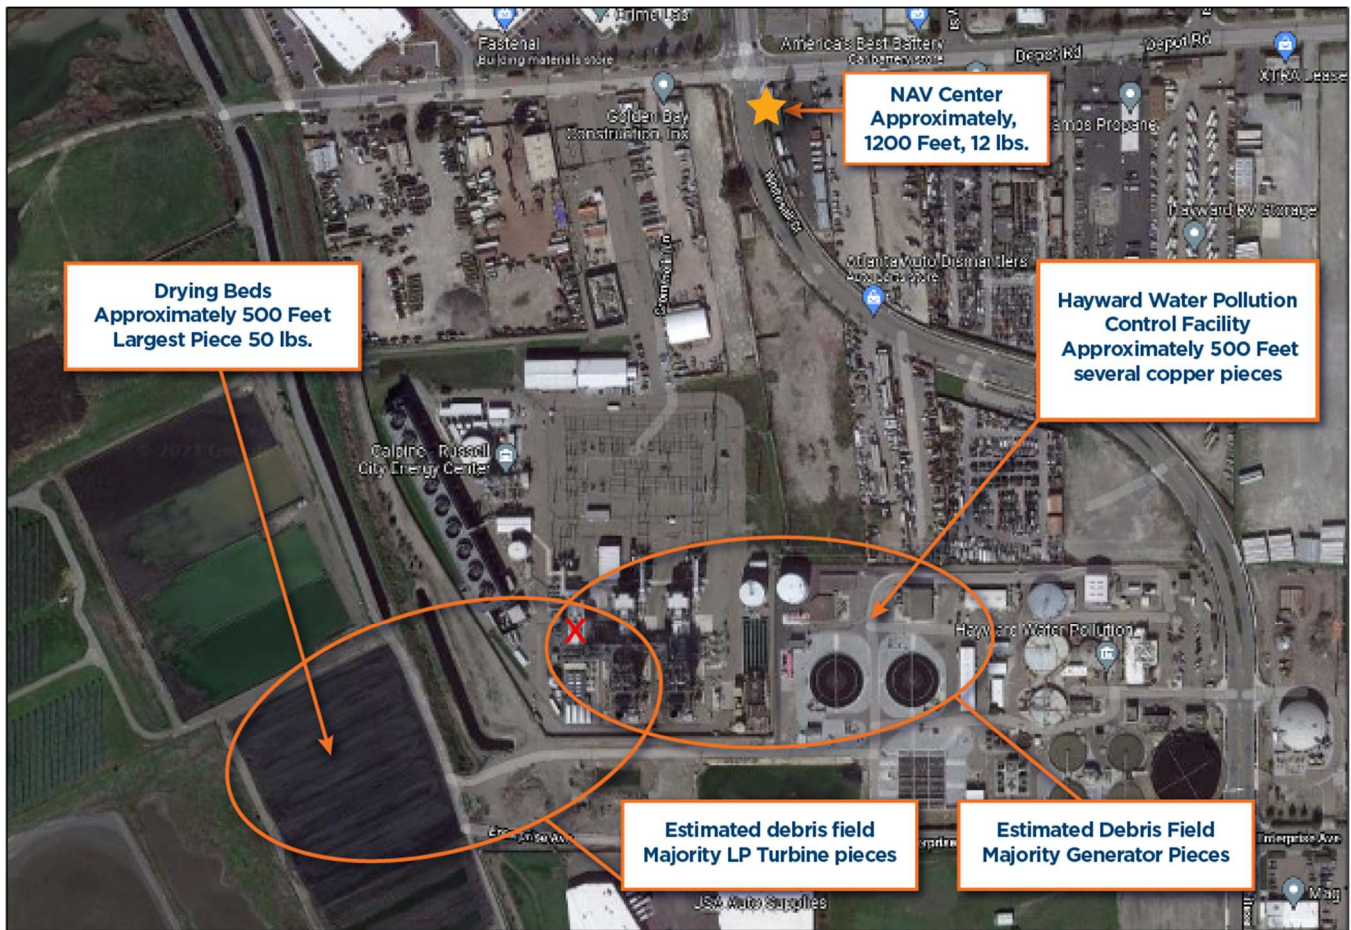
**Figure 2.2: Debris Field**

### **Steam turbine generator debris field**

The CEC staff then inspected the Hayward Navigation Center complex and met with the Housing Care Coordinator for Bay Area Community Services, the organization that operates the Hayward Navigation Center. Using data from the inspections at the HPWCF facility and the Hayward Navigation Center complex, the CEC staff created a map of the metal pieces found (Figure 2.2). Most of the metal pieces were found to the west of RCEC. These steel metal pieces ranged up to 50 lbs. Most of the small copper pieces of metal were found toward the east side of the power plant. The locations of the metal pieces released during the overspeed event are consistent with having been thrown from a rotating shaft.

The outlier of the debris field is the 12-pound piece of the LP turbine blade root. The blade root was discovered in the Hayward Navigation Center complex (Figure 2.2). The Hayward Navigation Center complex has multiple trailers on site serving people experiencing homelessness. The trailer used for meal preparation and eating was damaged when the 12-

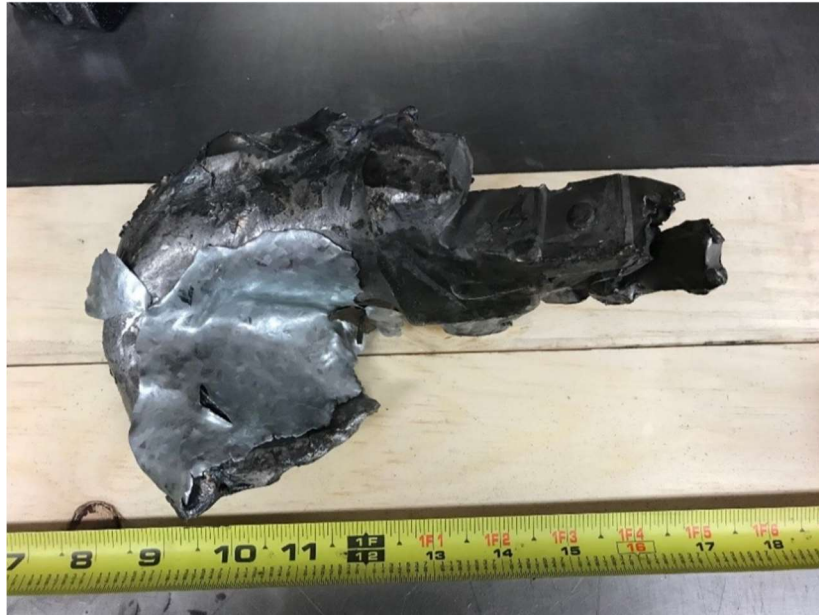
**Figure 2.3: RCEC Metal Piece**

pound metal piece traveled 1,200 feet, penetrated through the trailer's roof, and landed on the floor (Figure 2.3). No individuals were in the trailer at the time since it was after operating hours. There was no damage to the floor of the trailer.

**The metal piece traveled approximately 1,200 feet and weighed 12 lbs.**  
Credit: Hayward Navigation Center Staff

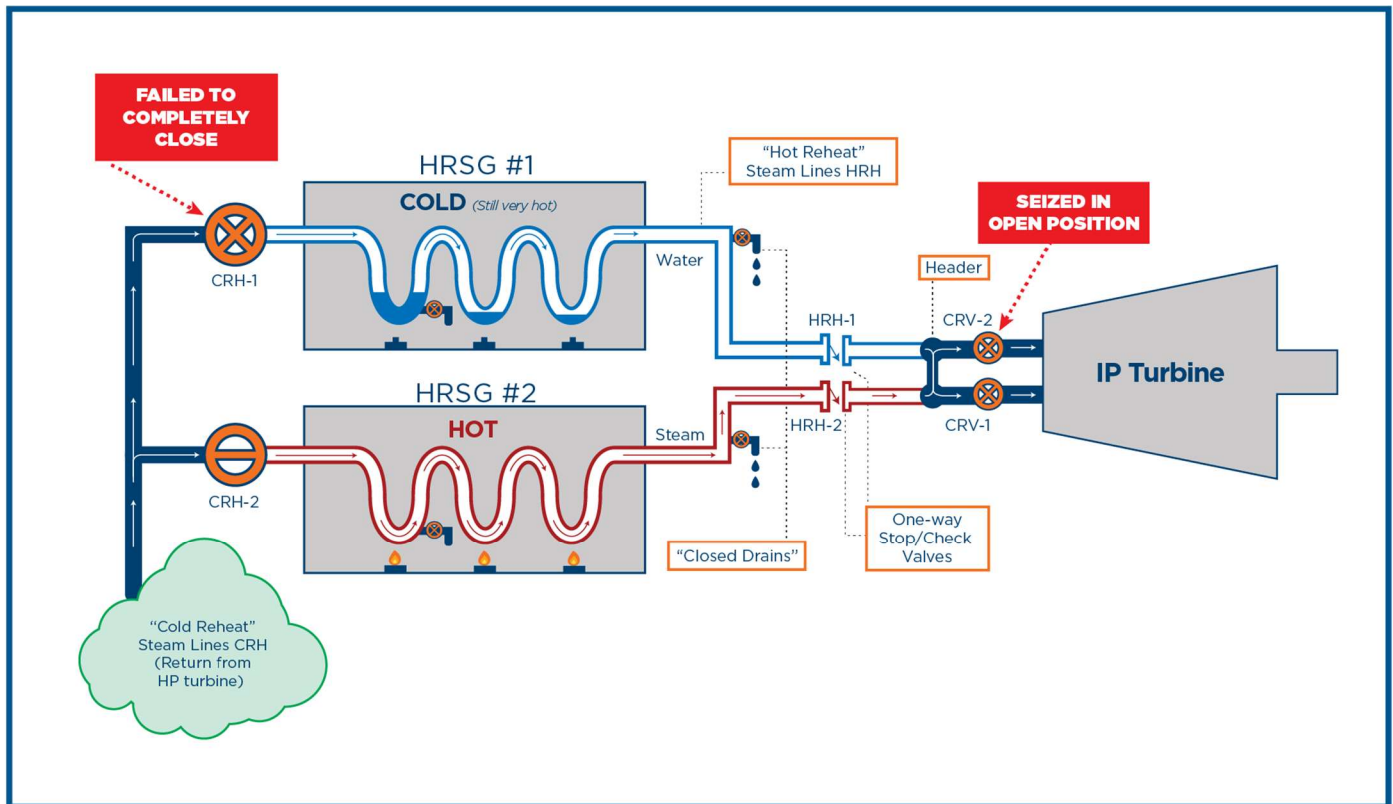
**Figure 3.1: Russell City HRSG Reheater Schematic**

Over the two days operating in that 1x1 configuration, the steam produced in HRSG-2 continued to leak past the CRH-1 valve into the offline and much cooler HRSG-1 causing the steam to condense into water. Enough water condensed in the offline HRSG-1 to collect a substantial quantity of water in the section of the offline HRSG-1 known as the reheater (Figure 3.1). Because of the large quantity and high temperature of the condensing superheated steam, the condensed water remained near its boiling point and at an elevated pressure.

**Schematic of RCEC's HRSG reheater path to the IP section of the steam turbine**
