# **WILSON & ASSOCIATES**

Date: March 26, 2022, Revised June 22, 2022 and May 1, 2023

Re: Arborist Report 1434 Grove Way Hayward, CA 94546

#### Memo:

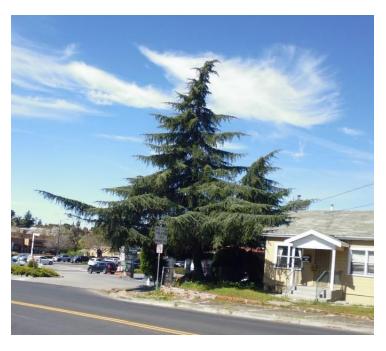
Tree 1. Deodar Cedar. Off-Site.

Tree No. 1. Deodar Cedar. 18" caliper.

V=\$8,700.00

See the latest landscape plan for information on the location of the proposed monument sign.

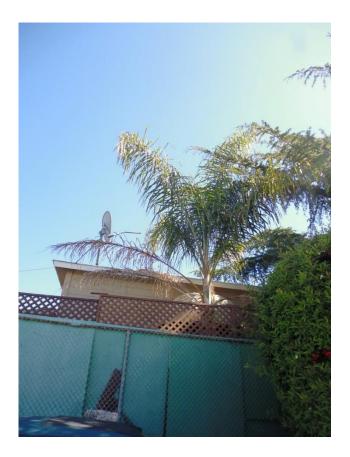
Tree 2. Queen Palm.

Tree No. 2. Queen Palm. To remain. 9' clear trunk at \$180.00 per foot = \$1,600.00. As noted, this tree could possibly be preserved or relocated on-site. *Per latest landscape plans, this tree is to be removed.*

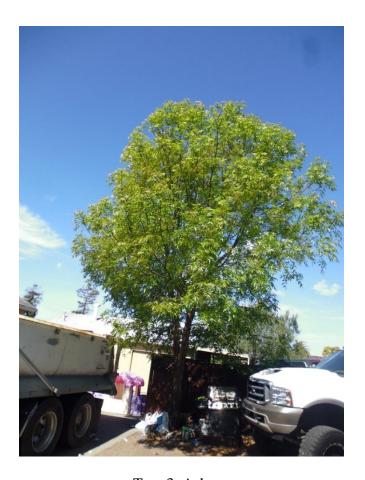
Tree 3. Ash.

Tree No. 3. Ash. Multi 6", 6" caliper. Trunk area = square root of trunk stems squared = 8".

V=\$1,500.00

Per latest landscape plans, this tree is to be removed.

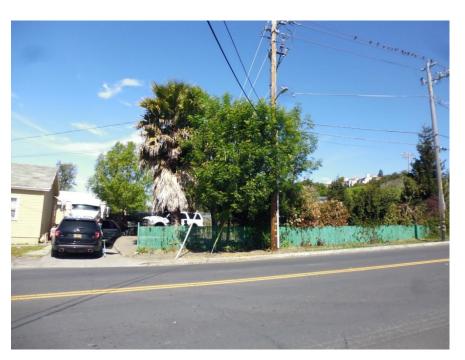
Trees 4, and 5. Mexican Fan Palm and Ash.

Tree No. 4. Mexican Fan Palm. Little to no value, *but given a nominal value of \$100.00*. Weed tree. Could possibly be preserved or relocated on-site, but this is not recommended. *Per latest landscape plans, this tree is to be removed.*

Tree No. 5. Ash. Multi 8", 7" 6" caliper. Trunk area = square root of trunk stems squared = 12"

V=\$2,700.00

Per latest landscape plans, this tree is to be removed.

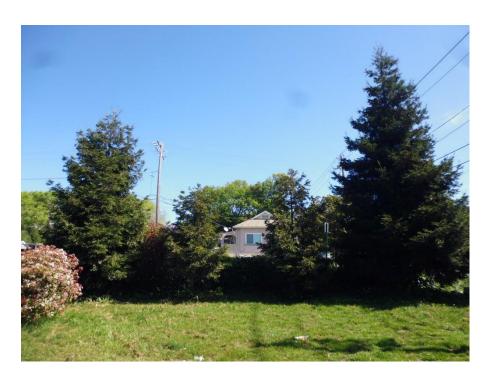
Tree 7, 8, 9, and 10. Coast Redwood Trees.

Trees Number 7, 8, 9 and 10 are probably the best candidates for preservation in the current location on-site due to location, condition and species. This would depend on the site development proposal. *Per latest landscape plans, this tree is to be removed.*

We have not reviewed any potential development proposals for this site, but some existing trees could possibly be preserved and left in place with normal protection measures performed. In particular, the four Redwood trees, numbers 7, 8, 9, and 10, would be worthy of preservation. The Queen Palm tree number 2 could possibly be relocated. The Deodar Cedar on the adjacent property overhangs this property and any development should take that into consideration. The other existing trees are not particularly special or of high value.

Per latest landscape plans, this tree is to be removed.

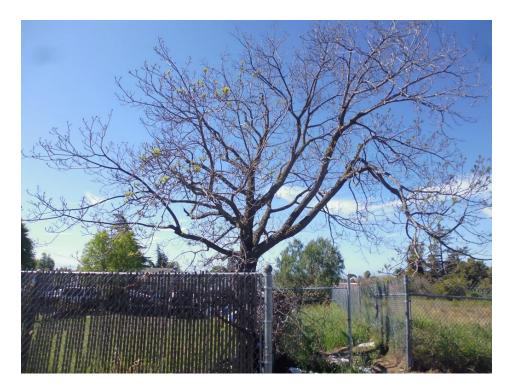
Tree 11. Walnut (?)

Tree No. 11. Walnut. 18"

V=\$950.00

This tree is shown to remain on the landscape plans dated 3/16/23, but per the City comments dated April 24, 2023, we recommend that this tree be removed.

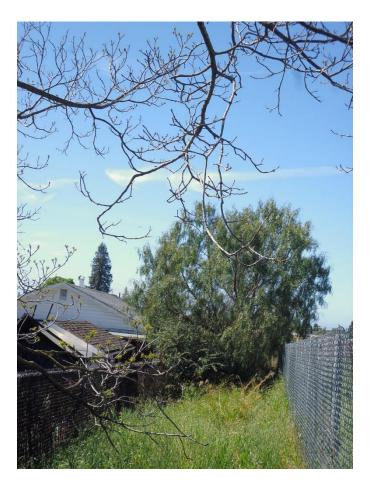
Tree 12. California Pepper Tree. Off-Site to Northwest.

Tree No. 12. California Pepper Tree. 10" caliper.

V=\$900.00
