# Investigation Report

## Calpine Russell City Steam Turbine/Generator Event

### May 27, 2021

Calpine Corporation - Russell City Energy Center

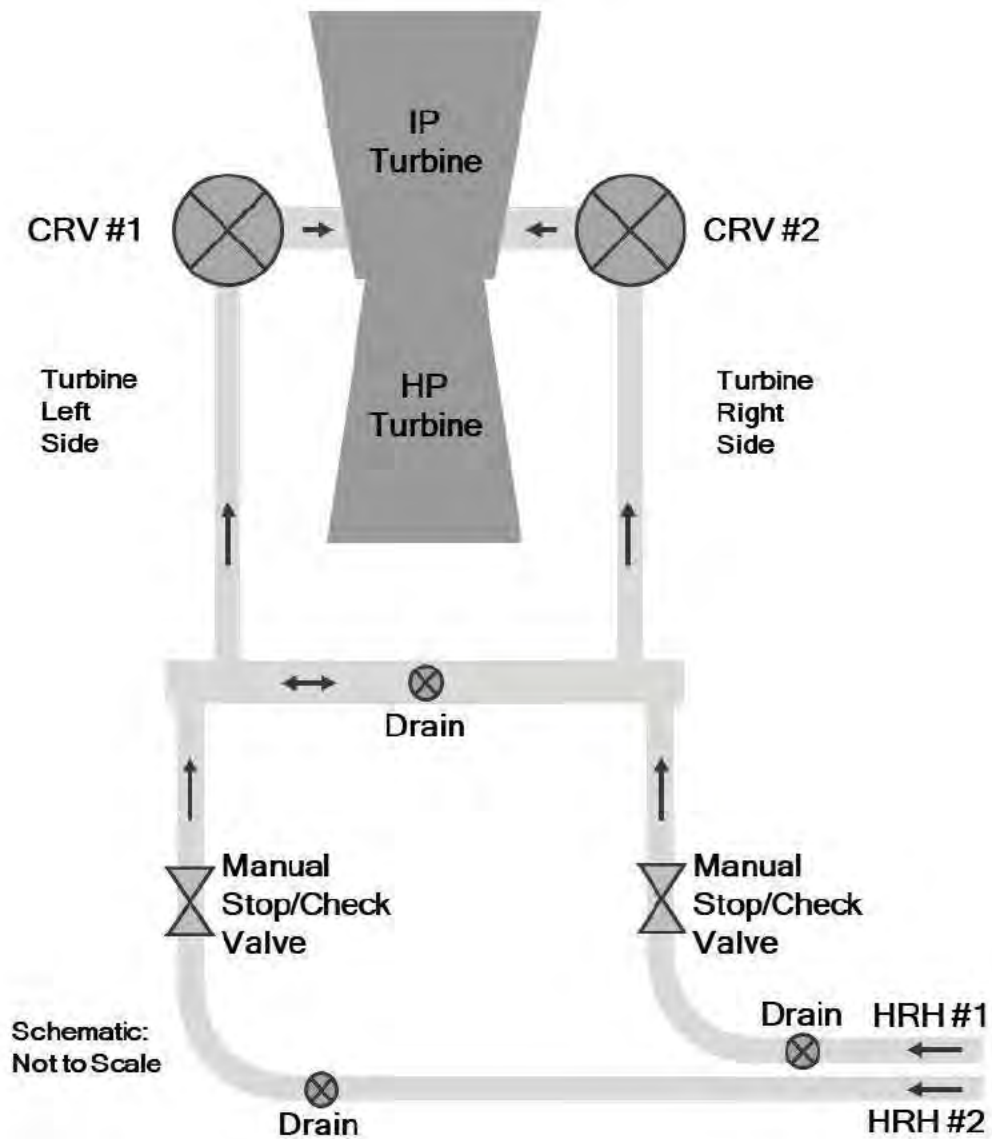
Figure 4-1. Arrangement of HRH Piping and Valves Upstream from the IP Turbine

While at the plant site, SI personnel requested that the drains on each HRH pipe upstream of the stop/check valves be opened to check for residual water in the system. The drain valve on HRH #2 was opened and a few drops of water emitted from the drain. The drain valve on HRH #1 was opened and flowed water steadily for approximately [REDACTED] minutes. Based on this observation, an additional drain located at a low point in HRH #1 pipe (situated in a [REDACTED] of HRSG #1 and HRSG #2) was opened; this drain emitted a strong flow of water (through a 1 inch opening) for approximately [REDACTED] minutes.

Based on the configuration of the STG HRH #1 and #2 pipes feeding the HRH header, shown in **Figure 4-1**, flow, temperature, and pressure changes from either HRSG will affect both CRVs and the STG. However, since the individual HRH pipes are closely aligned to the right and left vertical pipe legs, temperature and pressure differences downstream of the header would be expected during transient<sup>9</sup> conditions as flow balances through the header. During review of the alarm log, it was not uncommon for transient conditions to result in temperature differences that triggered alarms.

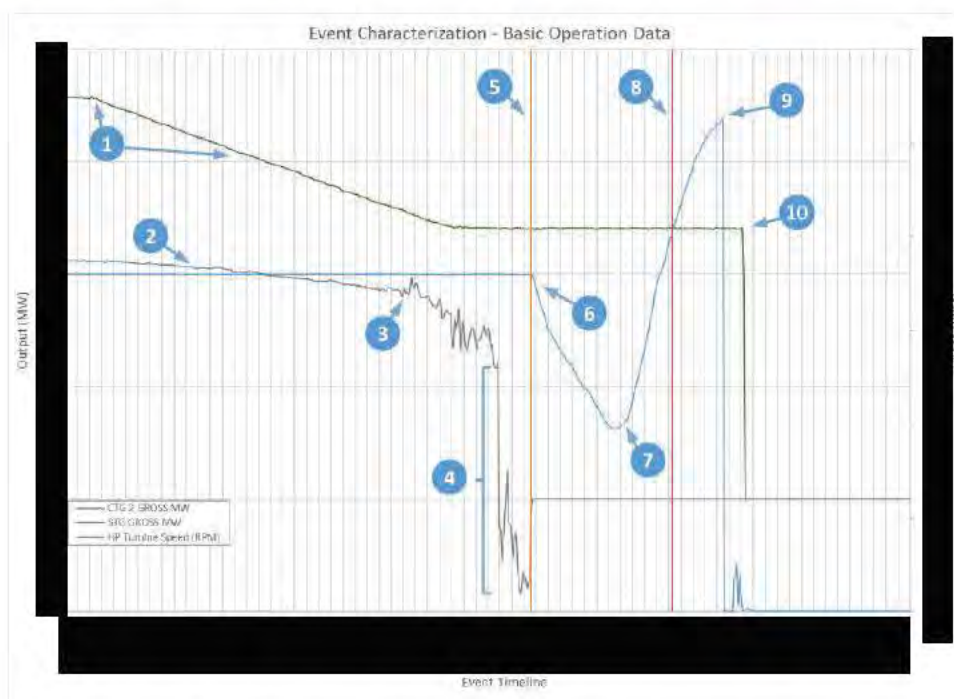
**Figure 5-1 - Event Characterization - Basic Operation Data**

Prior to the event and as part of the shutdown procedure, the operator initiated a (1) load reduction for CT 2 load to [REDACTED] MW at approximately [REDACTED]. As the reduction in CT output occurred, the (2) output of the STG began to decline accordingly. Both the CT and STG load reductions were smooth until approximately [REDACTED] when the (3) STG load began to fluctuate in an inconsistent manner with respect to the CT load reduction. At [REDACTED]

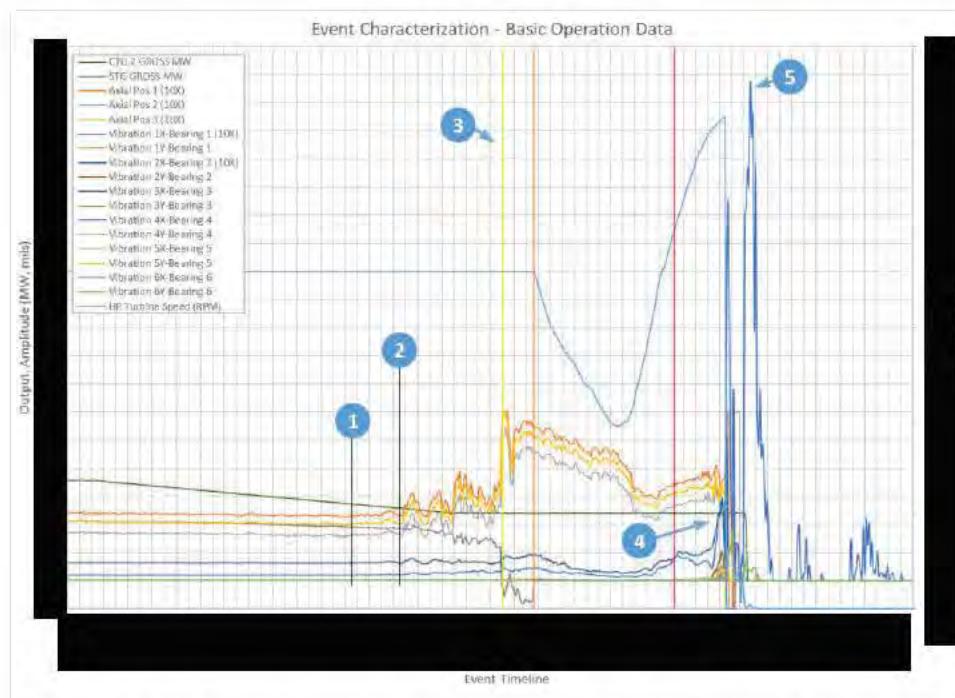
**Figure 5-2 - Event Characterization - Basic Operation Data (Continued)**

Minor trends (1) are visible beginning at [REDACTED] in **Figure 5-2** with the axial position probes and radial bearing 1X and 2X appearing inconsistent with prior operation, although these would likely not raise concern until a more significant (2) step change occurs at [REDACTED] within the axial position probes. The second (2) step change is consistent with STG load fluctuations identified in **Figure 5-1**.

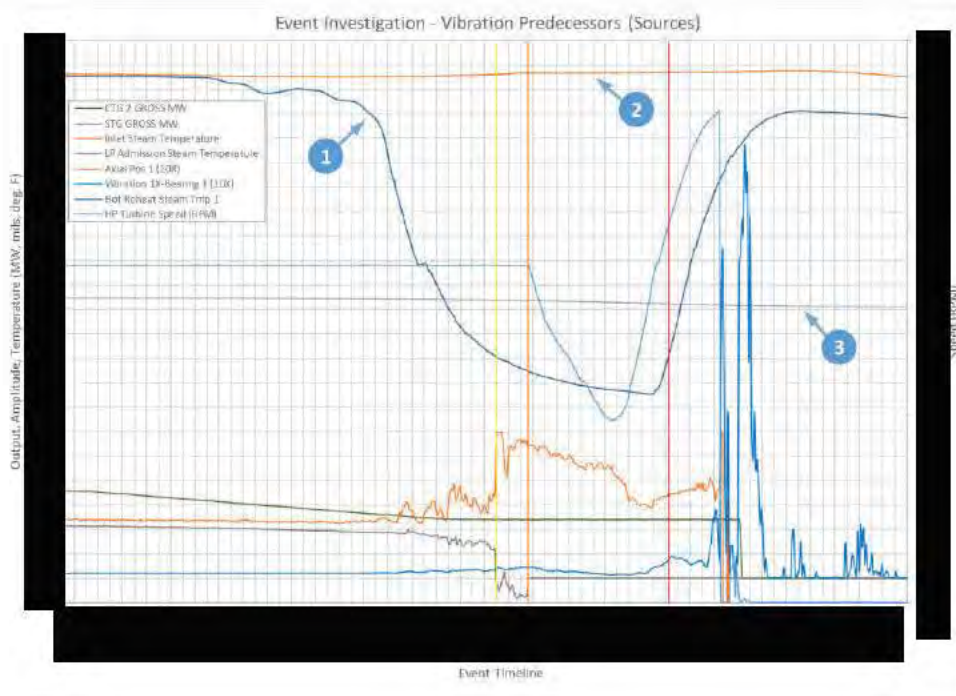
Figure 5-3 - Event Investigation - Vibration Predecessors

Based on the operational data review of STG speed, power output and vibrations, it has been identified that the overspeed event was substantially initiated by a water induction event. Review of HP, IP and LP inlet temperatures was utilized to isolate the turbine section that initially experienced this water induction. The IP section showed a significant reduction in temperature prior to the event and corresponding with the initial minor vibration trends identified in Figure 5-2. As shown in Figure 5-3, HP steam (2) inlet temperature and (3) LP admission steam temperature remained steady throughout the event, however, the (1) HRH steam entering through the right of the IP turbine showed a rapid reduction in temperature consistent with the induction of liquid water vs. steam.

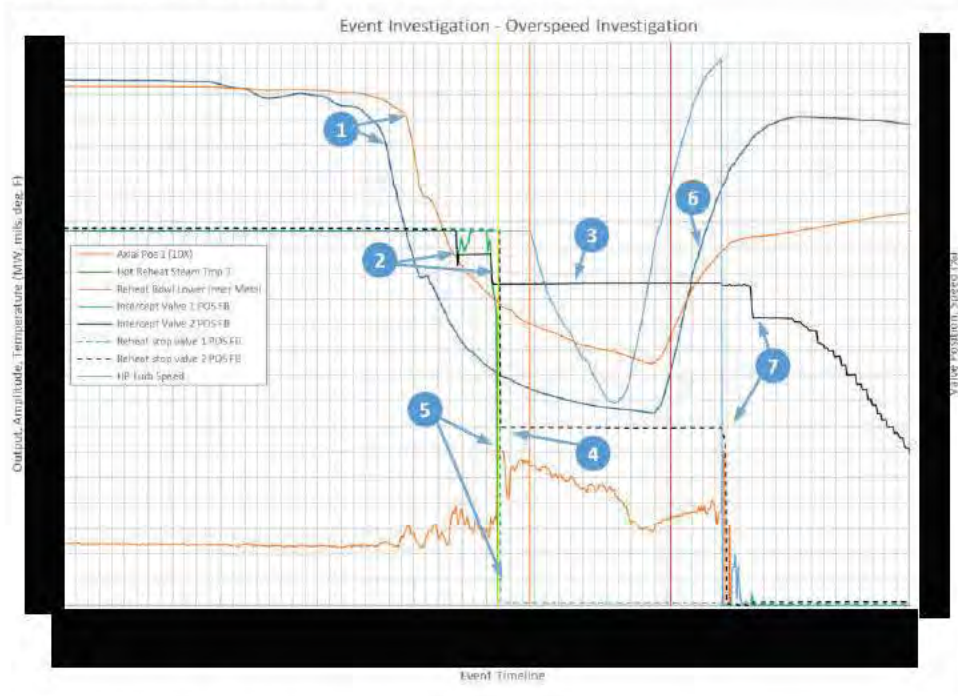
Figure 5-4 - Event Investigation - Overspeed Investigation

Figure 5-4 shows that (1) both the right HRH pipe beneath the STG and the right IP lower bowl temperatures were rapidly reduced from operating temperatures of approximately [REDACTED] to less than [REDACTED] when (2) both CRV IVs began to throttle in response to shutdown activities as described in Section 4.4. At this time, the right HRH pipe and IP lower bowl showed the presence of water versus the left HRH pipe and IP lower bowl, providing explanation as to why the IV #2 was (3) unable to close in response to flow throttling and RSV #2 in response to the trip command to (4) close all stop valves. At the time of the steam turbine trip, the left IP lower bowl temperature had begun to drop below [REDACTED] indicating a much smaller volume of water had entered through the left HRH pipe, allowing (5) IV #1 and RSV #1 to throttle and close as commanded.

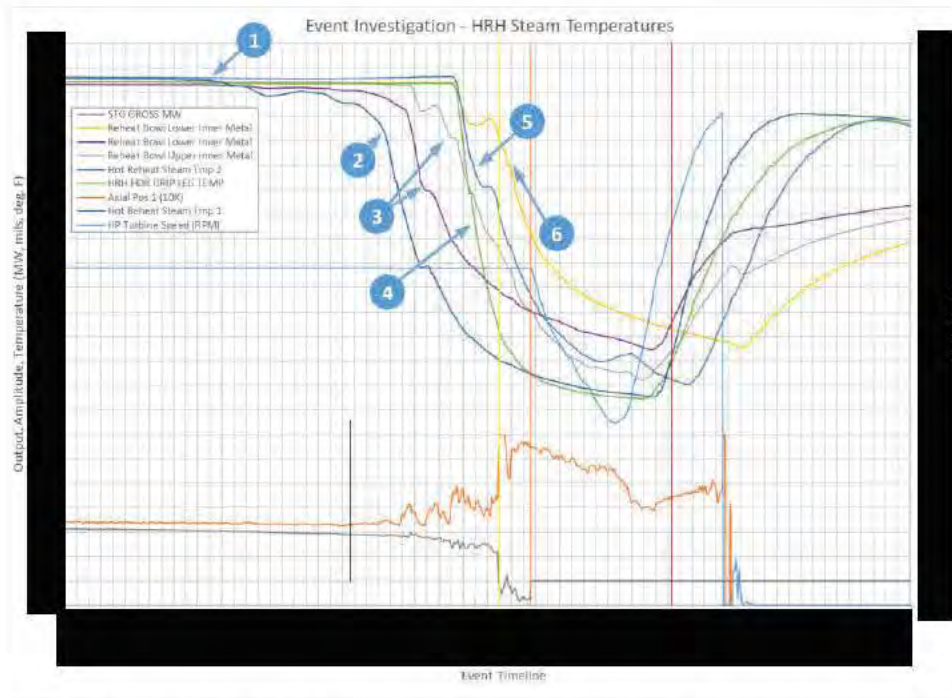
Figure 5-5 - Event Investigation - HRH Steam Temperatures

An (1) initial temperature disturbance occurred in the right HRH pipe beneath the STG prior to the initial vibration changes as previously highlighted in Figure 5-2. This disturbance was followed by a (2) significant drop in temperature in the same HRH pipe. Next, (3) the right, lower IP reheat bowl thermocouple, followed by the upper IP reheat bowl thermocouple, showed a sharp reduction in temperature, indicating that water was churning in the ST flow path. These significant temperature disturbances precede the axial vibration shift and the reverse power occurrence by less than one minute.

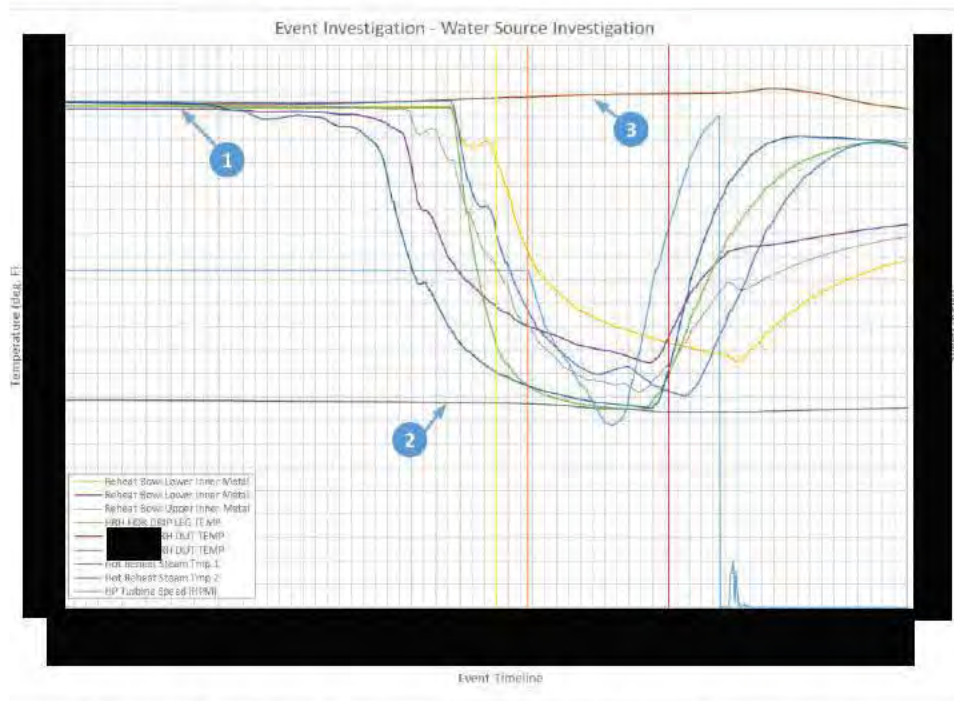
**Figure 5-6 - Event Investigation - Water Source Investigation**

During the initial shutdown of CT 2, (1) all left and right HRH pipe and reheat bowl thermocouple temperatures are aligned with the (3) output temperature of HRSG #2 RH, which was in service at the time. As the temperatures of the HRH pipe and IP bowls dropped, those temperatures became consistent with the (2) output temperature of HRSG #1 RH, which was out of service at the time. The HRSG #2 HRH outlet temperature remained at a (3) relatively consistent temperature throughout the event and only began to fall once CT 2 was tripped by the control room operator. This data gives a clear indication of the source of water in the water induction event is HRSG #1 RH and associated piping.

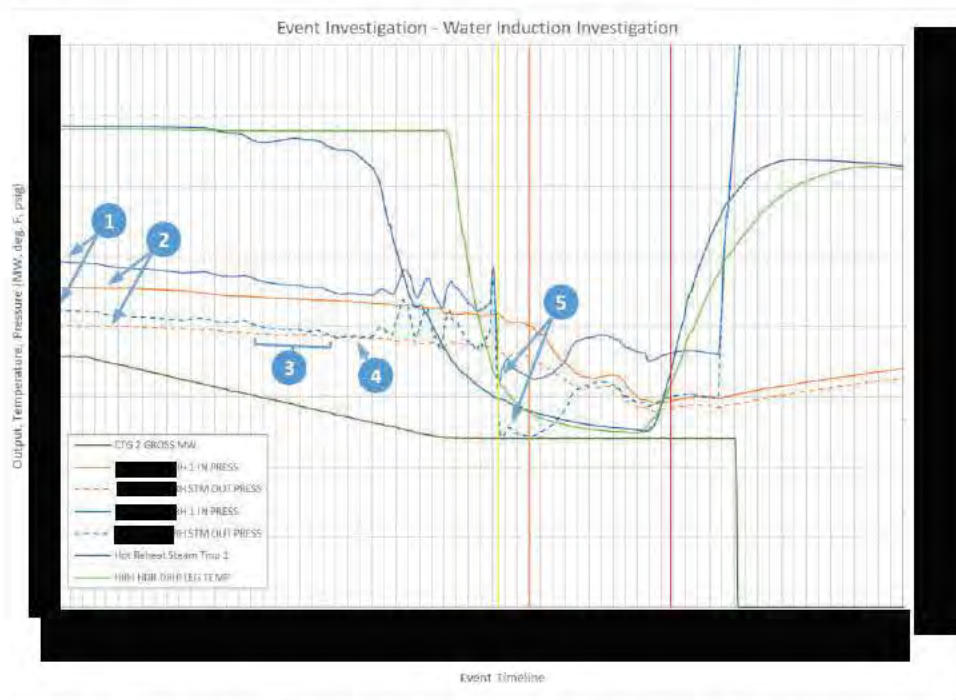
Figure 5-7 - Event Investigation - Water Induction Investigation

During normal operation prior to the event, (1) the inlet and exit pressures of HRSG #2 RH were greater than the (2) corresponding pressures of HRSG #1 which was out of service. As CT 2 load was reduced as part of the normal shutdown sequence, both (3) HRSG #2 RH inlet and outlet pressures declined with reduced CT output / exhaust temperatures, as expected. Later in the shutdown, the (4) outlet pressure of HRSG #2 RH drops below the outlet pressure of HRSG #1 RH, and the timing of this is consistent with the HRH #1 pipe showing the rapid temperature reduction. Immediately prior to the steam turbine trip, (5) both the inlet and outlet pressures of HRSG #2 RH drop below the corresponding pressures from HRSG #1 and remain below for approximately 1 minute.

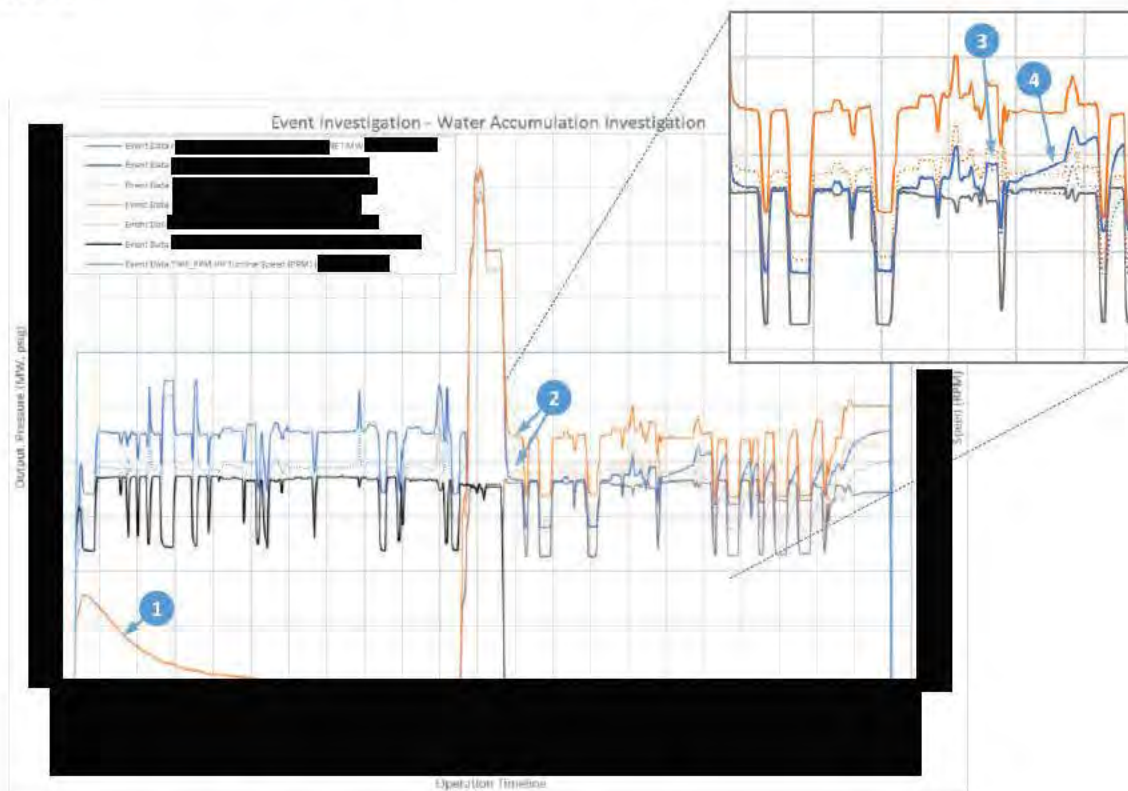
**Figure 5-8 - Event Investigation - Water Accumulation Investigation**

The plant operated in a [REDACTED]. During this time, block 1 provided [REDACTED]. [REDACTED] ranged between approximately [REDACTED]. Also, during this time, HRSG #1 RH inlet pressure followed CRH outlet pressure with typical losses through piping and valves. HRSG #1 RH outlet pressure shows an average differential relative to inlet pressure of approximately [REDACTED], consistent with pressure losses through the reheat cycle.

Notable to the investigation, at the start of the 1x1 operation with block 1, (1) HRSG #2 RH inlet and outlet pressures increase upon startup of the STG to approximately [REDACTED], but this pressure decays off over the [REDACTED]. Both HRSG #2 RH inlet and outlet pressures were equivalent throughout this time period, indicating that the RH circuit was pressurized and free of obstructions from inlet to exit.

Unlike how HRSG #2 RH pressure levels decayed as HRSG #1 came online on 5/23/21, (2) HRSG #1 RH held pressure throughout the remaining operation of block 2. Initially, with block 1 offline, the differential pressure across HRSG #1 RH inlet and outlet locations remained very low [REDACTED], which indicates unobstructed flow of steam through the reheater circuit. However, at approximately [REDACTED], the (3) HRSG #1 RH inlet pressure began to rise, holding an increased level of pressure over the HRSG #1 RH exit. The (4) HRSG #1 RH inlet pressure continued to increase, driving towards the CRH pipe pressure through the remaining operation, with the exception of CT 2 load reductions, which also dropped the CRH pressure.

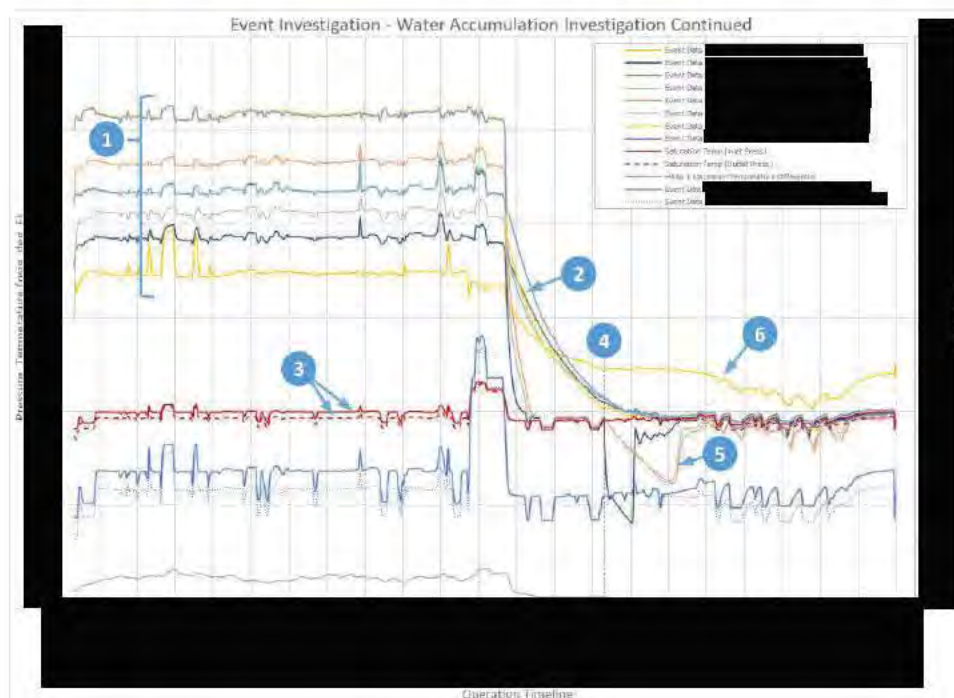
**Figure 5-10 - Water Accumulation Investigation Temperature Plot**

Temperature traces (1) show representative temperatures through the RH circuit including the inlet, 3 harps, and outlet; these traces show that the RH steam was steadily increasing in temperature when HRSG #1 was in service. These temperatures (2) decline after HRSG #1 is taken out of service. RH harp 1 drain ( ) temperatures, followed by harp 3 drain ( ) temperatures, decline first, followed by drops in temperature at the upper region thermocouples.

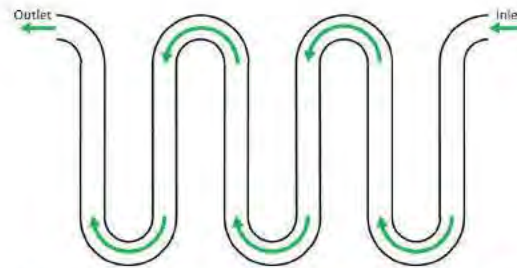
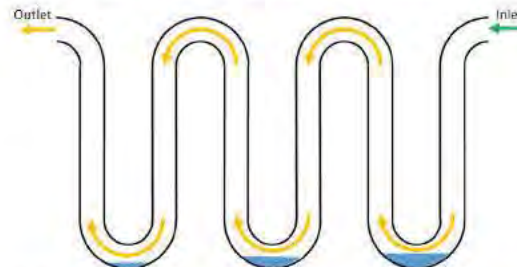
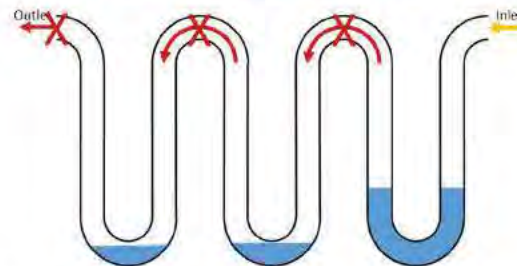
**Figure 5-11 - Loop Seal Depiction**

- No flow restrictions preventing flow through piping loops
- Equal inlet and outlet pressures

- Accumulation of liquid in the bottom loops partially restricts flow through piping loops
- Flow restriction may result in a small pressure reduction through the piping system

- Accumulation of liquid in the bottom loops obstructs flow through piping loops
- Inlet pressure is able to increase substantially over the outlet pressure

Along with this maintained pressure, the temperatures within the RH system were at or near saturation temperature. The maintained pressure acted as one force driving accumulated water into the IP ST via the HRH pipe when the exit pressure of HRSG #2 dropped. The second driving force was the additional pressure created as portions of the high temperature water boiled off (flashed) and expanded as the HRH header pressure dropped.

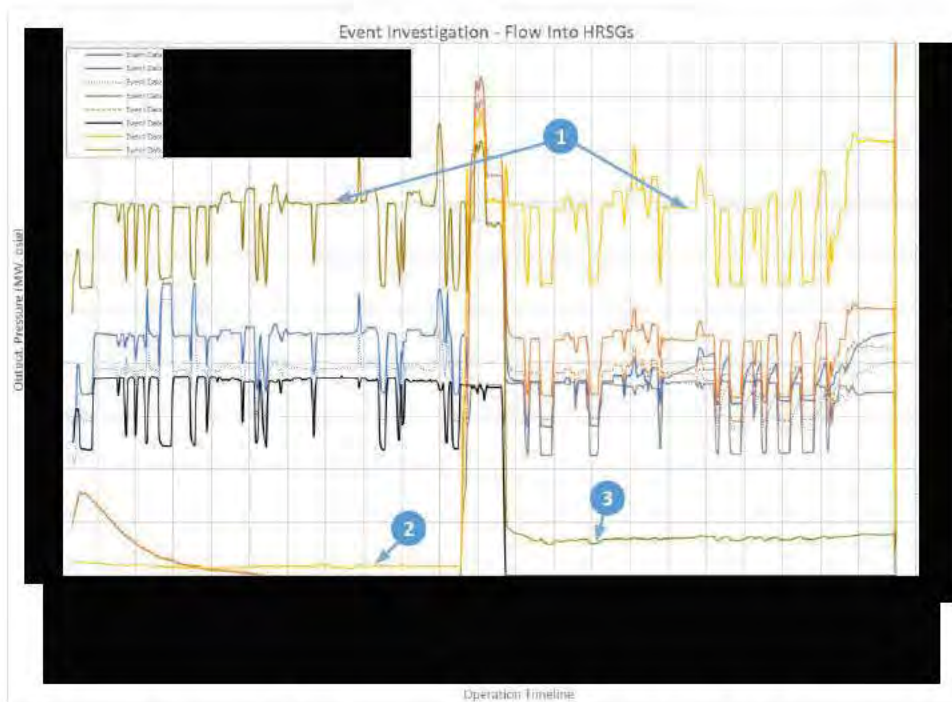
**Figure 5-12 - Event Investigation Flow into HRSGs**

The CRH Flow Balance Flowmeter is in-line downstream of the HRSG CRH SV, CRH flow balance valve and HP bypass piping. As shown in Figure 5-12, (1) both HRSG #1 and HRSG

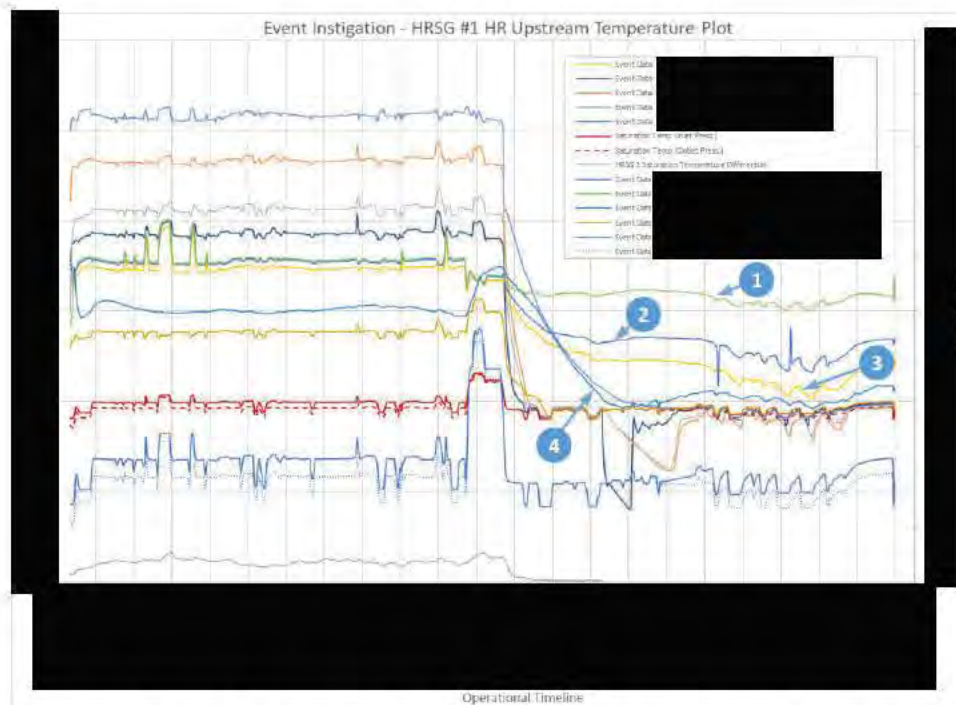
Figure 5-14 - HRSG #1 HR Upstream Temperature Plot

- Based on the low supply pressure from the IP superheater and the {Figure 5-14 (3)} temperatures within the IP superheater piping, it is unlikely that this contributes any significant steam flow or pressurization of the HRSG #1 RH.

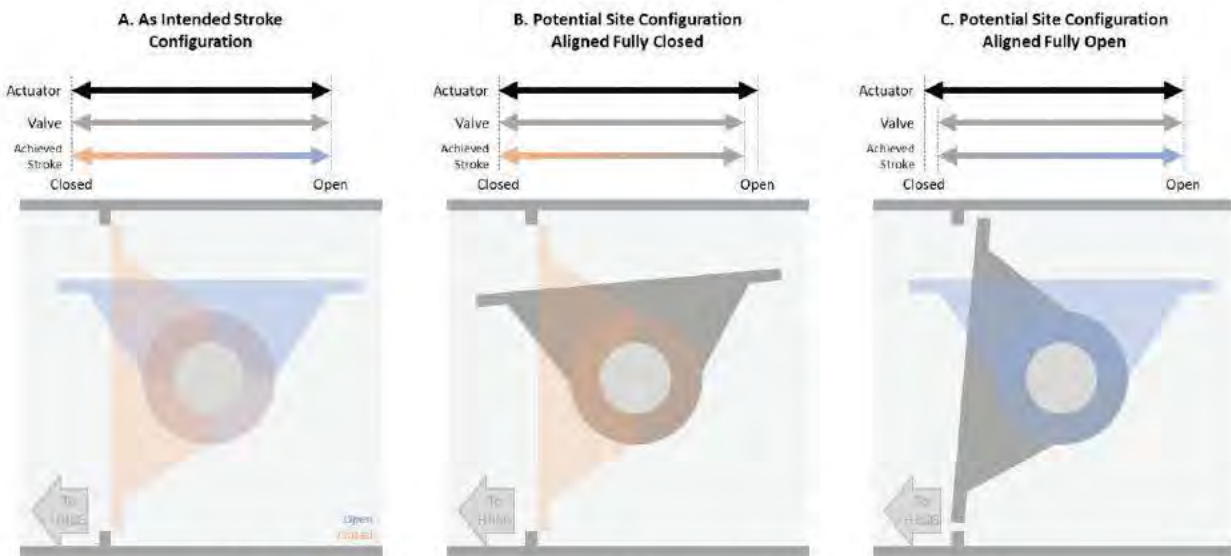
**Figure 5-16 - CRH Stop Valve Component Stroke Depiction**

Both the actuator and valve were disassembled with no notable findings impacting the stroke of the valve. The valve stem and yoke bearing were identified with galling damage which was noted to potentially increase actuator load but would not significantly impact the range of stroke. Disassembly of the gearbox identified a heavily damaged gear box shaft roller bearing. The bearing components had been trapped within the worm and quarter gear further damaging the gearbox. This damage increased the gearbox backlash and resulted in reduced valve stroke.

Had the gearbox been able to efficiently translate the full actuator motion to the valve, both positions in **Figure 5-16A**, could have been achieved. The fully opened position is depicted in blue and the fully closed position is shown in orange. Intermediate positions are shown as grey in depictions B and C.

The assembly actuation was tested both at shop temperatures and heated to [REDACTED] to simulate operating conditions. The valve was found to move smoothly throughout the actuator stroke in both tests. When configured to fully close, as shown in **Figure 5-16B**, the valve passed a graphite seat contact test and feeler gage inspection.

To perform a static pressure test, the valve was manually actuated to the closed position and tested at 250 PSI. The valve experienced significant leakage (8 oz. / minute) at 250 PSI and was unable to achieve pressurization to 500 PSI due to the leakage level. Per American Petroleum Institute (API) Standard 598 - Valve Inspection and Testing, the maximum allowable leakage for this size valve is 28 drops per minute (0.06 oz. per min) at 1,625 PSI. The test leakage equates to approximately 135 times the acceptable leakage at 15% of the API Standard test pressure.

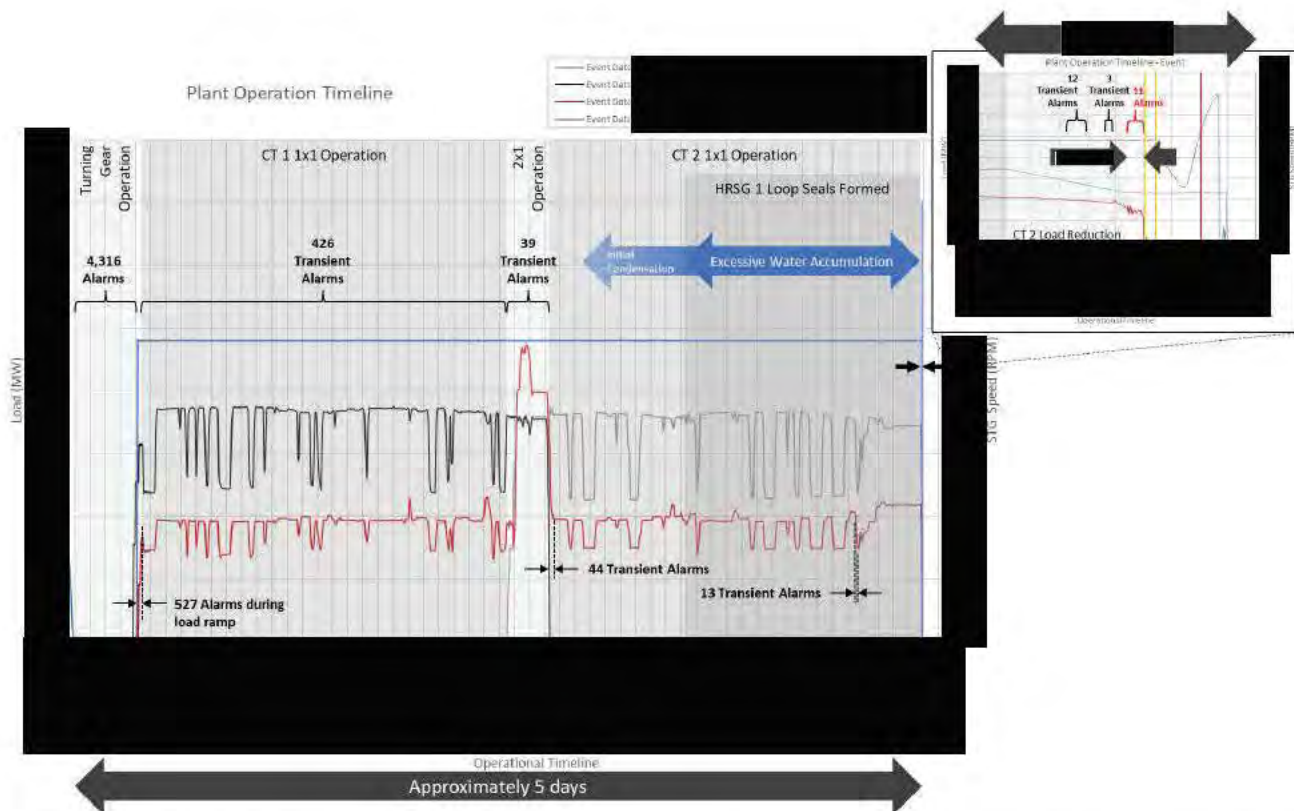
**Figure 5-17 - Plant Operation Timeline ( ) with Alarm Overlay**

Of the 5,391 alarms, 5,352 occurred from the start of turning gear operation up to ( ) prior to ( ) to the event. The 5,352 alarms occurred prior to water accumulation in offline and transient conditions and do not present abnormal operating conditions. Of these alarms, 5,308 occurred on turning gear or with HRSG 1 online in conditions that would not condense or accumulate water within the HRSG. The remaining 44 alarms occurred in 1x1 operation as block 1 was shutting down with HRSG 1 still at operating temperature. Based on the CT and HRSG operation time periods, these alarms would not have been associated with large amounts of water accumulating within the offline HRSG. These alarms are not related to the event or its precursors.
