STAFF REPORT

Russell City Energy Center May 2021 Incident: Root Cause Gap Analysis

April 2022 | CEC-700-2022-004

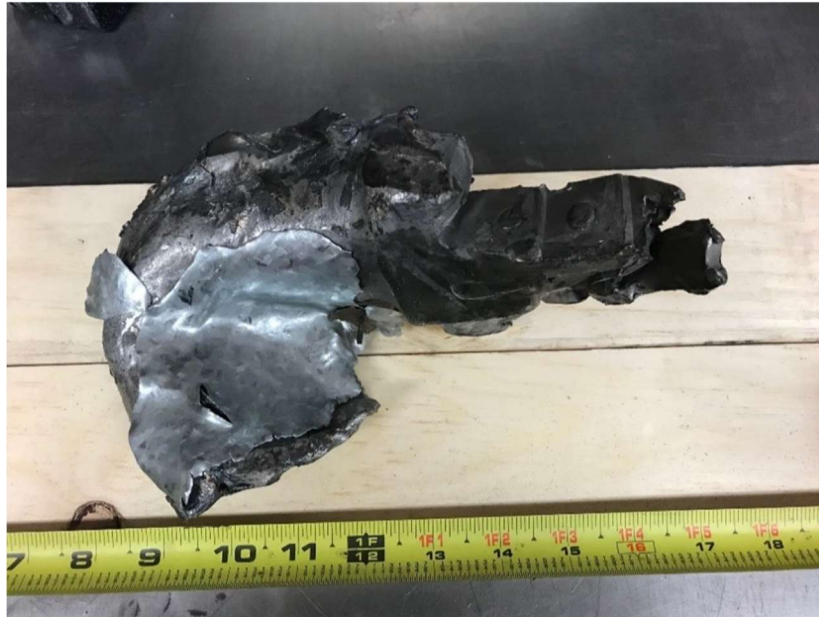
Figure 2.3: RCEC Metal Piece

The outlier of the debris field is the 12-pound piece of the LP turbine blade root. The blade root was discovered in the Hayward Navigation Center complex (Figure 2.2). The Hayward Navigation Center complex has multiple trailers on site serving people experiencing homelessness. The trailer used for meal preparation and eating was damaged when the 12-

pound metal piece traveled 1,200 feet, penetrated through the trailer's roof, and landed on the floor (Figure 2.3). No individuals were in the trailer at the time since it was after operating hours. There was no damage to the floor of the trailer.

The metal piece traveled approximately 1,200 feet and weighed 12 lbs.
Credit: Hayward Navigation Center Staff
