Preliminary Arborist Report

24041 Amador Street
Hayward, CA 94544

April 29, 2025

Updated July 7, 2025

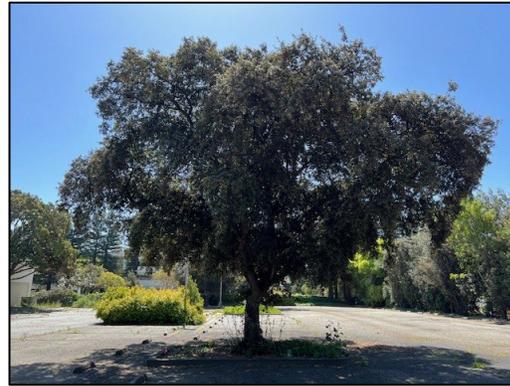
Photo 1. Holly oak #534 was in good condition with a wide, healthy crown.

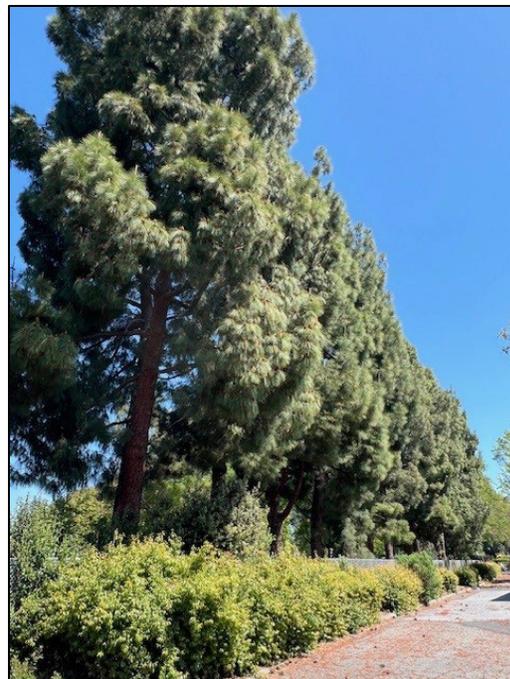
Photo 2. Canary Island pines #574 – 560 L-R) were growing off-site 4 foot off the fence line.

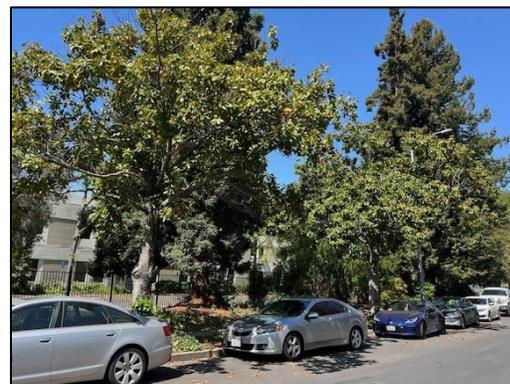
Photo 3. Southern magnolias #508 and 509 were street trees located on the southeast side of the site.

Street trees #508 and 509 should have type II fencing 6' x 6' around each tree well using free-standing chain link to protect the trunks from impacts during construction.

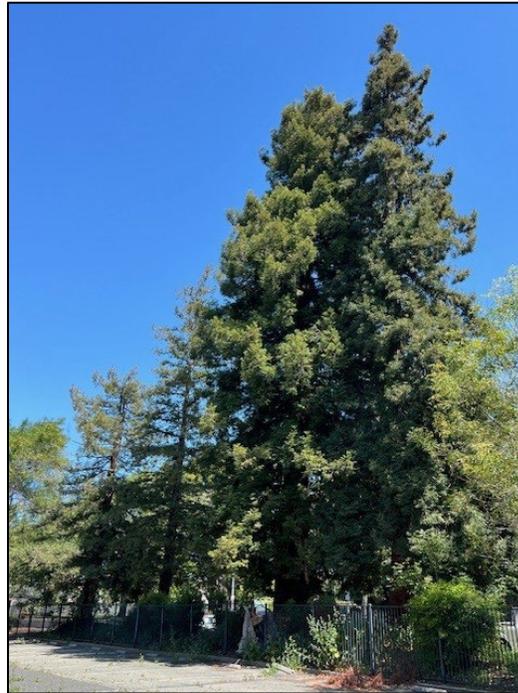
Photo 4. Coast redwoods #501 – 503 (L-R). Redwood #503 was the largest tree on-site with a 58-inch trunk diameter.

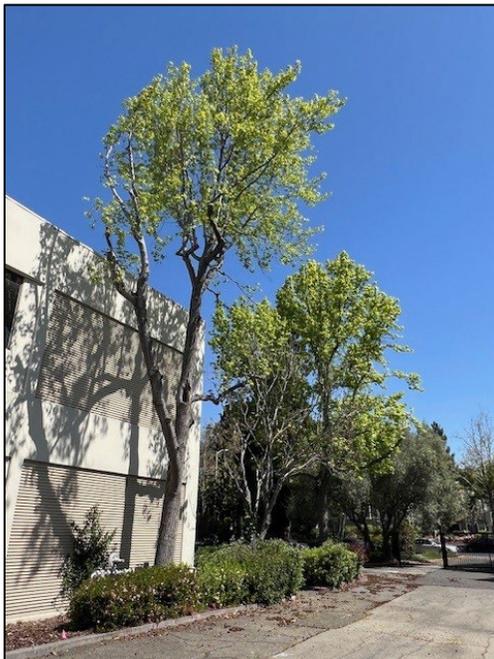
Photo 5. Sweetgum #515 was in poor condition with poor structure and form and a history of poor pruning.

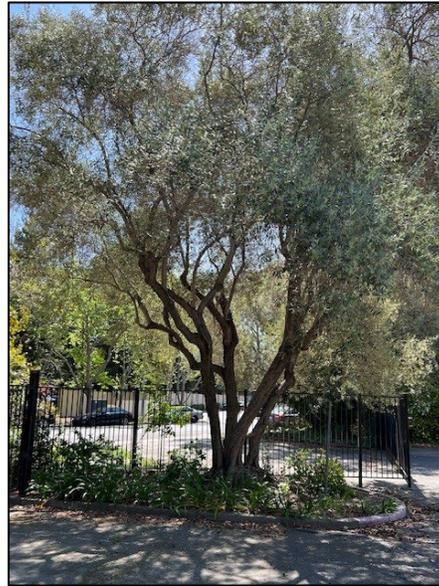
Photo 6. Olive #512 was previously topped at 15 feet and in fair condition.

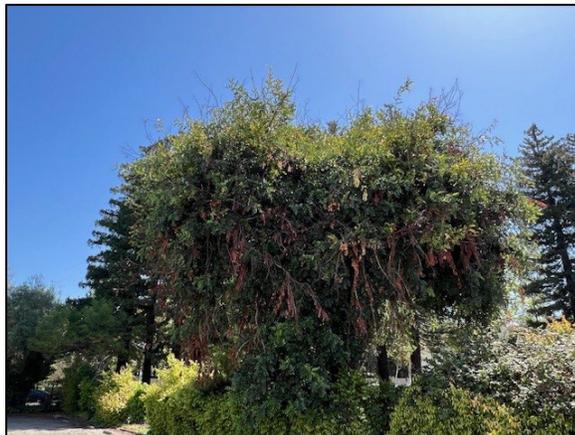
Photo 7. Off-site carob #531 was in fair condition with small branch and tip dieback.

3. Off-site evergreen ash #559 is located on the northeast side with branches overhanging the project site by 20 feet. Carobs #529 and 531 may also require the reduction of branches over the site. Branches should be pruned back to avoid interfering with construction equipment.
