December 11, 2024 (revised September 4, 2025)

This revised arborist report addresses the proposed townhomes project at 1101 Walpert Dr, Hayward. **Notable changes to the report are highlighted in red**; minor content or wording changes were not specifically highlighted. For this report, I used the following references:

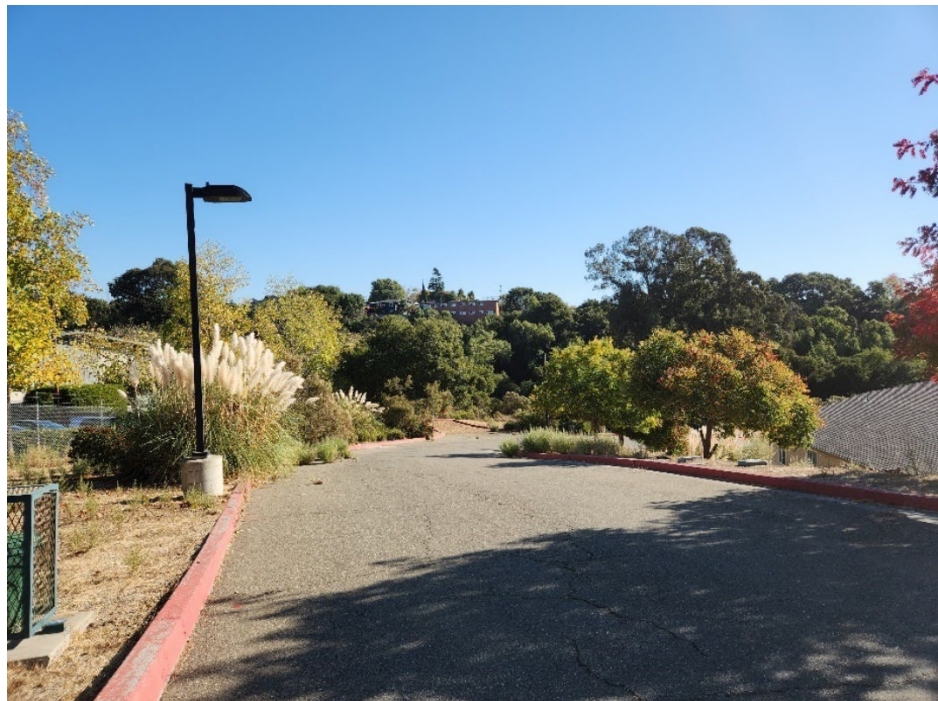
Figure 1. Photo taken facing south to the larger parcel; the tallest tree right of the center is growing on the creek bank.

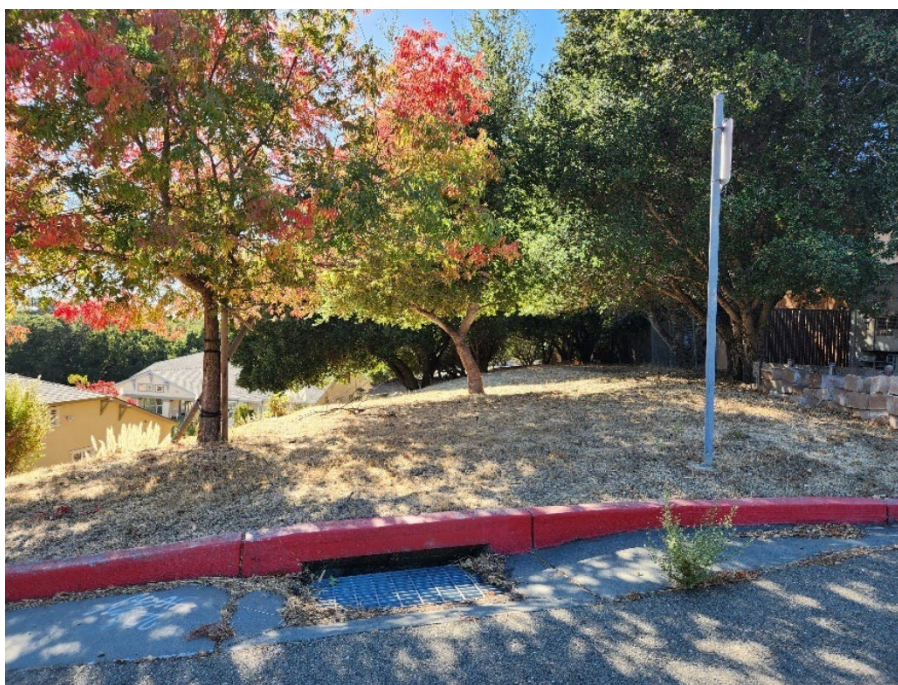
Figure 2. The central oak grove is visible in the background, at the border between the north and south parcels. Several oaks will be removed due to new retaining walls and accessibility ramps; others may be affected by landscaping within the area.

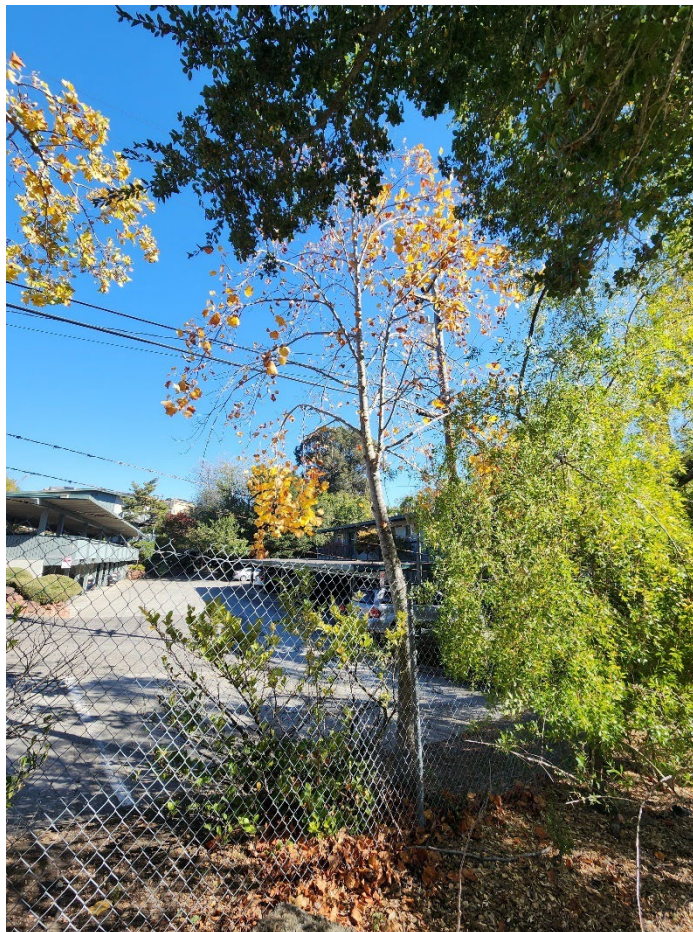
Figure 3. Tulip tree #80 grows on the apartment's side of the fence. Its stunted and sparse canopy is likely due to insufficient water. Parking spaces extend within 2' of its trunk on the apartment side.

- The project arborist shall be on-site during grading or excavation by trees #79, 80, 82, 83, 85-87 & 98 (8 trees). If root loss is significant and there is no flexibility in working around roots, the tree(s) may need to be removed.

- Trees #79, 85, 87 & 98 are considered protected.
  - Trees #79, 80, 82, 83, 85-87 & 98 are co-owned or off-site and require the neighbors' approval for removal.

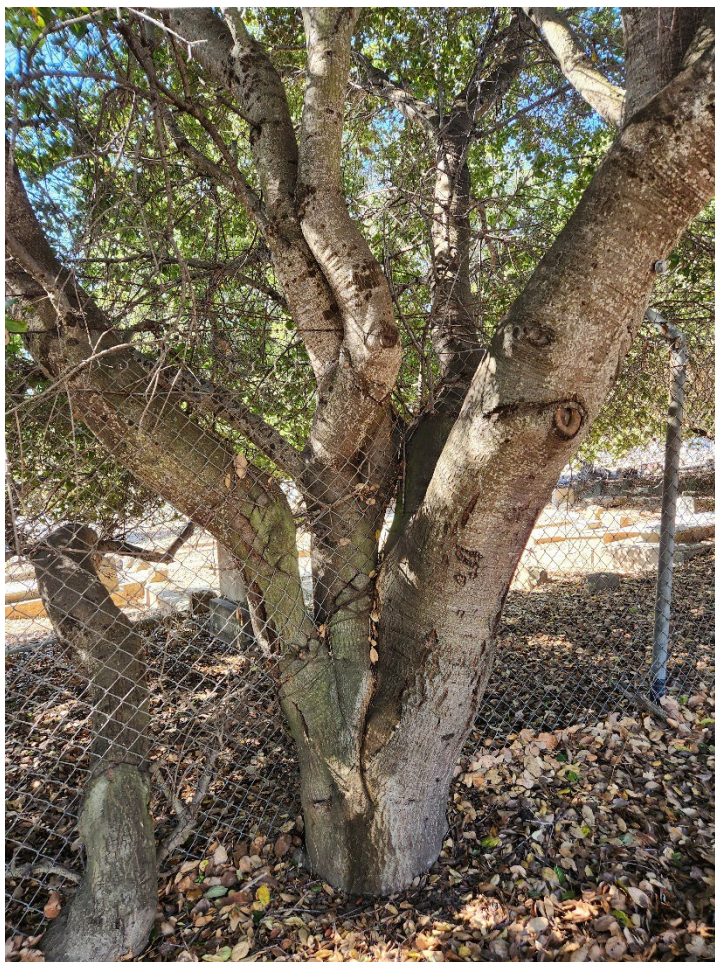
been cut down before but could not be completely eliminated because of the fence. They have since regrown with multiple trunks, which are all embedded in the fence (Figure 4). I expect this issue to recur as long as the fences exist, and there may be structural or health complications in the future. Additionally, the west perimeter trees are very crowded. Their overall forms and structures are affected, since the less-dominant trees are forced to lean out from under the larger trees to reach sunlight.

Figure 4. Tree #65 is an example of the trees growing along the west property line. Its trunk grew at the fence, which has now been embedded into the wood. The small tree at the left of the photo is forced to grow in an odd way to reach sunlight.

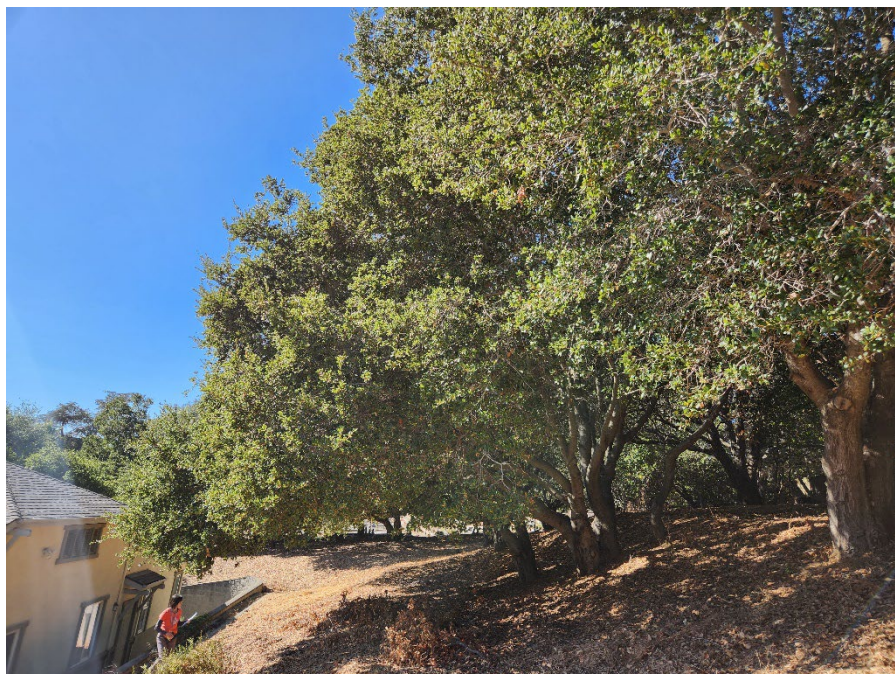
Figure 5. Oaks #53-55 (center) and #51 (right) are part of the oak grove. #51 is in the accessibility switchback and must be removed; the others may be affected by landscaping improvements but the plan was not yet available.

Several tall retaining walls were already constructed on the south parcel – one separating the buildings from the oak grove (Figure 5), and another supporting the fire turnaround portion of the driveway by trees #73 & 74. **The southernmost retaining wall was shifted north, which creates enough distance from oak #73 that it can be preserved (though other trees affected by retaining walls will still be removed). This change means that an additional protected tree can be preserved.**
