| <b>DOCKETED</b> | |
|---|---|
| <b>Document Title:</b> | Calpine Russell City Steam Turbine Generator Event Investigation Report - Redacted |

# Investigation Report

## Calpine Russell City Steam Turbine/Generator Event

Calpine Corporation - Russell City Energy Center

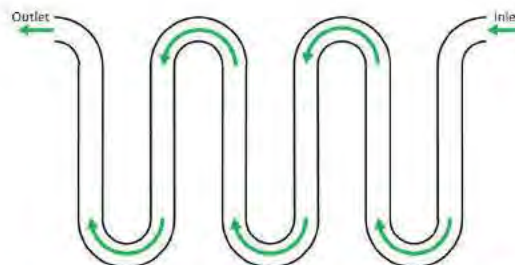
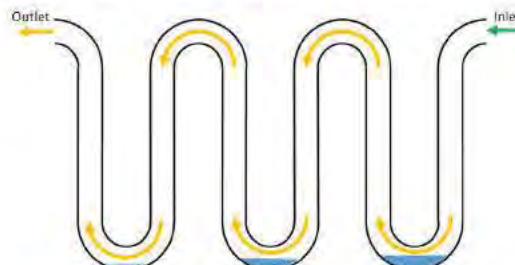
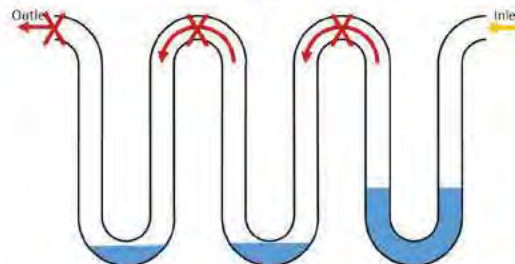
**Figure 5-11 - Loop Seal Depiction**

To aid in the investigation (3) the steam saturation temperature was calculated based on the HRSG #1 RH inlet and outlet pressures and trended through the operation period. The 3 drains identified above quickly dropped in temperature to the saturation temperature after the unit shut down. Approximately ( ) after block 1 shut down, (4) RH harp 1 drain temperature dropped below the steam saturation temperature, quickly followed by the (5) RH harp 3 drains. This indicates that steam condensed within the HRSG. Approximately ( ) later, the HRSG #1 RH inlet and outlet pressures began to separate, indicating that a sufficient amount of water had accumulated in the lower turns of the harps to form loop seals, as depicted in **Figure 5-11**, and was preventing free flow through the circuit.

- Accumulation of liquid in the bottom loops partially restricts flow through piping loops
- Flow restriction may result in a small pressure reduction through the piping system

- Accumulation of liquid in the bottom loops obstructs flow through piping loops
- Inlet pressure is able to increase substantially over the outlet pressure

Along with this maintained pressure, the temperatures within the RH system were at or near saturation temperature. The maintained pressure acted as one force driving accumulated water into the IP ST via the HRH pipe when the exit pressure of HRSG #2 dropped. The second driving force was the additional pressure created as portions of the high temperature water boiled off (flashed) and expanded as the HRH header pressure dropped.
