December 11, 2024 (revised September 4, 2025)

This revised arborist report addresses the proposed townhomes project at 1101 Walpert Dr, Hayward. **Notable changes to the report are highlighted in red**; minor content or wording changes were not specifically highlighted. For this report, I used the following references:

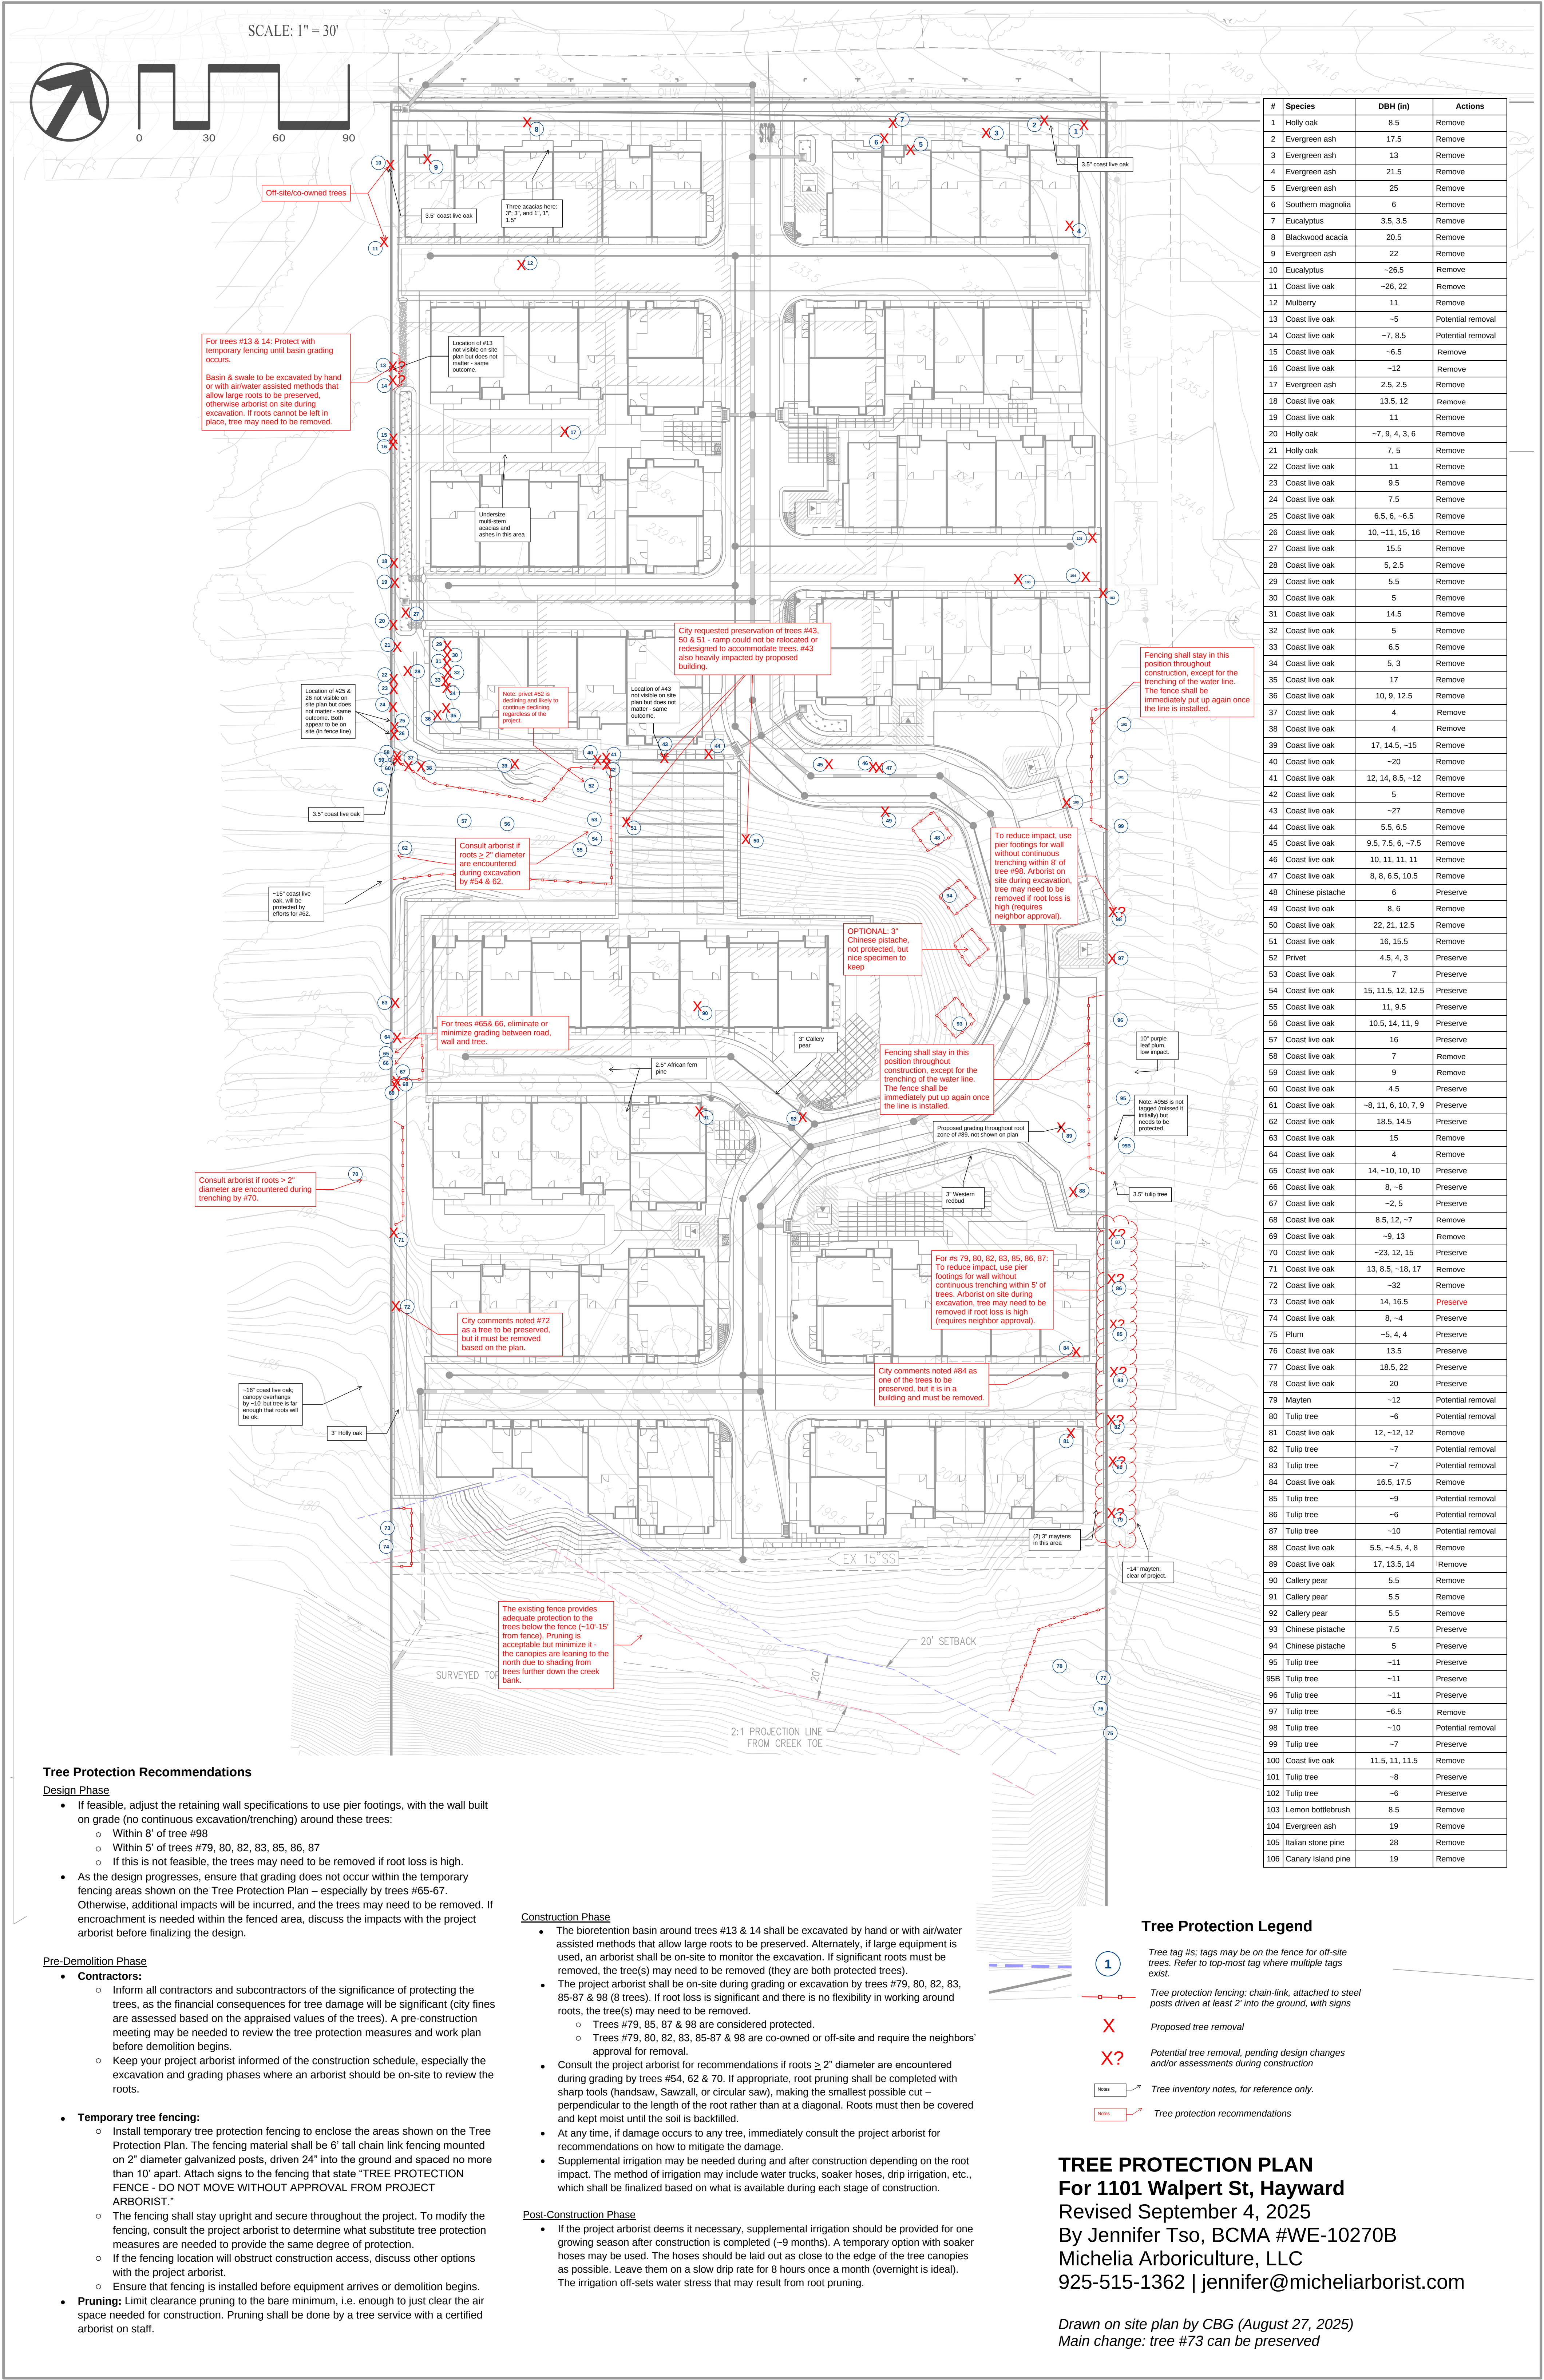
## Appendix 2: Tree Protection Plan

A tree protection plan is attached on the following page. If it is not included, please contact me and/or the project lead for a copy. It distills the recommendations in a visual format for use in the field.
