**THE BOARD OF DIRECTORS OF HAYWARD
GEOLOGIC HAZARD ABATEMENT DISTRICT**

**RESOLUTION APPROVING THE HAYWARD GEOLOGIC HAZARD ABATEMENT
DISTRICT PLAN OF CONTROL FOR THE LA VISTA DEVELOPMENT**

Attachments: Attachment A (Hayward GHAD Plan of Control for La Vista Development)

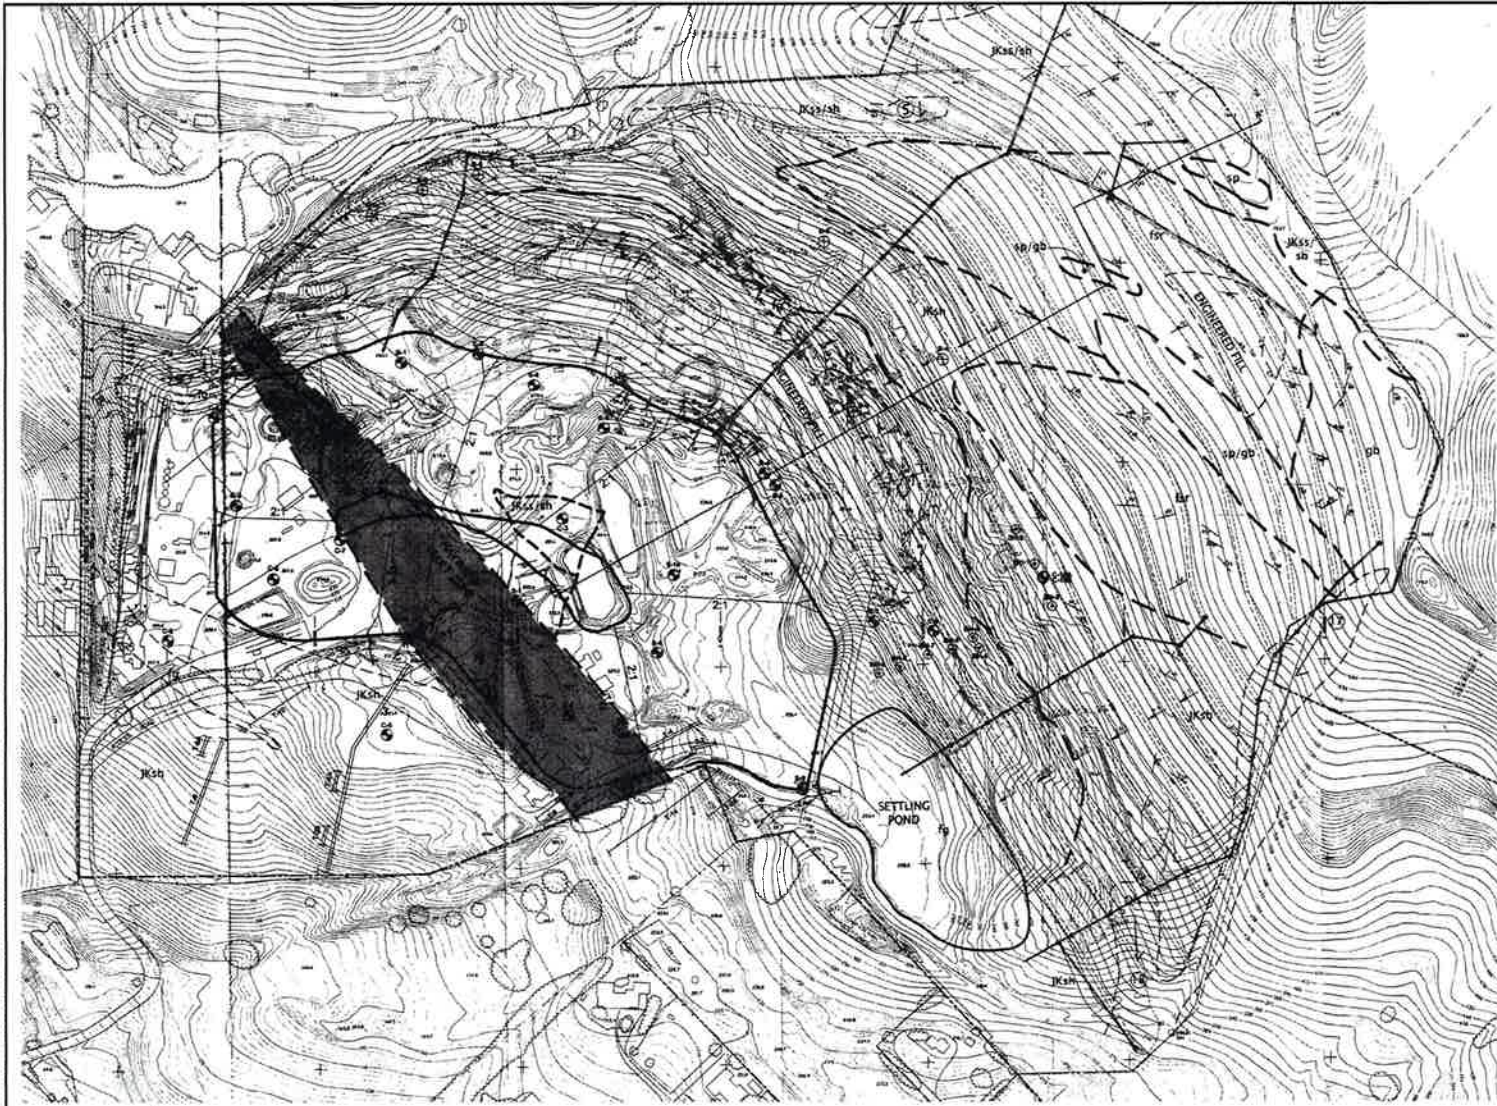
EXPLANATION
ALL LOCATIONS ARE APPROXIMATE

Regional landslide mapping by Nilsen (1975) shows two landslide areas on the eastern portion of the La Vista property that appear to have been removed during quarry operations. Several additional landslides were identified by BGC during a previous study (2000). As shown on Appendix A, Figure 2, a number of additional landslides were mapped by BGC. During site grading, landslides were mitigated as shown on Table 4.1-1.

The Project lies within the mapped Alquist-Priolo Earthquake Fault Hazard Zone for the Hayward Fault, established by the California Geological Survey (CGS). A geologic map of the quarry, including the location of the Hayward Fault zone as determined by site-specific mapping, is shown on Appendix A, Figure 2. As discussed above, the active Hayward Fault zone generally occurs at the base of the historic steeper ridge slopes that existed prior to quarry excavations. The fault zone consists of a band of sheared soil and rock designated by BGC as the “concentrated fault zone” that varies in width from roughly 300 feet at the southern side of the property to 100 feet at the north side. BGC performed refined mapping of the concentrated fault zone at the east and west boundaries of the zone by excavating and logging a series of trenches. BGC logged additional shear zones in four trenches outside the main “concentrated fault zone” and outside the 50-foot setback zone designated from the edge of the “concentrated shear zone” (Trenches T-3, T-4, T-14 and T-15) some of which appear to have exposed sheared contacts between greenstone and soil (Trenches T-14 and T-15); however, these shear zones were not designated as active by BGC or depicted on the geologic map in the design-level report. BGC interpreted these zones as not active based on reported lack of continuity or inconsistent orientations between trenches. BGC designated a “special building foundation zone” which includes Lots 147 through 159 and 164 through 171. This zone was designated to mitigate the risk of “minor sympathetic rupture” in the event of rupture along the adjacent main fault zone. BGC does not provide a specific estimate of the expected magnitude of the “minor sympathetic rupture” or the type of movement that can be expected in terms of vertical, horizontal or shear displacement. They recommend post-tensioned slab foundations to mitigate the risk in the special foundation zone, but do not provide specific slab design recommendations.

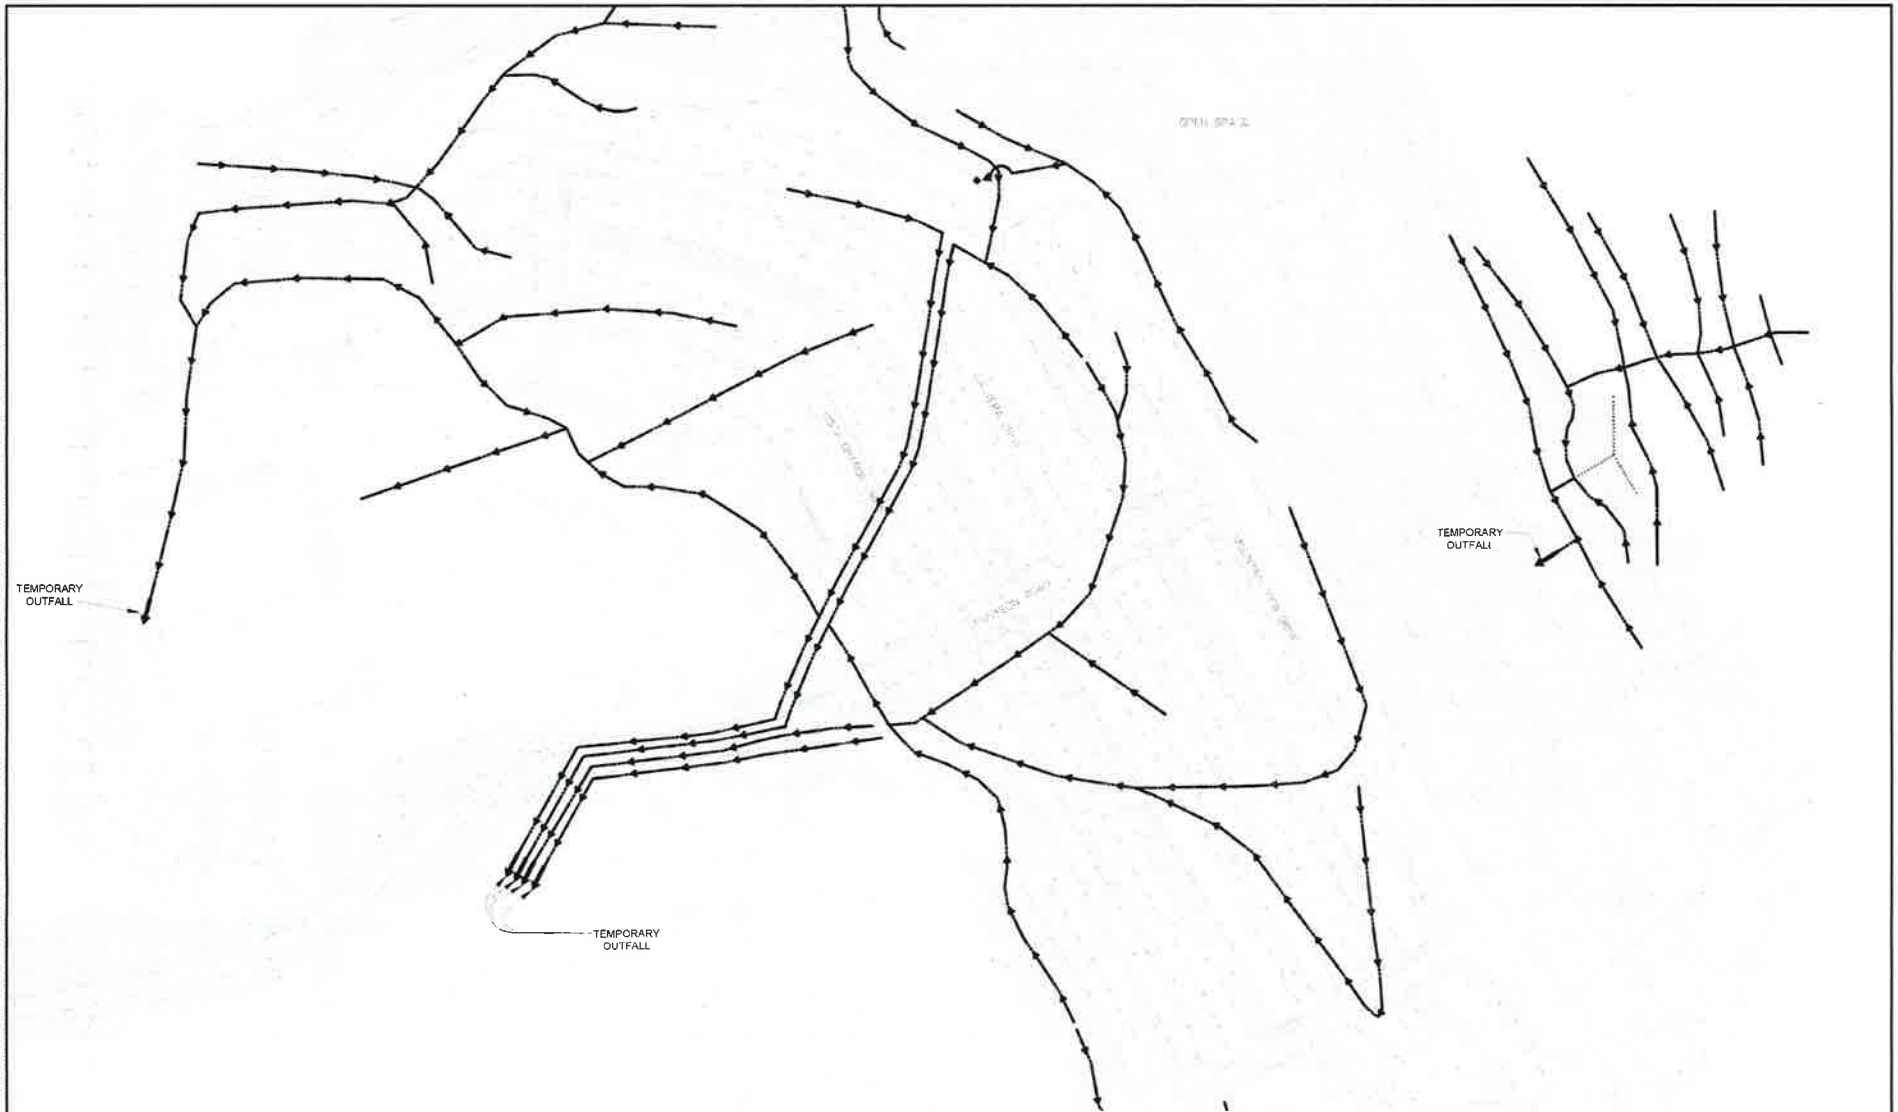
EXPLANATION

The grading also included repair of a landslide that had developed on the reclamation slope in 2005 and installation of a system of subsurface drains throughout the Project. The as-built locations of the drain system are shown on Appendix A, Figure 3.

Landslides located within open space areas are natural landforms that do not require mitigation except where they affect man-made improvements. Debris catchment areas are the principal mitigation method used within the GHAD for areas between potentially unstable slopes and improvements. The debris catchment structures include debris benches, debris berms, and runout areas. GHAD maintenance of the areas will be critical to maintain adequate protection for the Site Improvements (as such term is defined in Section 5.1). Maintenance and monitoring of these areas is described in Section 9. Potential mitigation and repair measures for GHAD areas near development are discussed in Section 7. A copy of the as-built subdrain plan is shown on Appendix A, Figure 3.

- Debris benches and walls.
- Subdrains, including, but not limited to, those shown on Appendix A, Figure 3.
- Storm drain inlets, outfalls and pipelines within the GHAD Parcels and a portion of the public park area as shown on Appendix A, Figure 1.

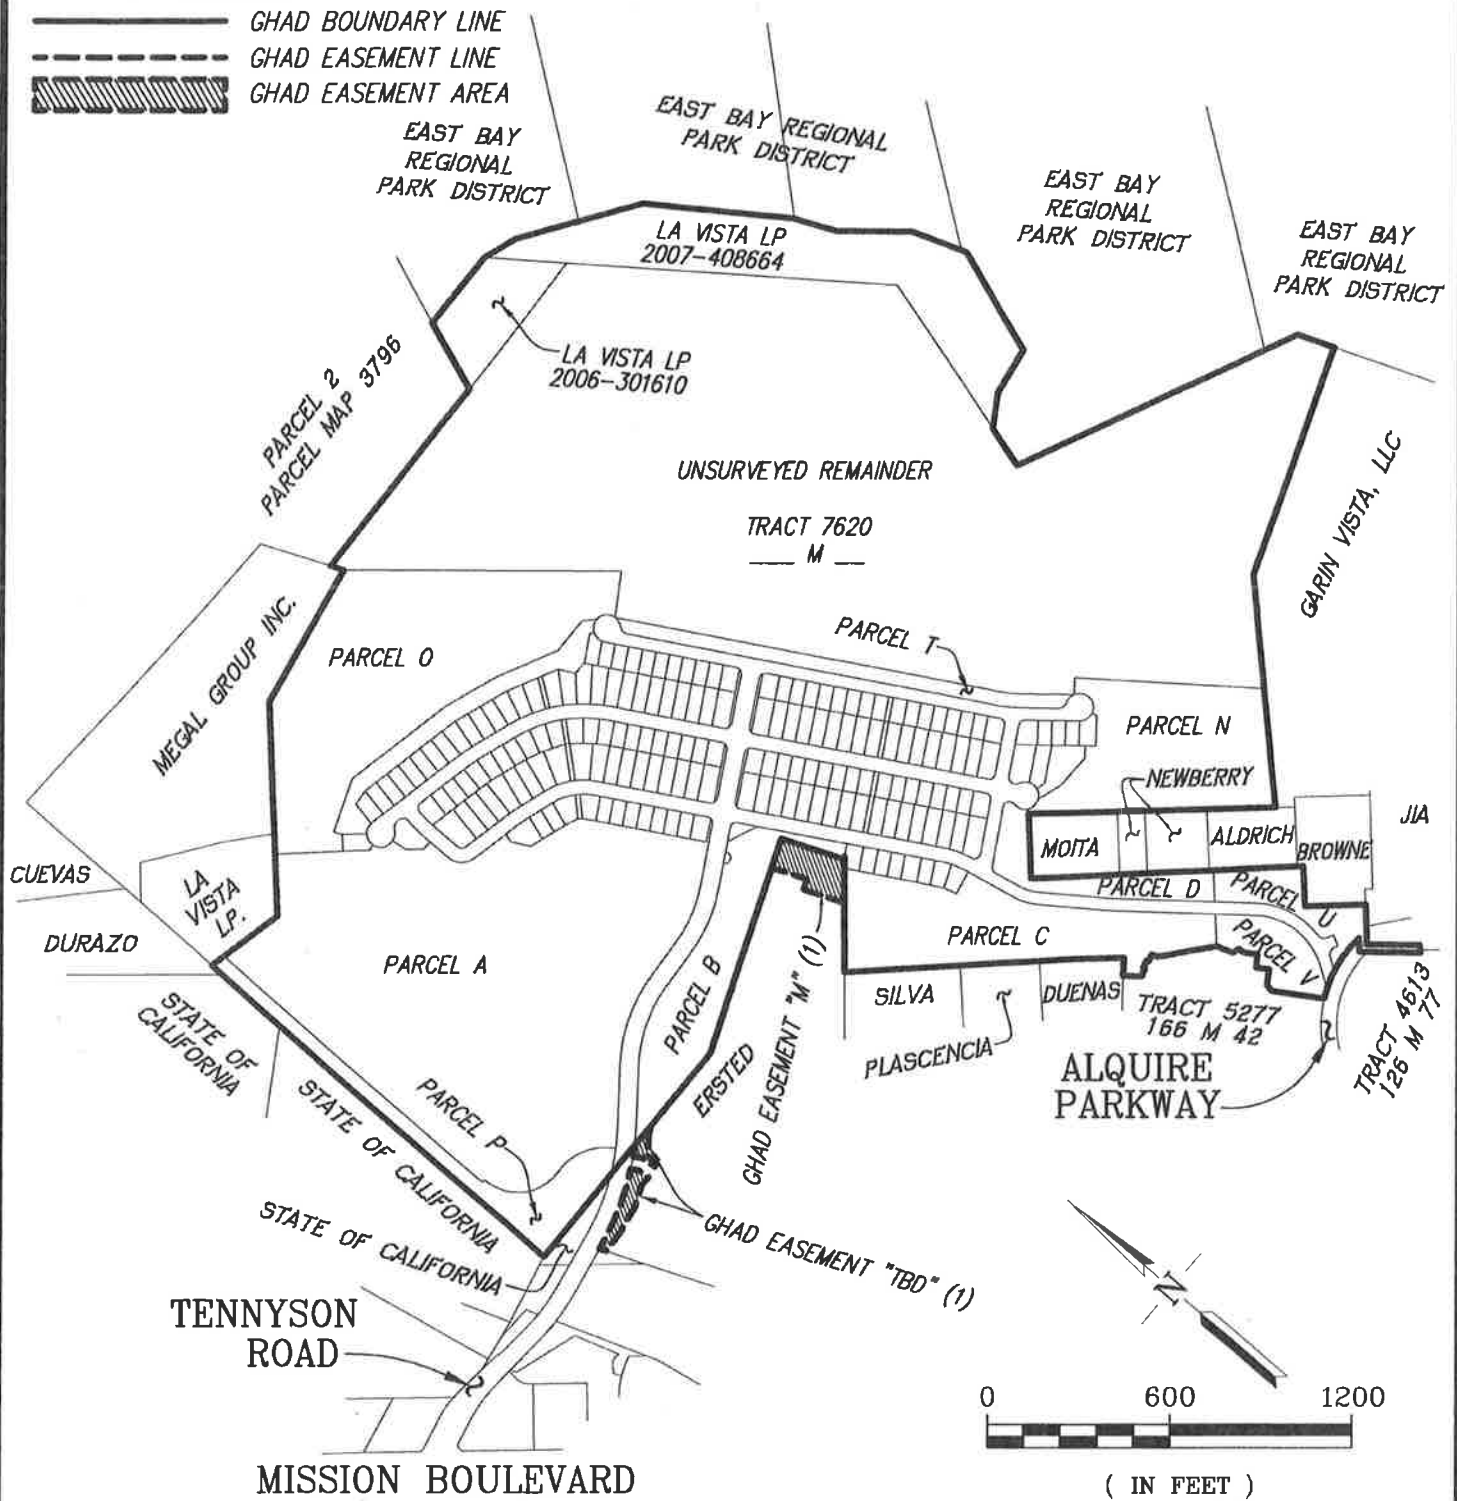
SHEET 1 OF 3 SHEETS

(1) HAYWARD TENNYSON, LLC EASEMENTS MAINTAINED BY THE HAYWARD GHAD.

EXHIBIT A
PLAT TO ACCOMPANY LEGAL DESCRIPTION
FOR
GEOLOGIC HAZARD
ABATEMENT DISTRICT
CITY OF HAYWARD, ALAMEDA COUNTY, CALIFORNIA

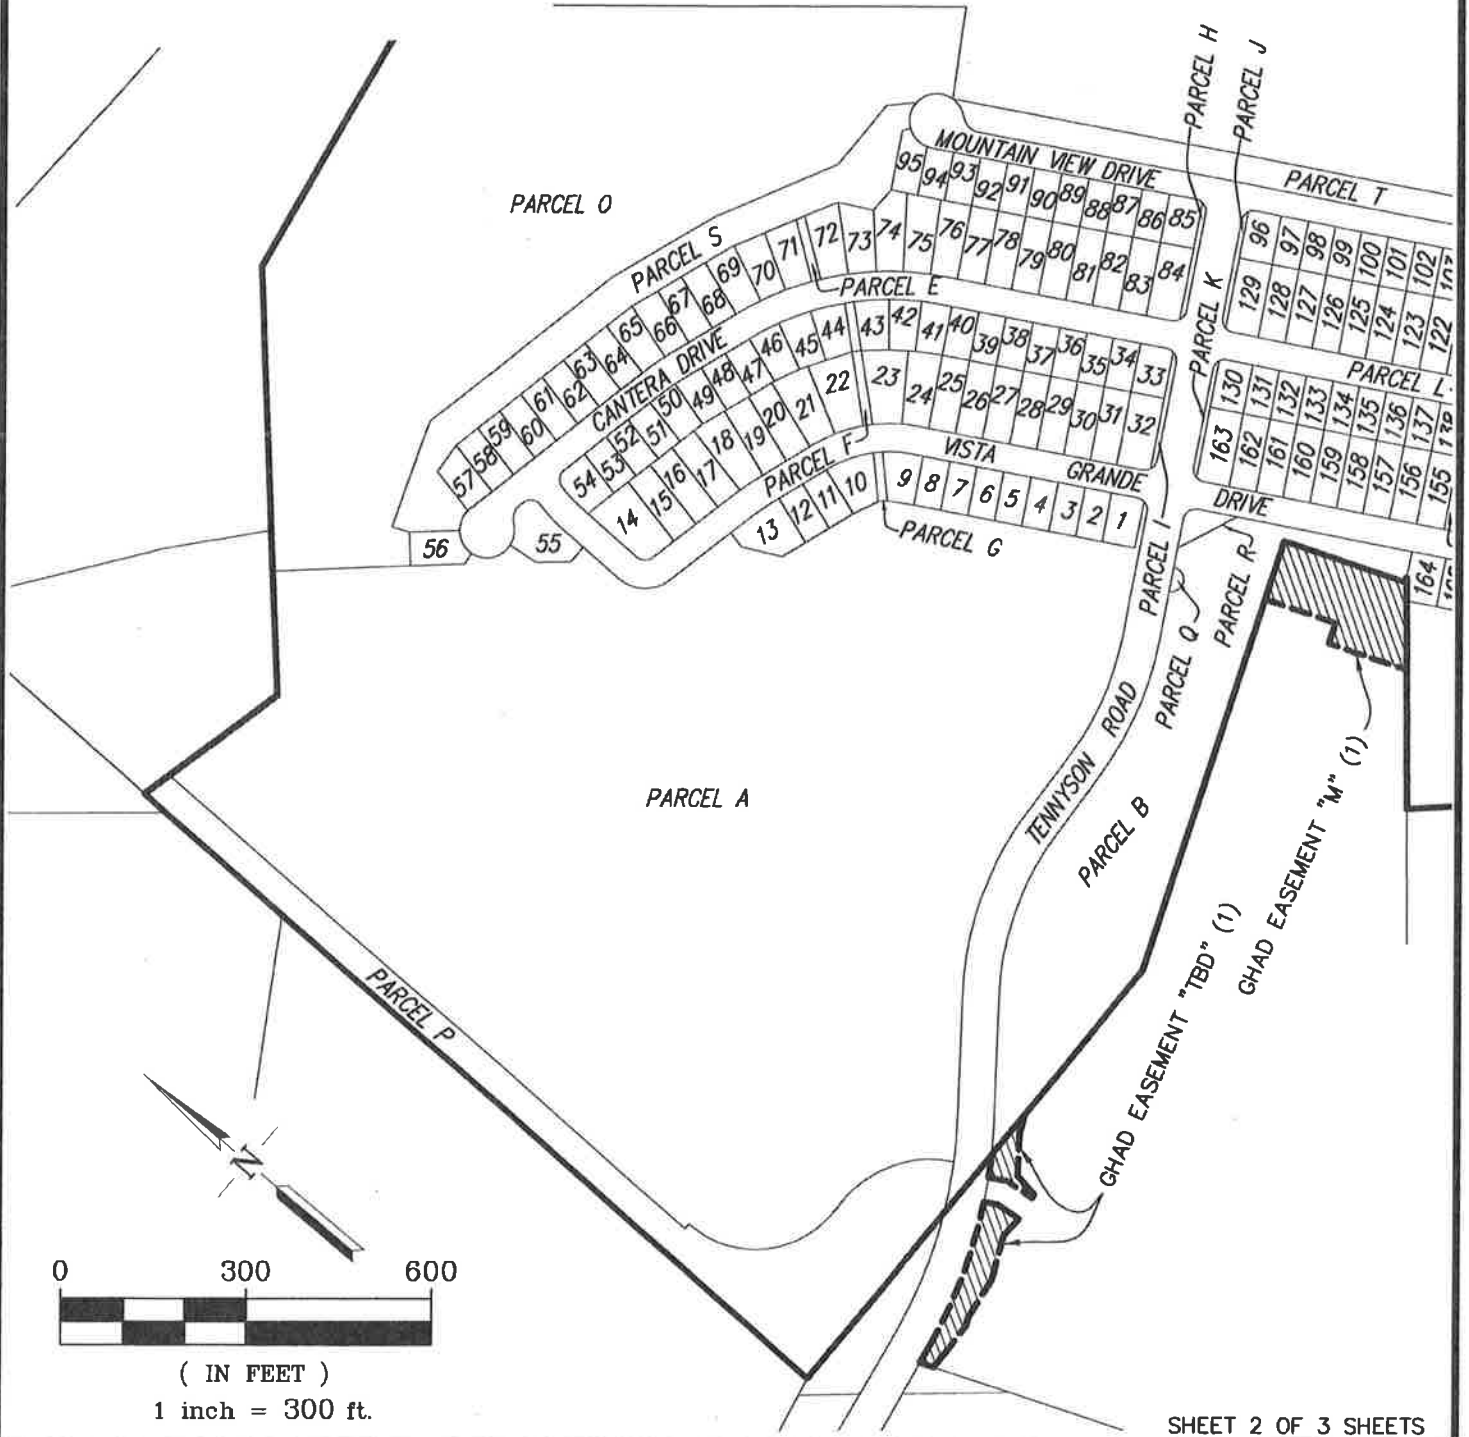
SHEET 2 OF 3 SHEETS

EXHIBIT A
PLAT TO ACCOMPANY LEGAL DESCRIPTION
FOR
GEOLOGIC HAZARD
ABATEMENT DISTRICT
CITY OF HAYWARD, ALAMEDA COUNTY, CALIFORNIA

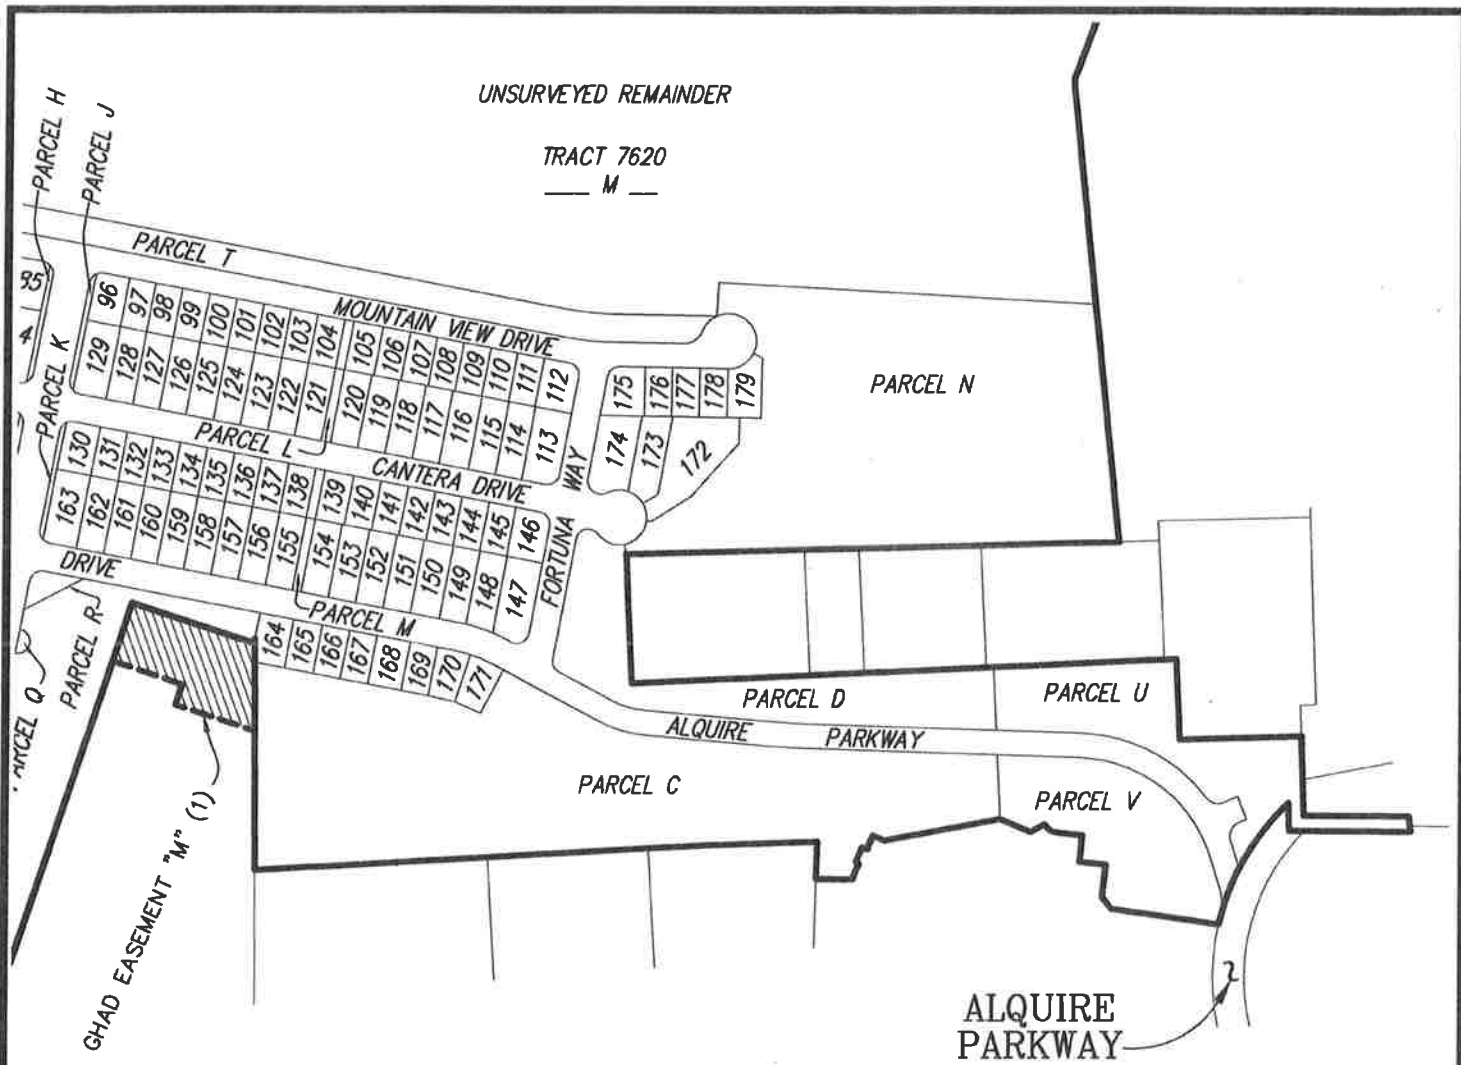
SHEET 3 OF 3 SHEETS

EXHIBIT A
PLAT TO ACCOMPANY LEGAL DESCRIPTION
FOR
GEOLOGIC HAZARD
ABATEMENT DISTRICT
CITY OF HAYWARD, ALAMEDA COUNTY, CALIFORNIA
