# RUSSELL WAY GARDEN

1289 RUSSELL WAY  
HAYWARD, CA

**PROJECT DESCRIPTION:**  
3 STORY 14 UNIT  
APARTMENT BUILDING WITH COVERED GARAGE

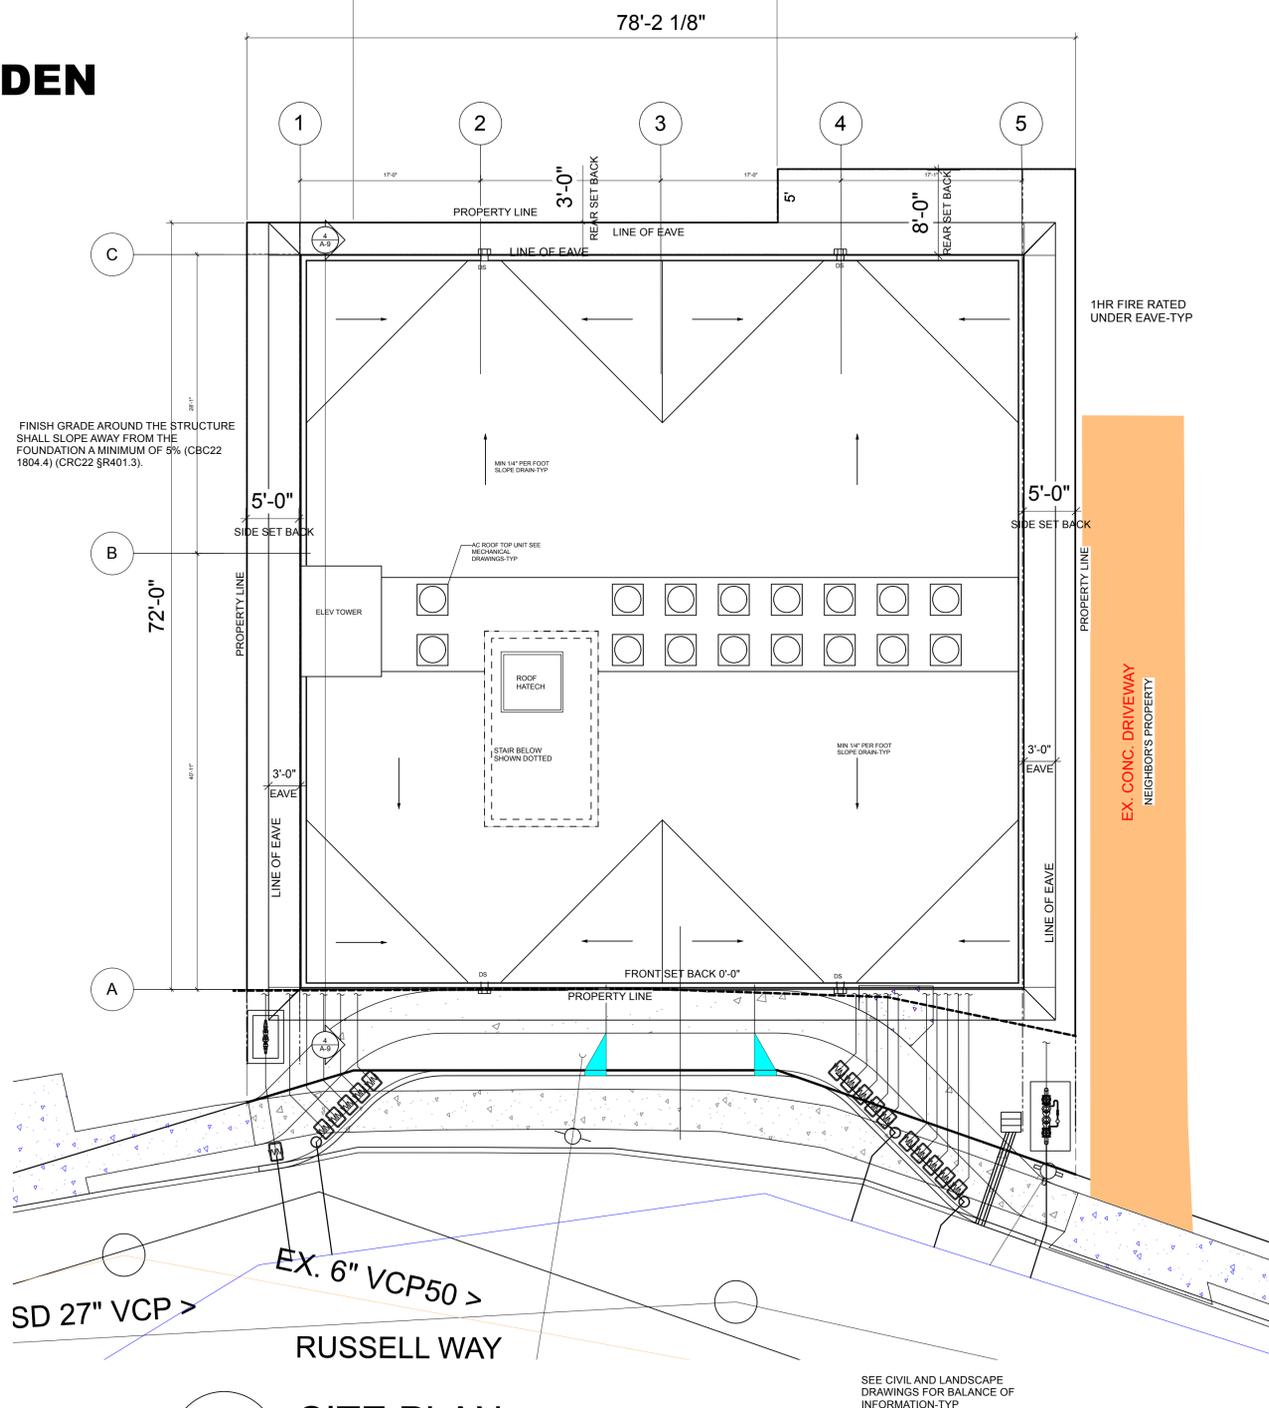
1 **SITE PLAN**  
Scale: 1/8" = 1'-0"

FINISH GRADE AROUND THE STRUCTURE SHALL SLOPE AWAY FROM THE FOUNDATION A MINIMUM OF 5% (CBC22 1804.4) (CRC22 §R401.3).

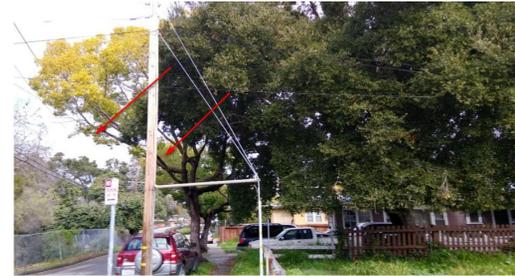
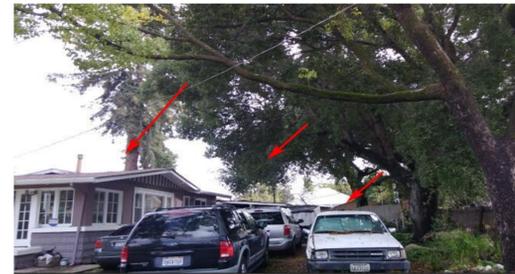
Photos – Proximity to R.O.W and Adjacent Home.

Top photo show risks posed to the public, street/sidewalk (arrows). Bottom photo shows risks posed to neighboring property (arrows).

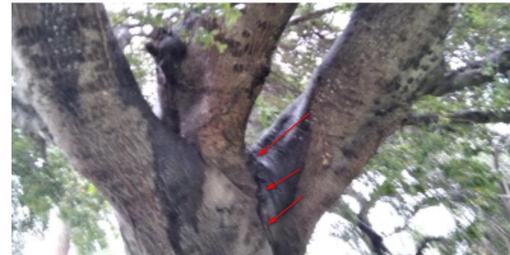
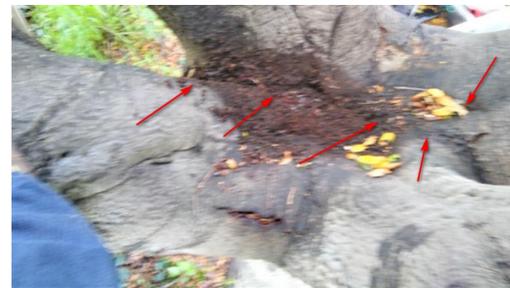
Photos – Visible defects

Top photo shows significant crack/split in the main crotch (arrows). Bottom photo (taken in the tree) shows how this crack/split extends from the side (top photo) across the entire main crotch of the tree's trunk. The potential for failure is extremely high.

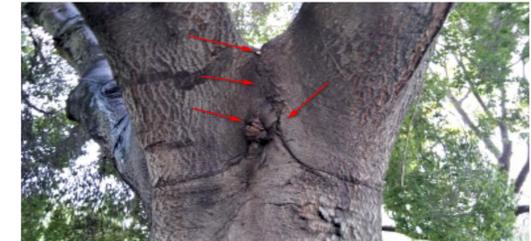
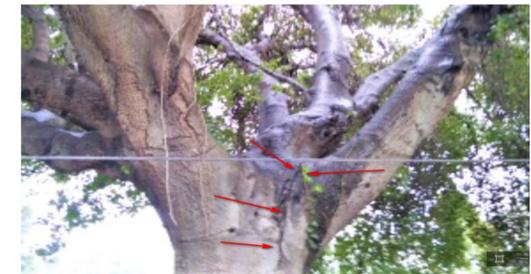
Photos – Additional Visible Defects

Both top and bottom photos show other weak attachments different from previous photos. Large, heavy, and overextended primary limbs have created significant stress cracks that will eventually fail. High risk to surrounding areas beneath canopy.

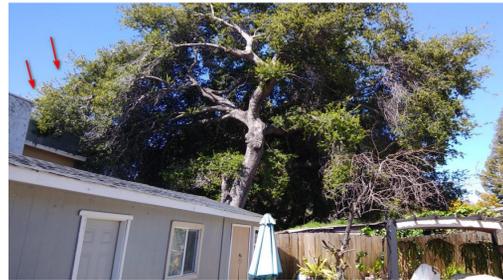
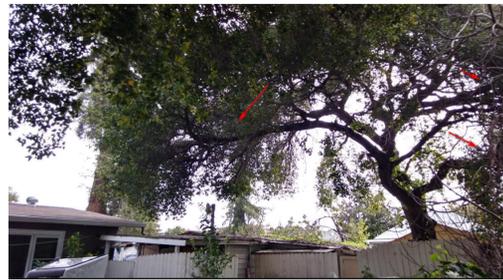
Photos – Rear & Front View of Subject Tree

Top photo shows the over-pruned back side and limbs on neighbor's building (arrows) Bottom photo shows overextended, tip heavy limbs growing over existing property roofs and adjacent undeveloped lot on other side of fence. (arrows).

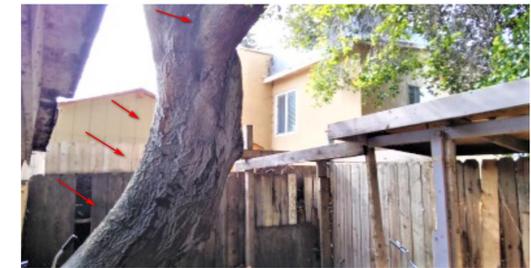
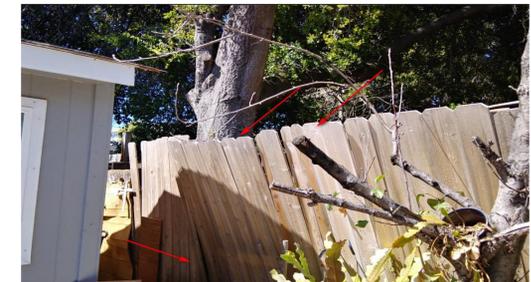
Photos – Significant Lean and Fence Upheaval

Top photo shows significant trunk lean (toward existing structures) and weak attachment. The majority of weight of the entire tree is on the leaning side of the canopy. Bottom photo (taken in neighbor's yard) shows section of fence lifted by the base of the tree's trunk.

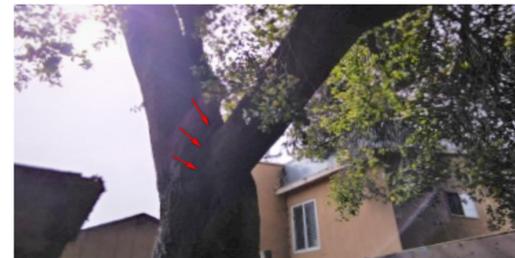
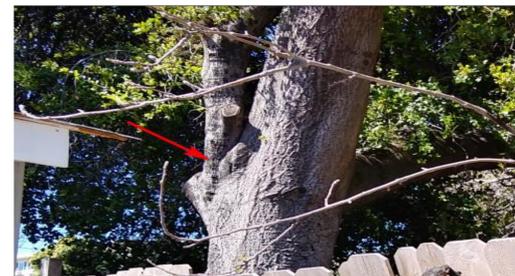
Photos – Weak Attachments, Stress Sites

Top photo (front side of the trunk) shows the weak attachment of a major co-dominant limb that overextends the subject property. The bottom photo shows the stress crack on back side of the same large, tip heavy limb. Over-weighted limbs with weak attachments will eventually fail. Substantial risk to surrounding areas beneath canopy.

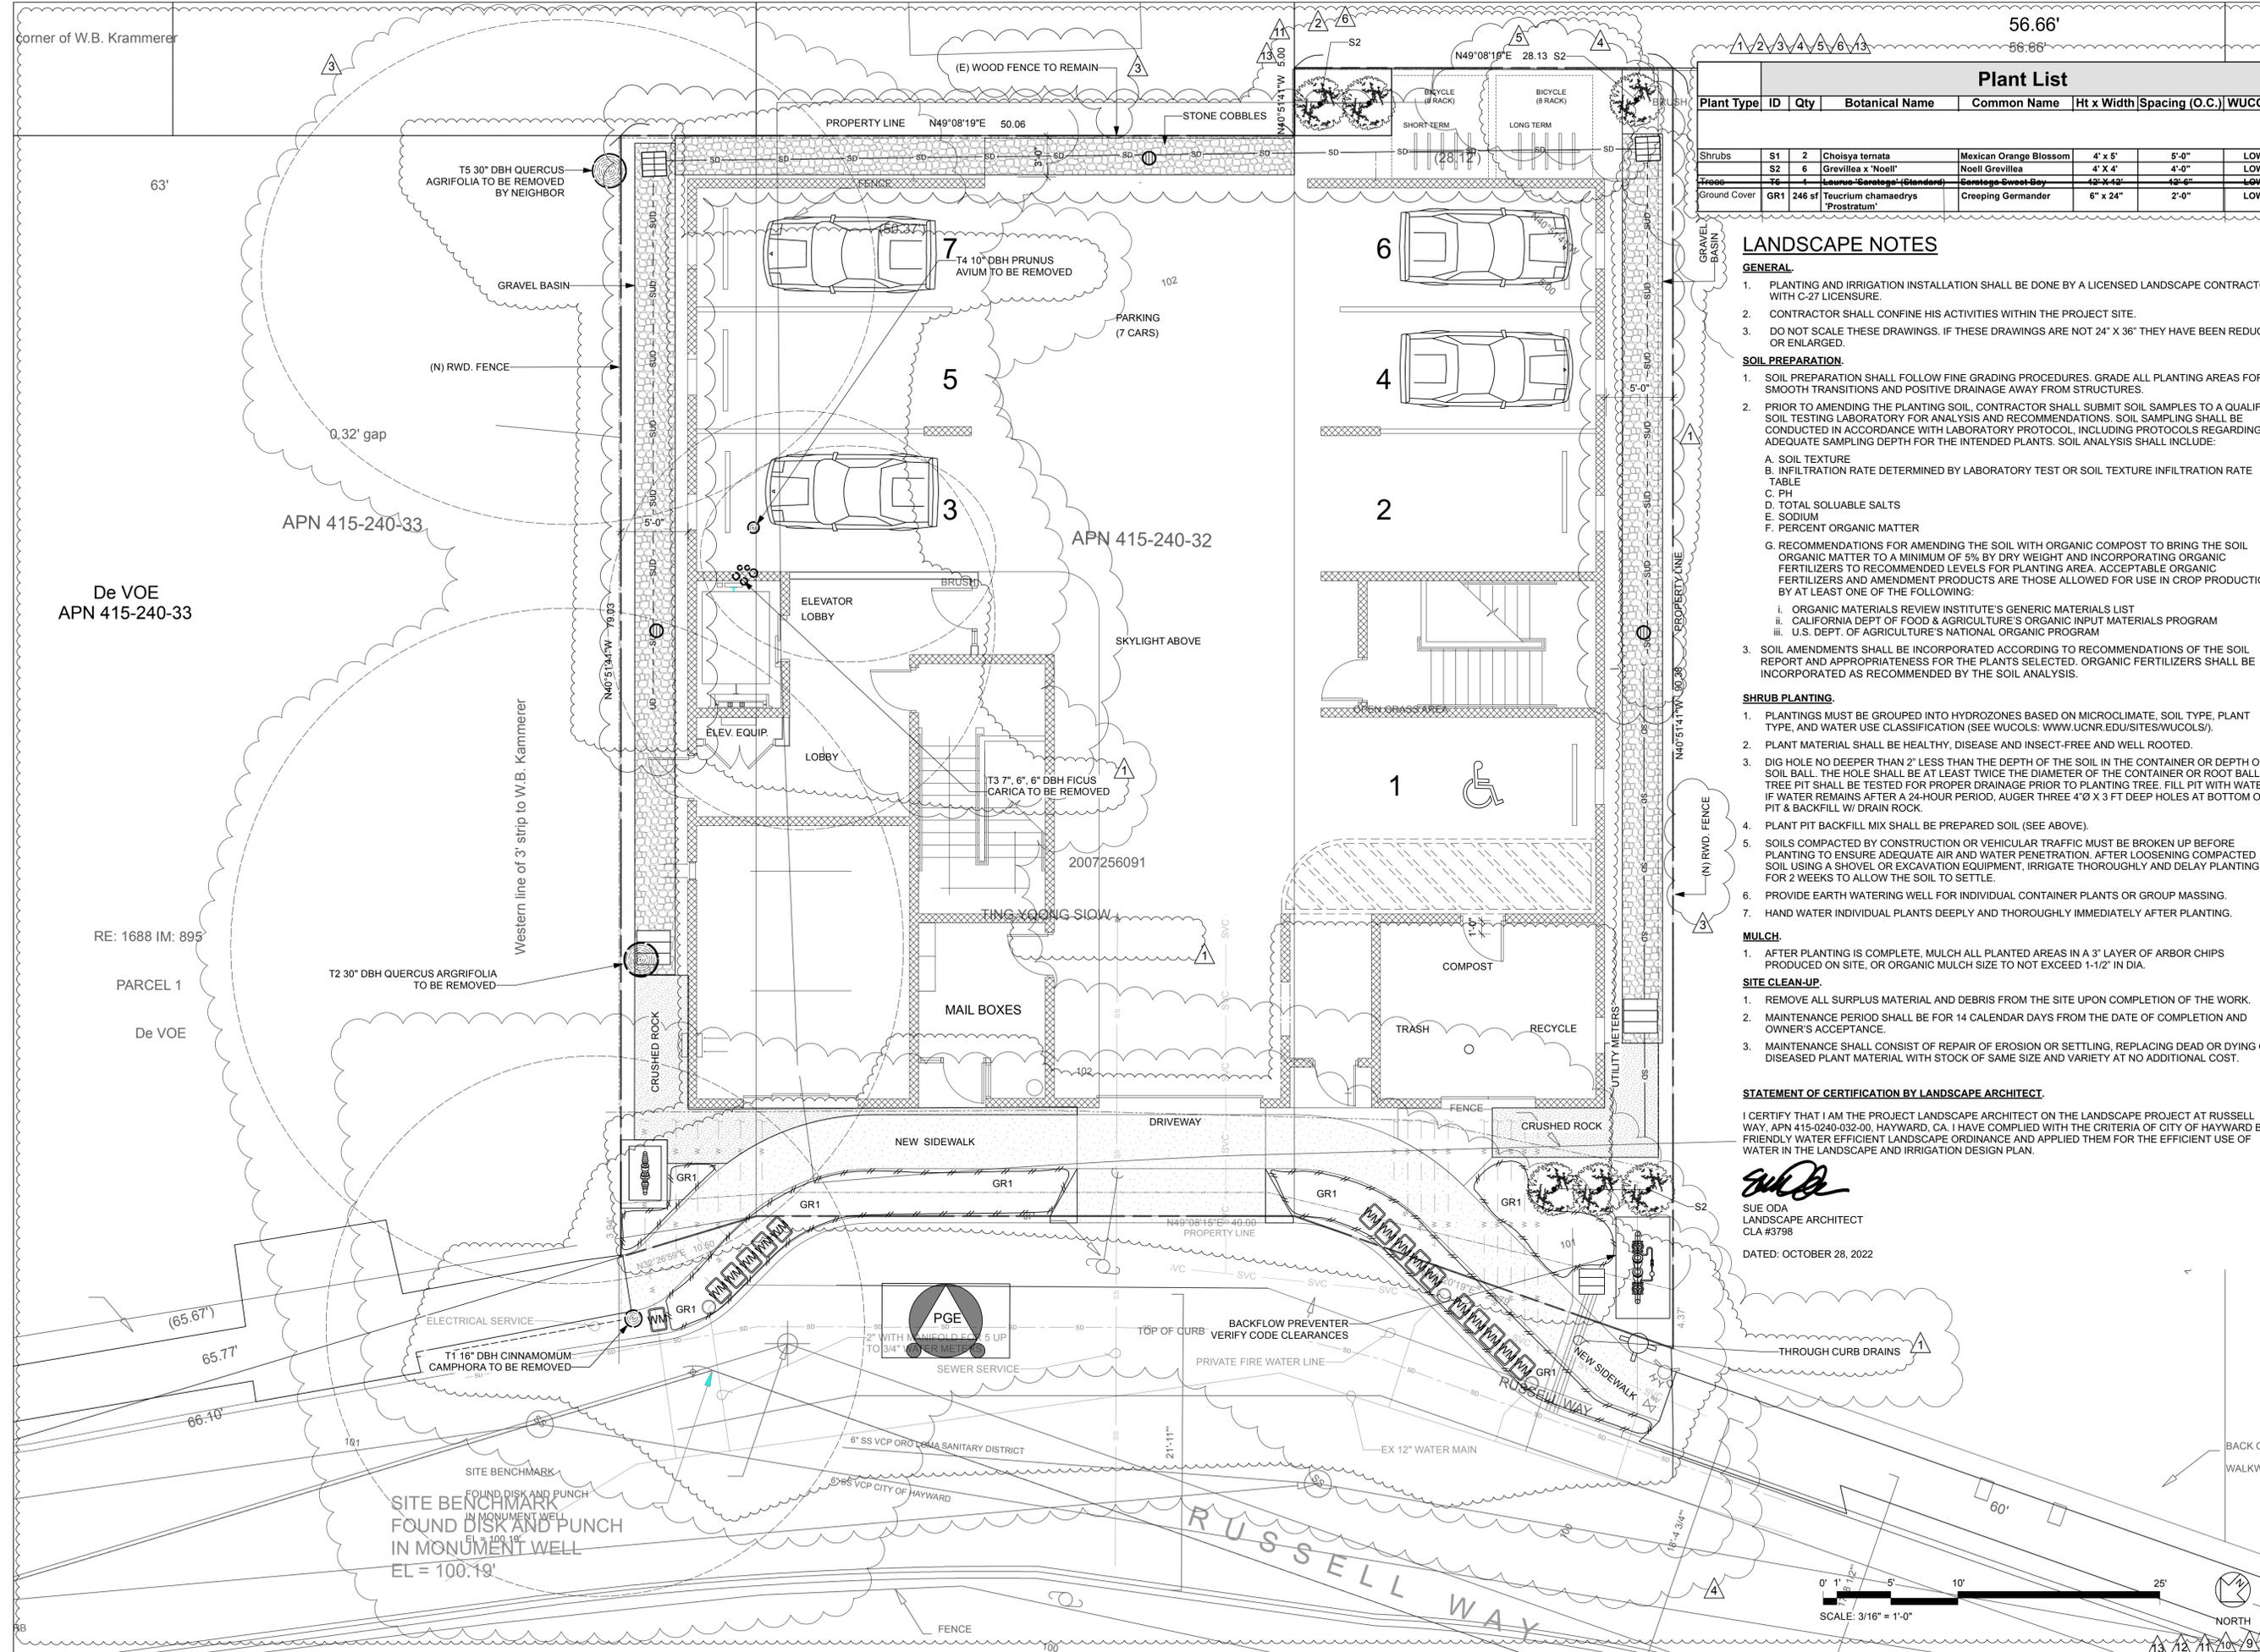
JOB TITLE  
 SHEET TITLE  
**PLANTING PLAN**  
 SCALE: 3/16" = 1'-0" DATE: 11/08/22  
 DRAWN: NR CHECKED: SEO  
 SHEET **L1** OF **4** SHEETS

Plant List									
Plant Type	ID	Qty	Botanical Name	Common Name	Ht x Width	Spacing (O.C.)	WUCOLS		
Shrubs	S1	2	Chelaya ternata	Mexican Orange Blossom	4' x 5'	5'-0"	LOW		
	S2	6	Grevillea x 'Noell'	Noell Grevillea	4' x 4'	4'-0"	LOW		
Grass	G1	1	Lawnus-Santegozi-(Standard)	Santegozi Sweet Bay	12'-x-12'	12'-0"	LOW		
	G2	1	Lawnus-Santegozi-(Standard)	Santegozi Sweet Bay	12'-x-12'	12'-0"	LOW		
Ground Cover	GR1	246 sf	Tauscium chamaedrys 'Prostratum'	Creeping Germander	6" x 24"	2'-0"	LOW

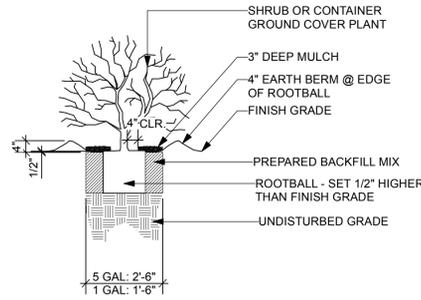
**SHRUB PLANTING**  
NOT TO SCALE

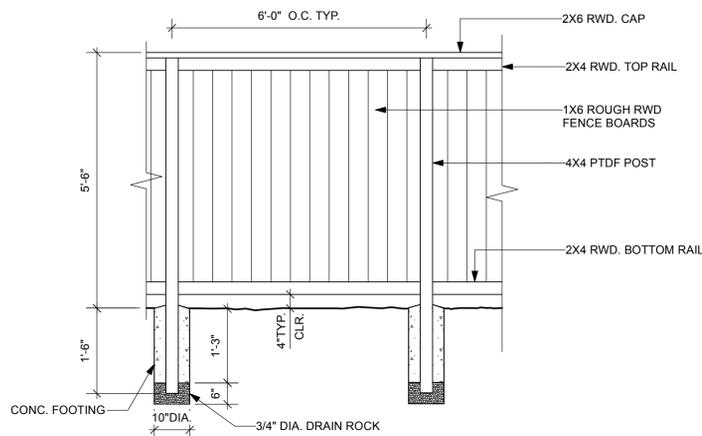
**REDWOOD FENCE**  
SCALE: 1/2" = 1'-0"

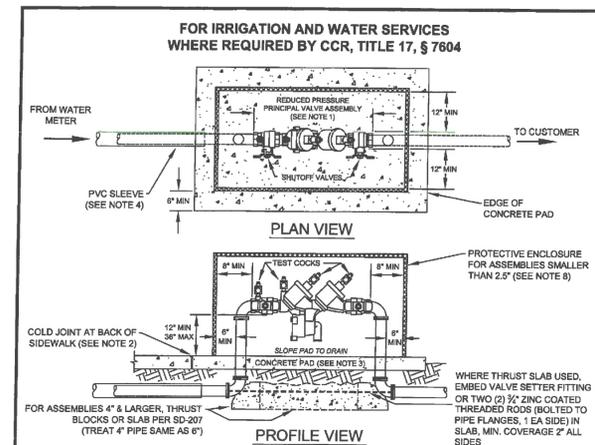
- NOTES:**
- ALLOWED BACKFLOW ASSEMBLIES AND THEIR ORIENTATIONS SHALL BE LIMITED TO THOSE SPECIFIED ON THE "LIST OF APPROVED BACKFLOW PREVENTION ASSEMBLIES" BY THE UNIVERSITY OF SOUTHERN CALIFORNIA'S FOUNDATION FOR CROSS-CONNECTION CONTROL AND HYDRAULIC RESEARCH, 2010 LA TEST REVISION.

- THE BACKFLOW DEVICE SHALL BE LOCATED: (A) A MAXIMUM OF 5' FROM BACK OF SIDEWALK (TYP.); (B) WHERE SCREENING IS REQUIRED, A MAXIMUM OF 30" FROM BACK OF SIDEWALK; OR (C) AT A LOCATION DETERMINED BY THE WATER DISTRIBUTION CROSS CONNECTION PERSONNEL IN THE FIELD.

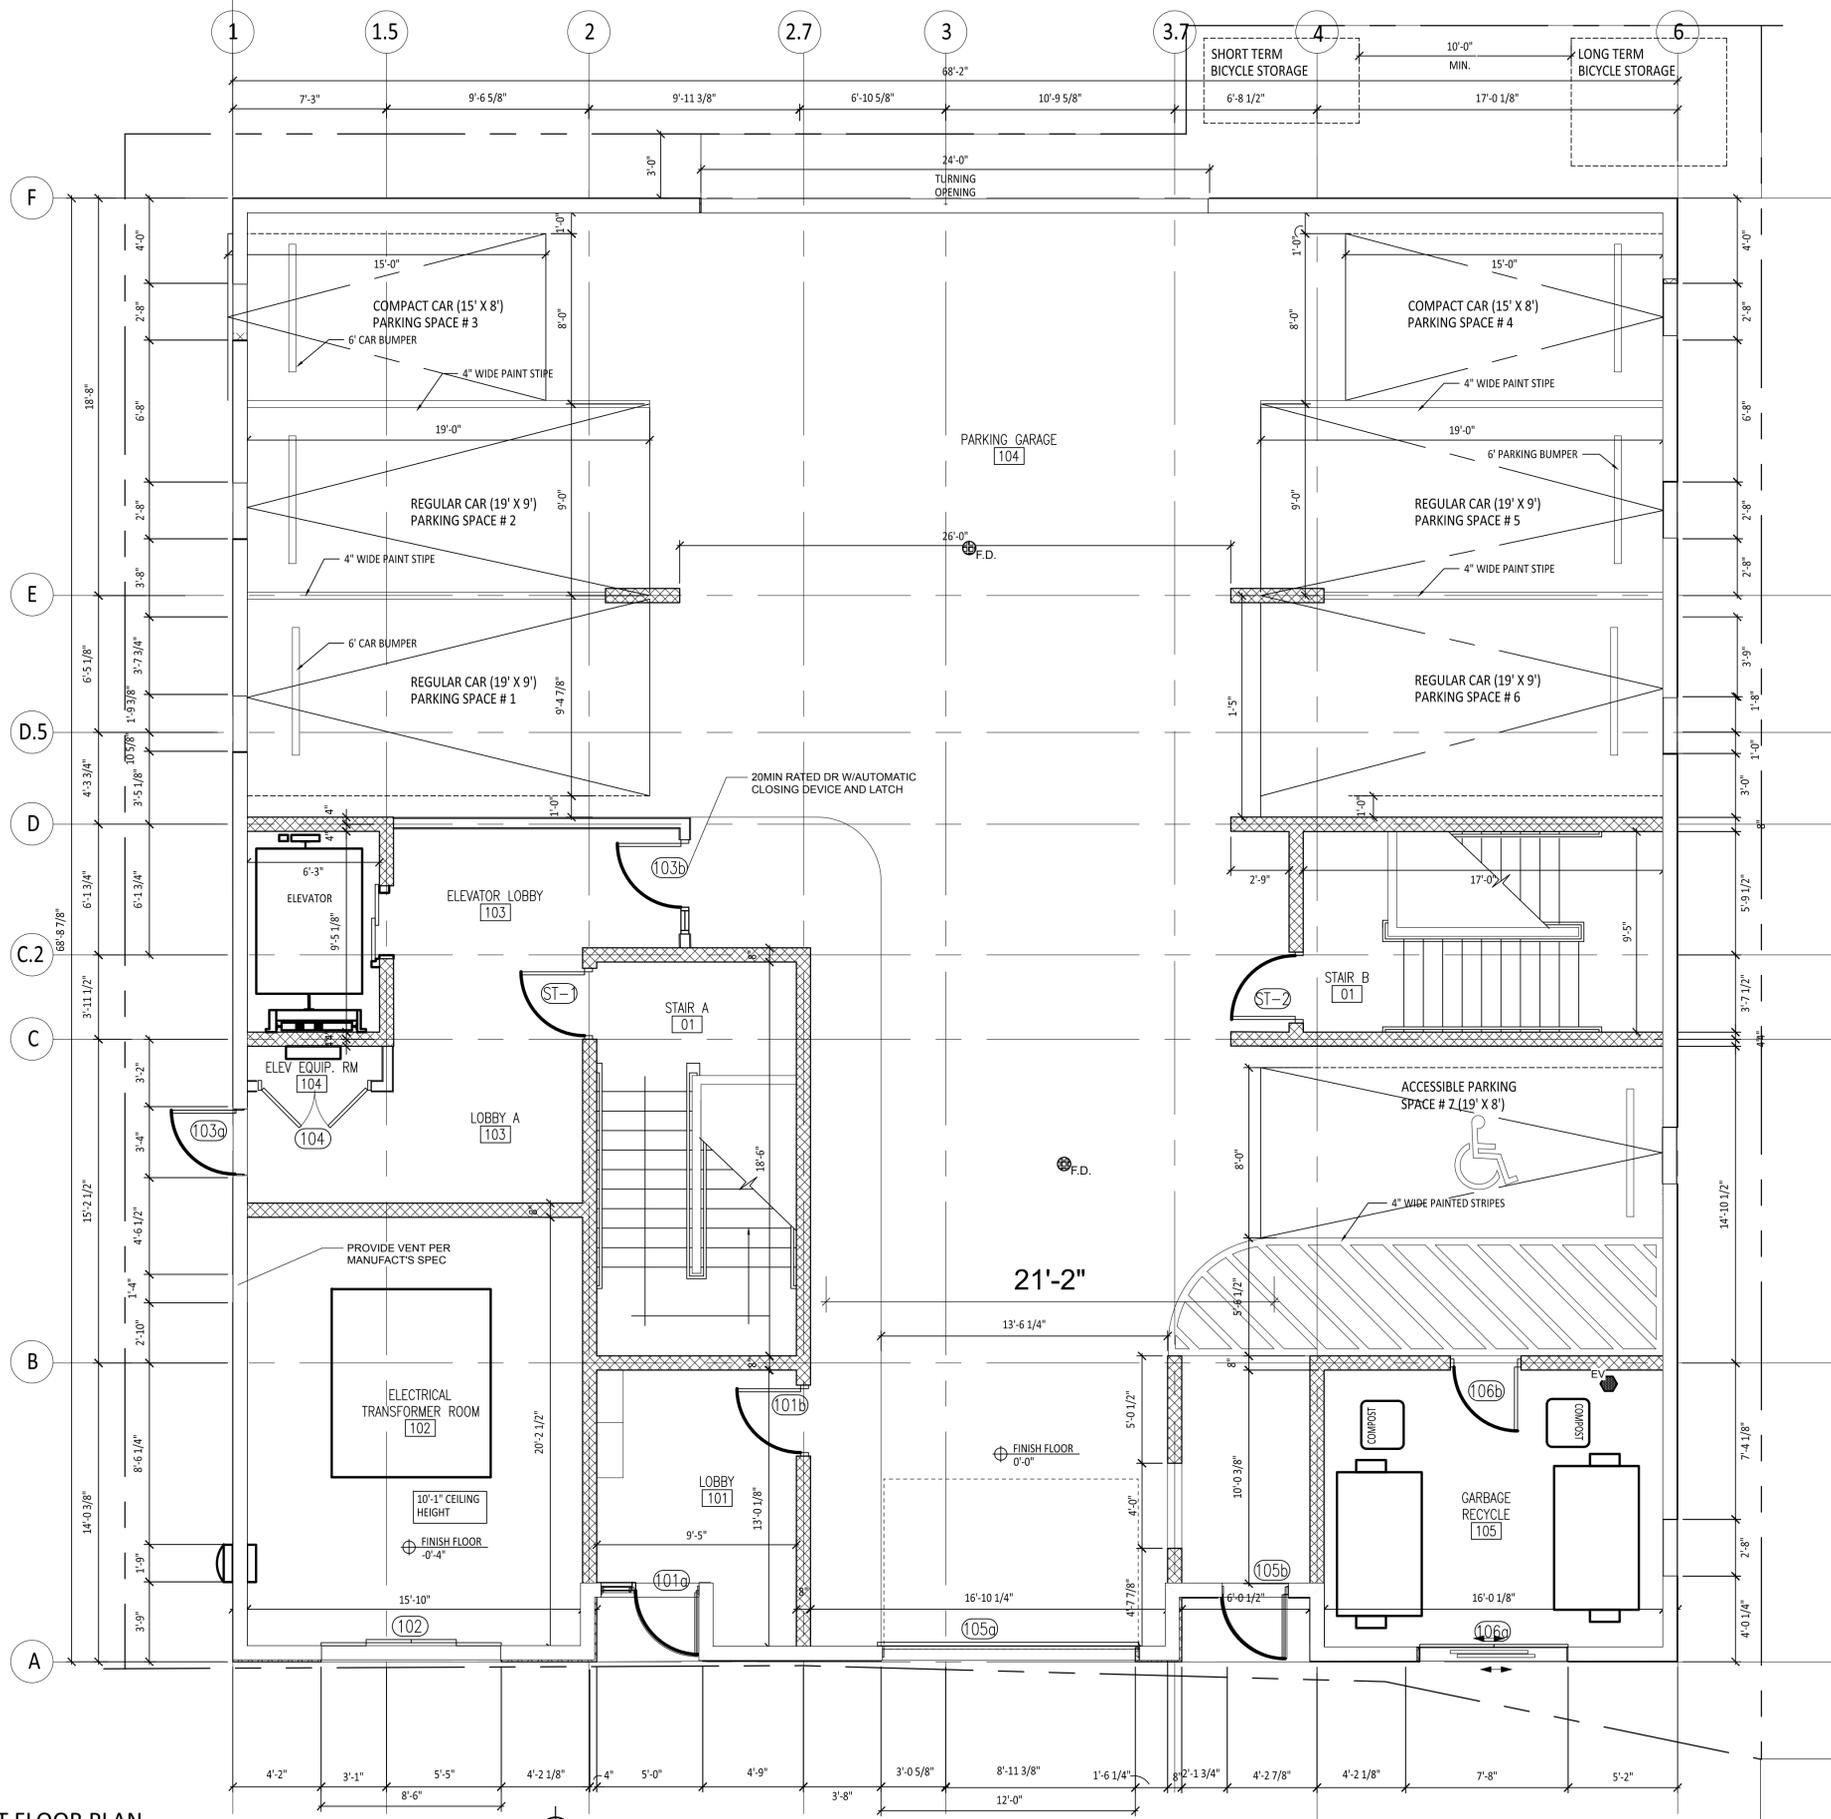
Project Manager: <b>FUMIO SUDA</b>	Project ID: <b>2022-513</b>
Drawn By: <b>Drawn By FS</b>	Scale: <b>1:1</b>
Reviewed By: <b>Reviewed By FS</b>	Sheet No.: <b>A-1.1</b>
Date: <b>4/14/2024</b>	
CAD File Name: <b> </b>

- EV OUTLET 7x40%=2.8  
3 EV PROVIDED
- F.D. FLOOR DRAIN

3 HOUR SEPARATION FROM GARAGE FLOOR AND LIVING AREAS  
DOORS ON THIS FLOOR TO BE SELF CLOSING AND SELF-LATCHING 1HR RATED

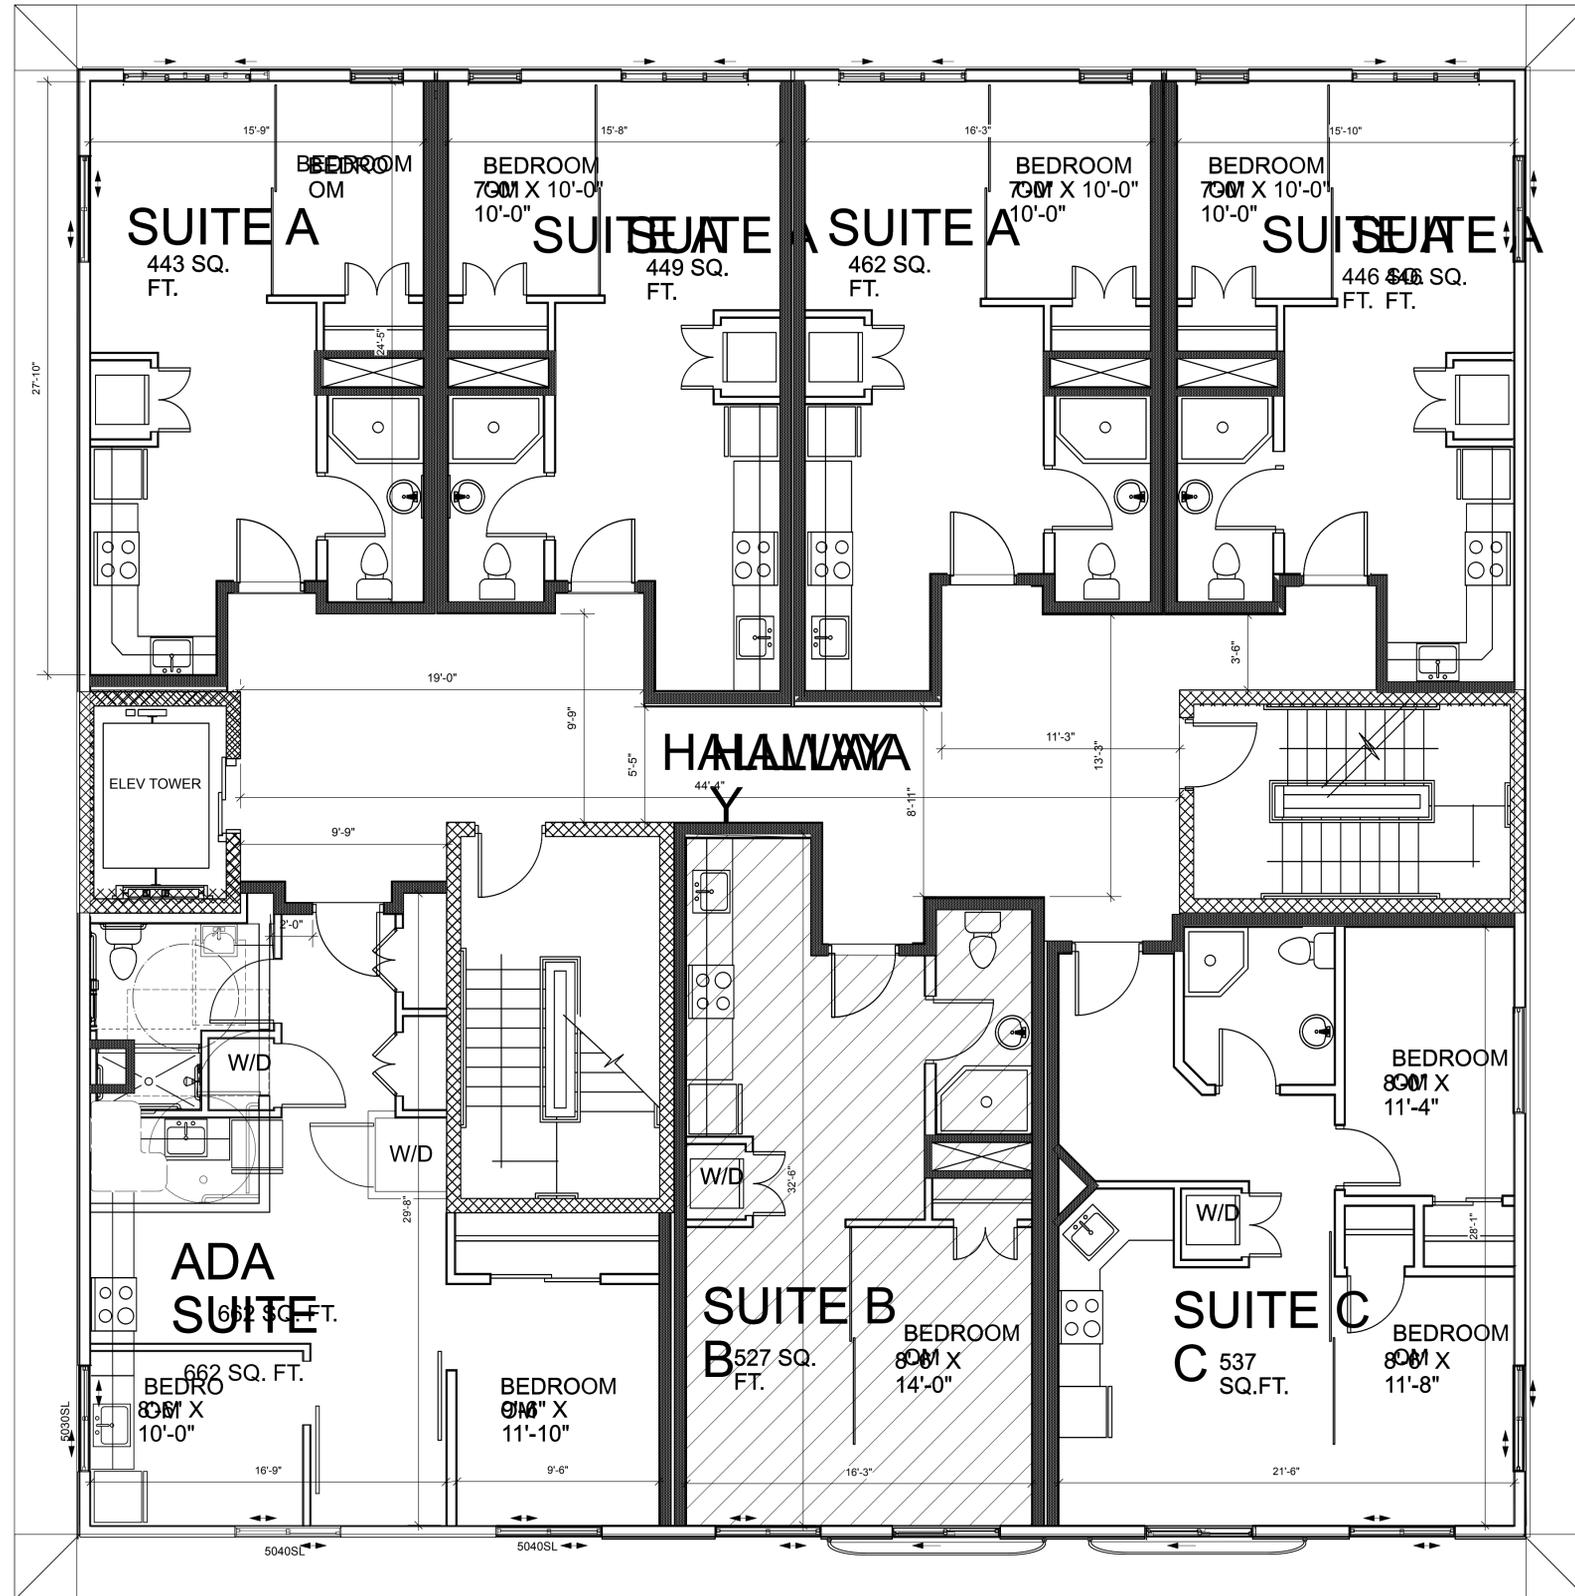
Sheet Title  
2ND FLOOR PLAN

3 HOUR SEPARATION FROM GARAGE FLOOR AND LIVING AREAS  
DOORS ON THIS FLOOR TO BE SELF CLOSING AND SELF-LATCHING 1HR RATED

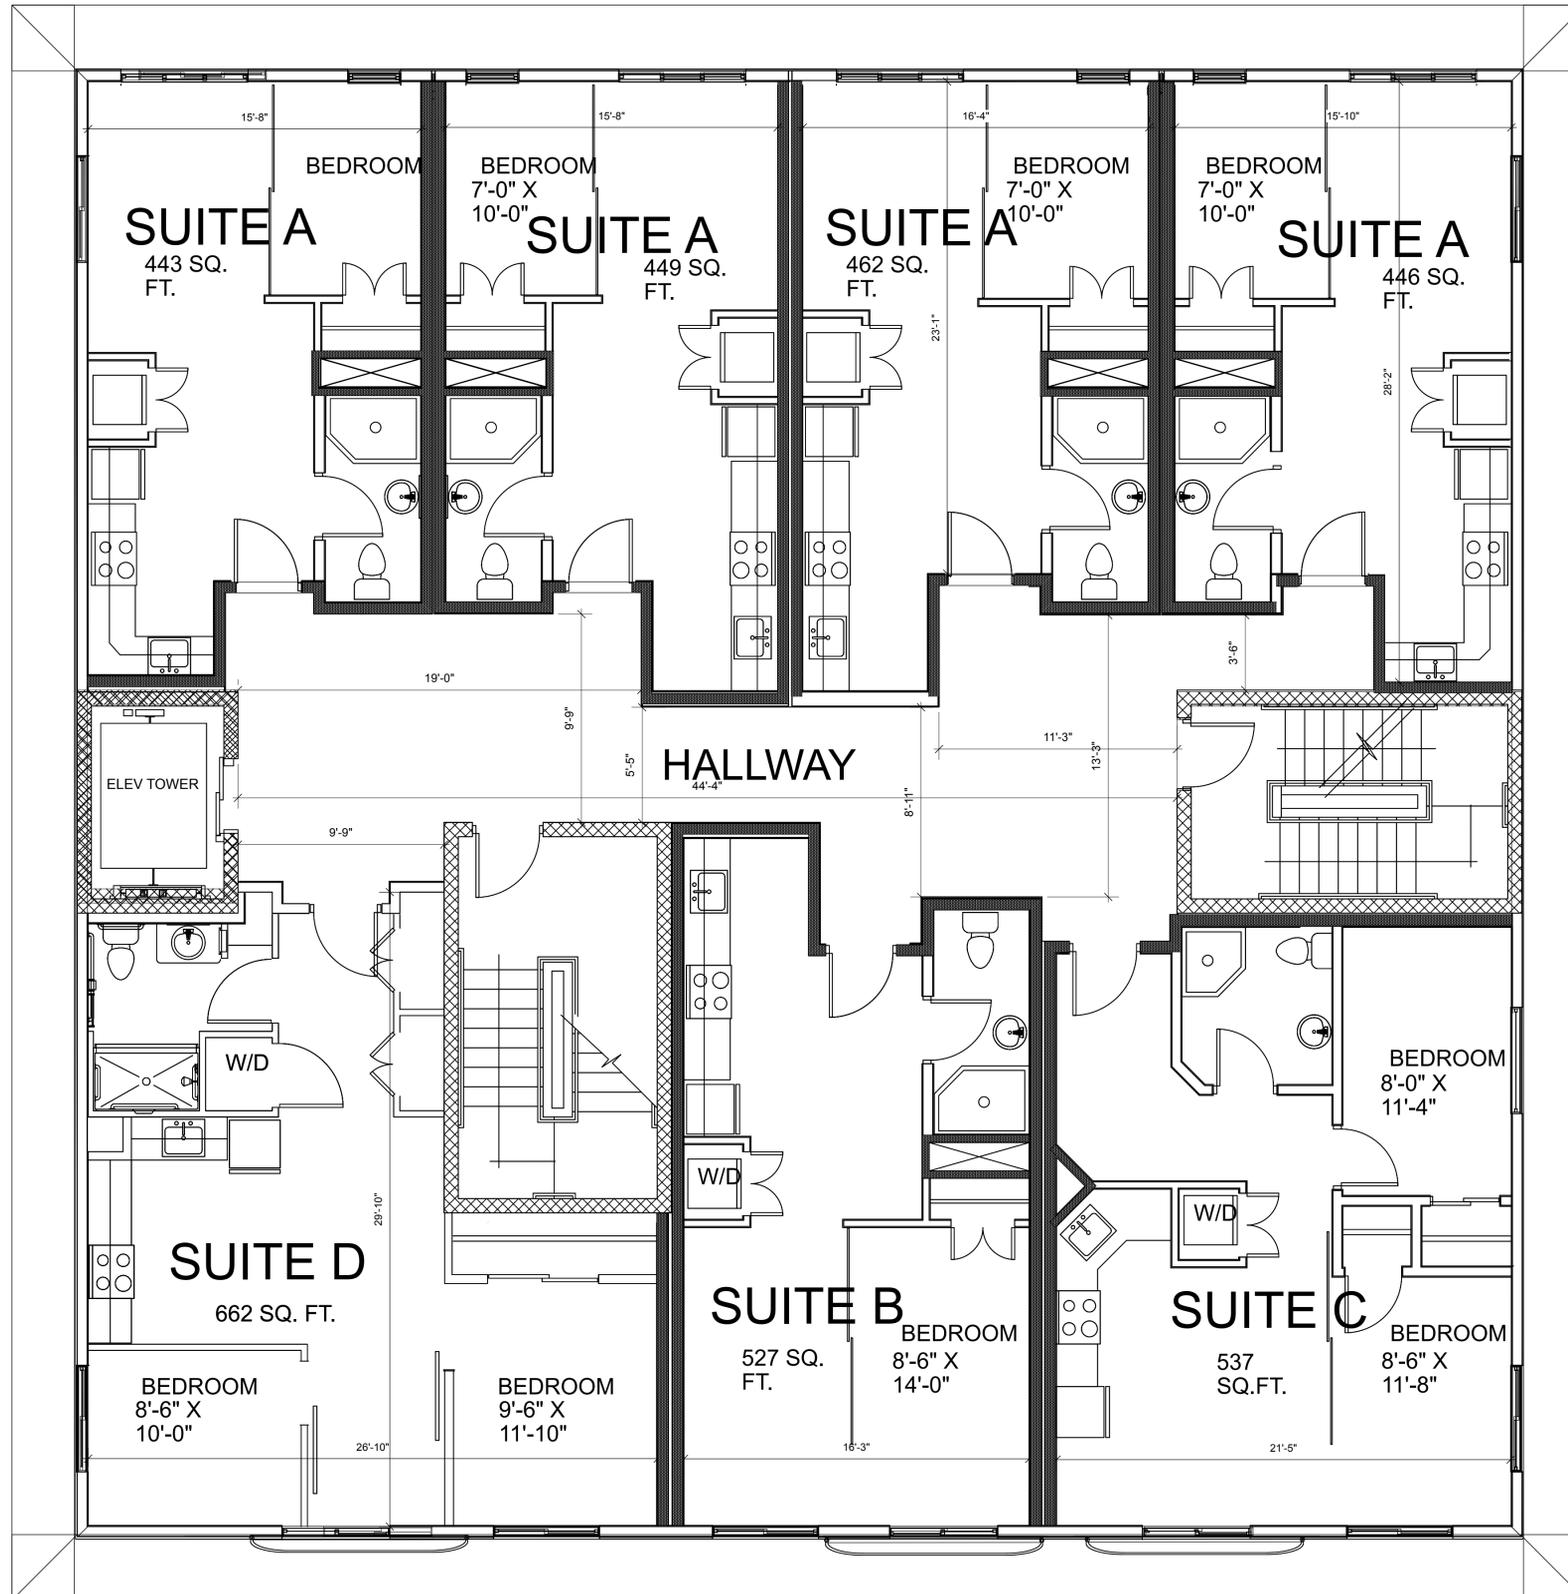
1. **3RD FLOOR PLAN**  
Scale: 1/4" = 1'-0"

3 HOUR SEPARATION FROM GARAGE FLOOR AND LIVING AREAS  
DOORS ON THIS FLOOR TO BE SELF CLOSING AND SELF-LATCHING 1HR RATED

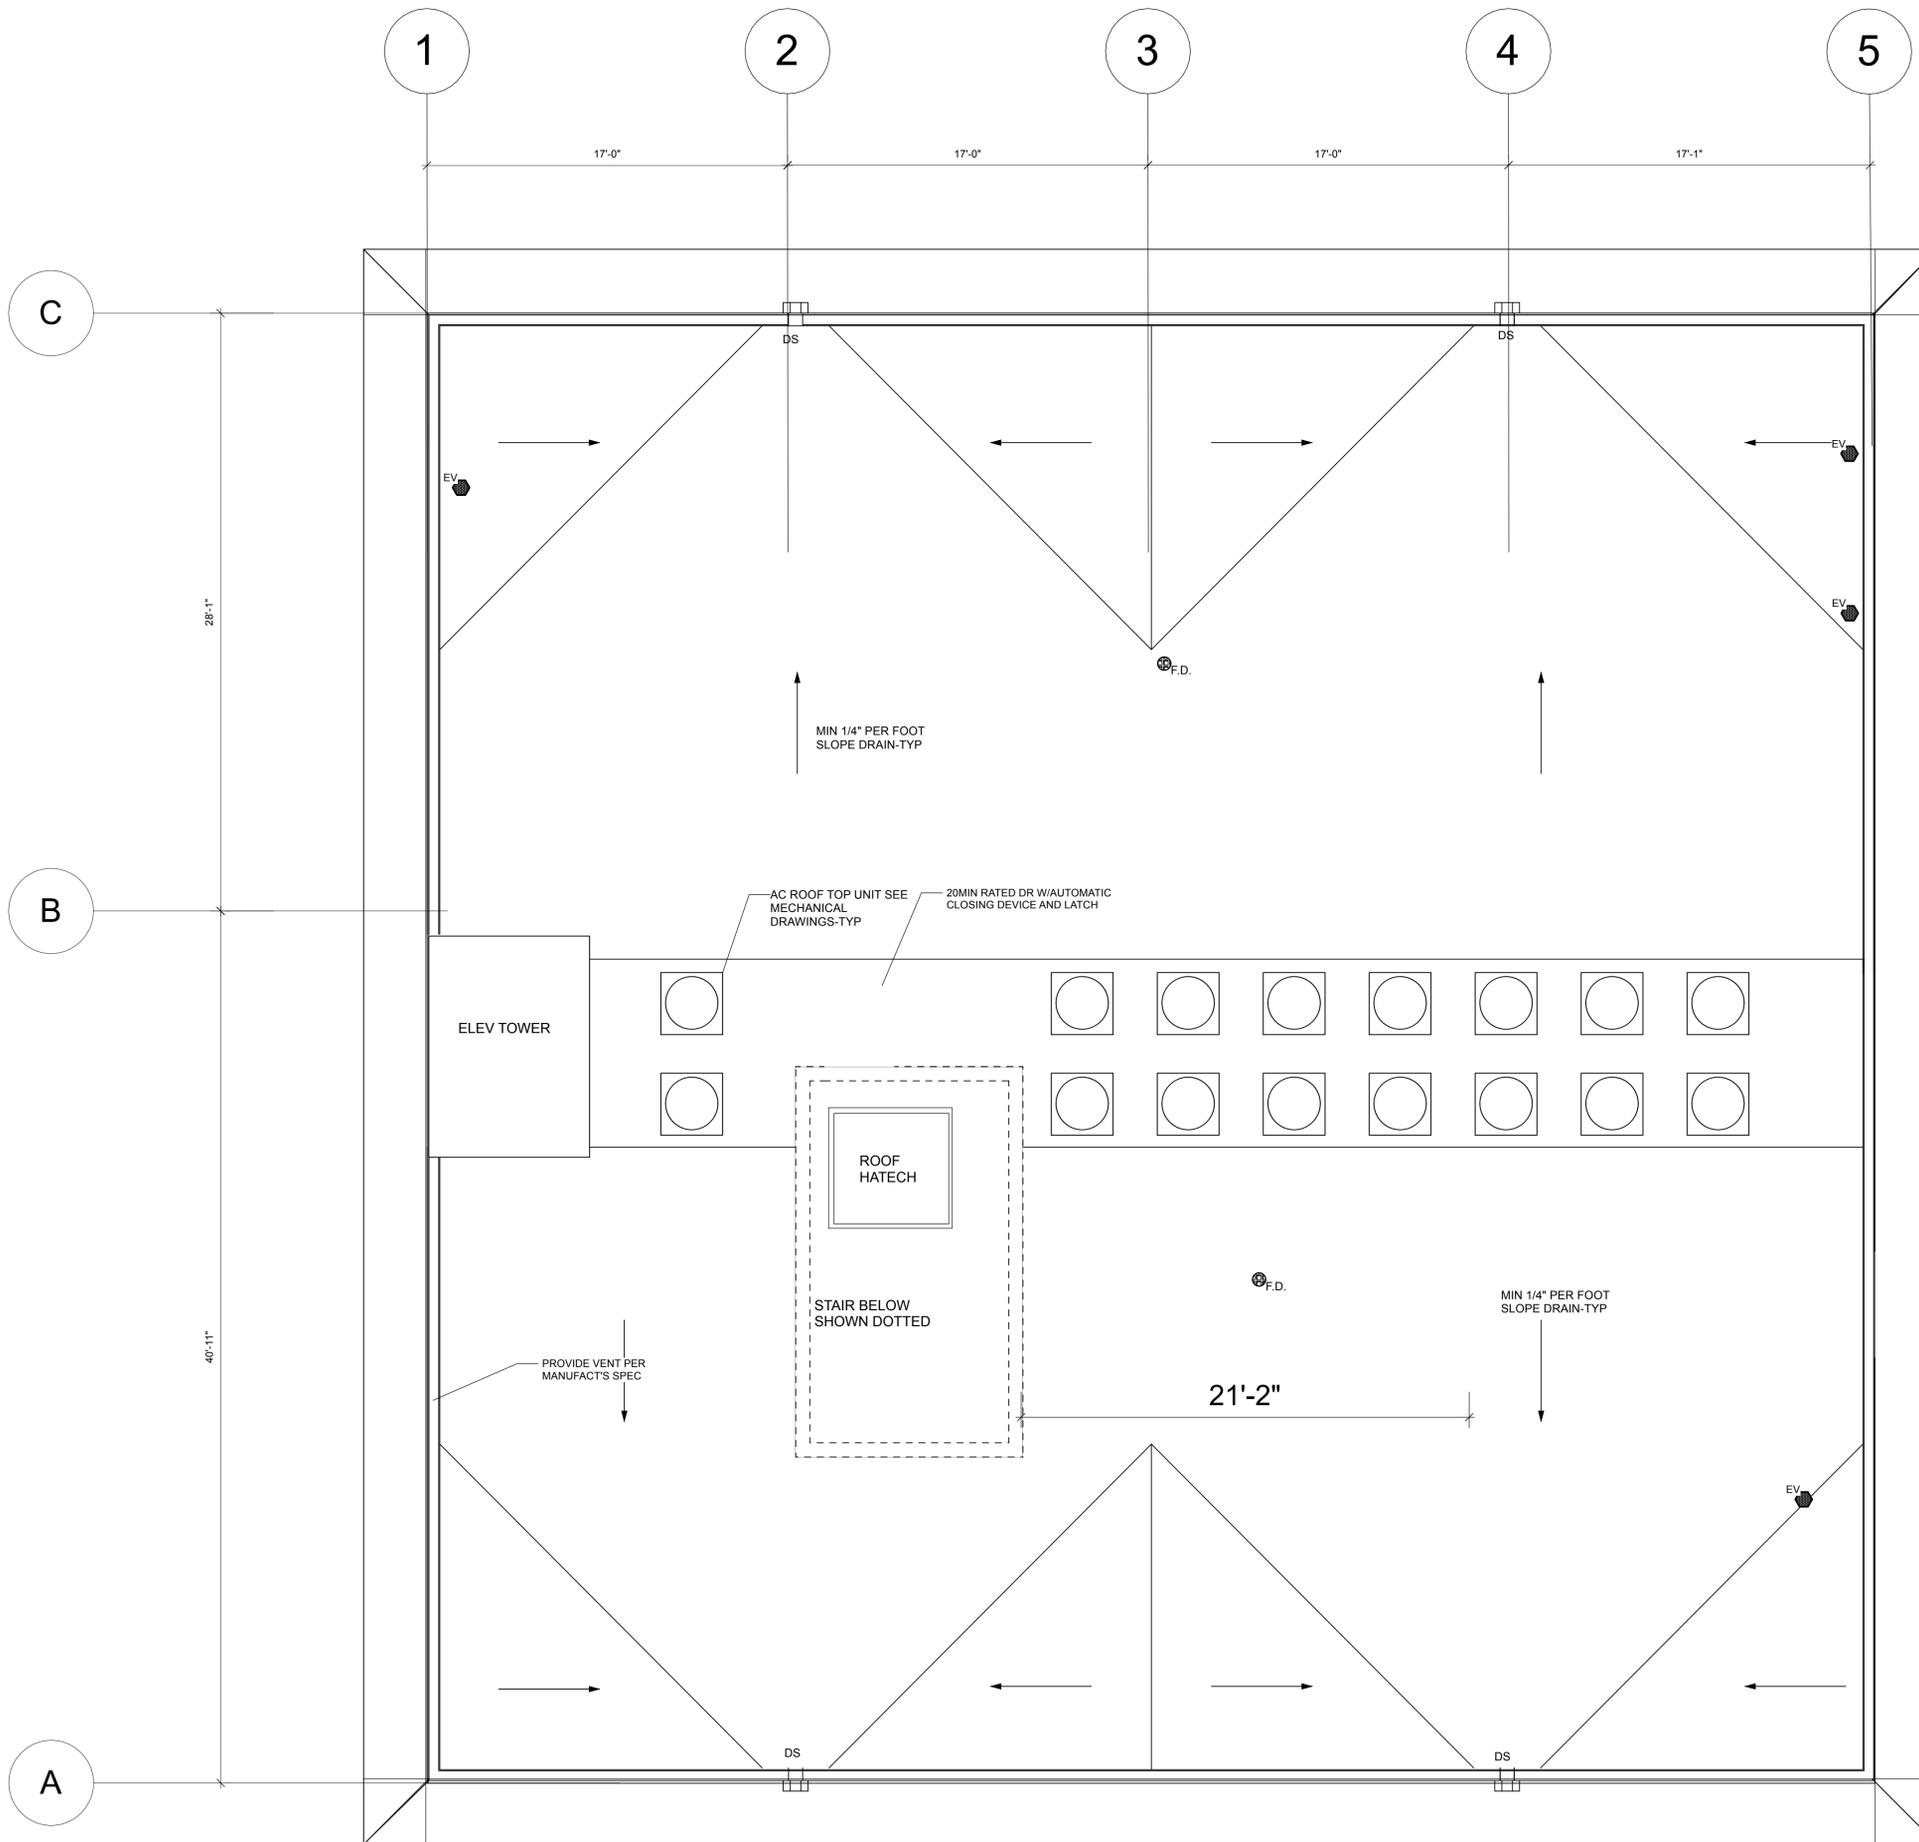
1 ROOF PLAN  
Scale: 1/4" = 1'-0"

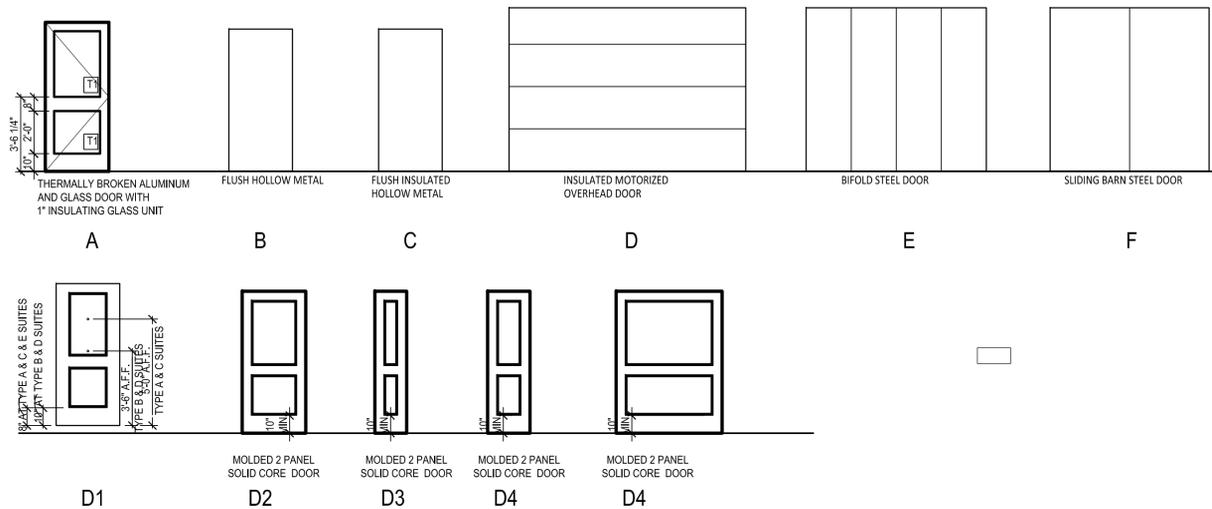
### DOOR TYPE

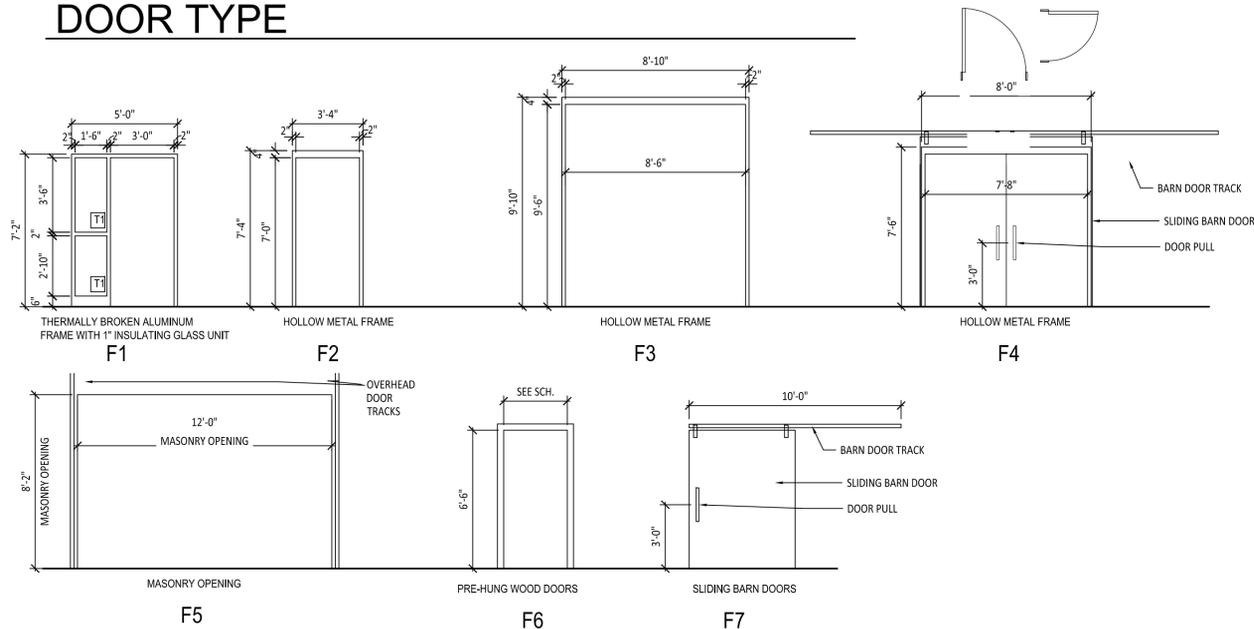
### FRAME TYPE

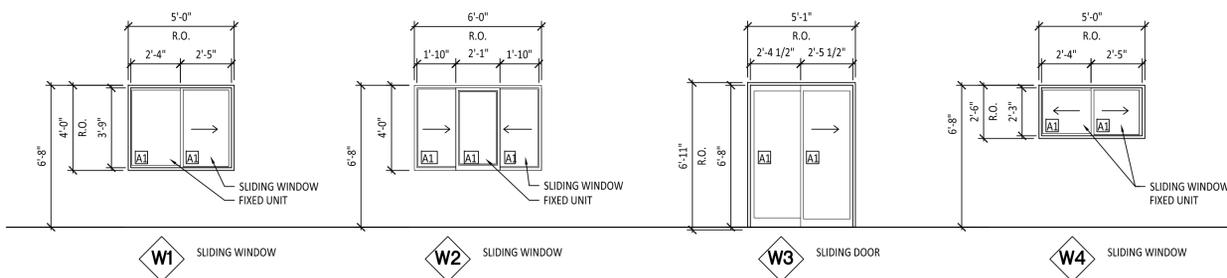
### WINDOW TYPES

**BEDROOM RESCUE WINDOWS MUST MEET ALL:**  
 Minimum 20 in. clear width  
 Minimum 24 in. clear height  
 Minimum 5.7 sq. ft. (or on ground floor minimum 5.0 sq ft.) of clear opening area  
 Maximum 44 in. from floor to bottom window opening  
 CBC 1031
