# RUSSELL WAY GARDEN

1289 RUSSELL WAY  
HAYWARD, CA

**PROJECT DESCRIPTION:**  
3 STORY 14 UNIT  
APARTMENT BUILDING WITH COVERED GARAGE

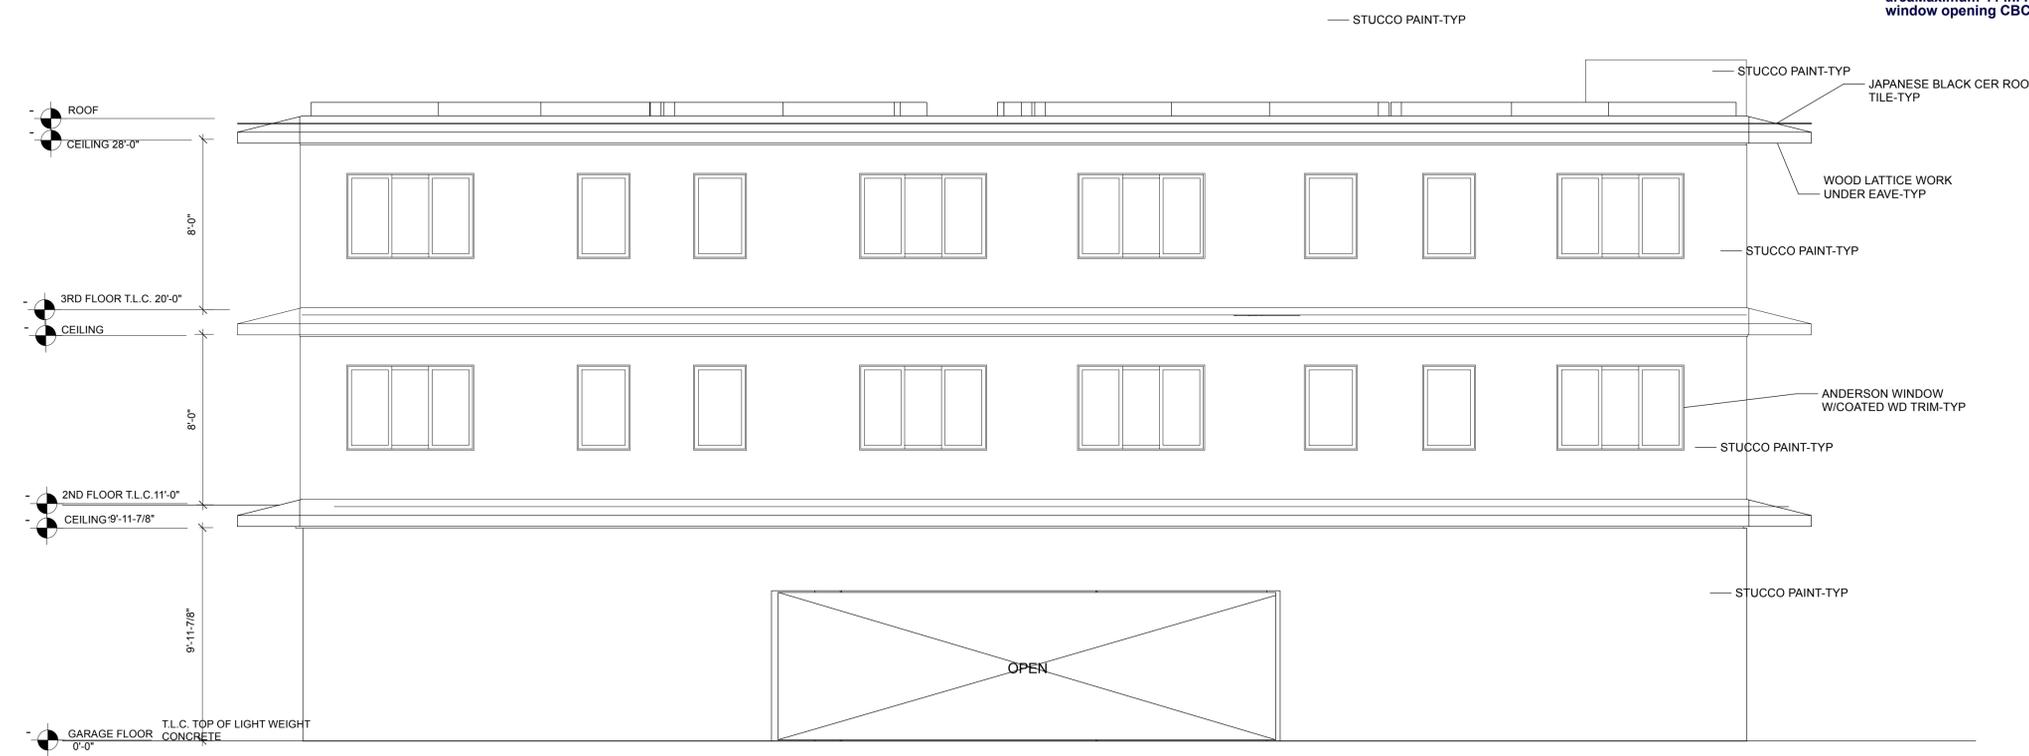
**1 REAR ELEVATION**  
 Scale: 1/4" = 1'-0"

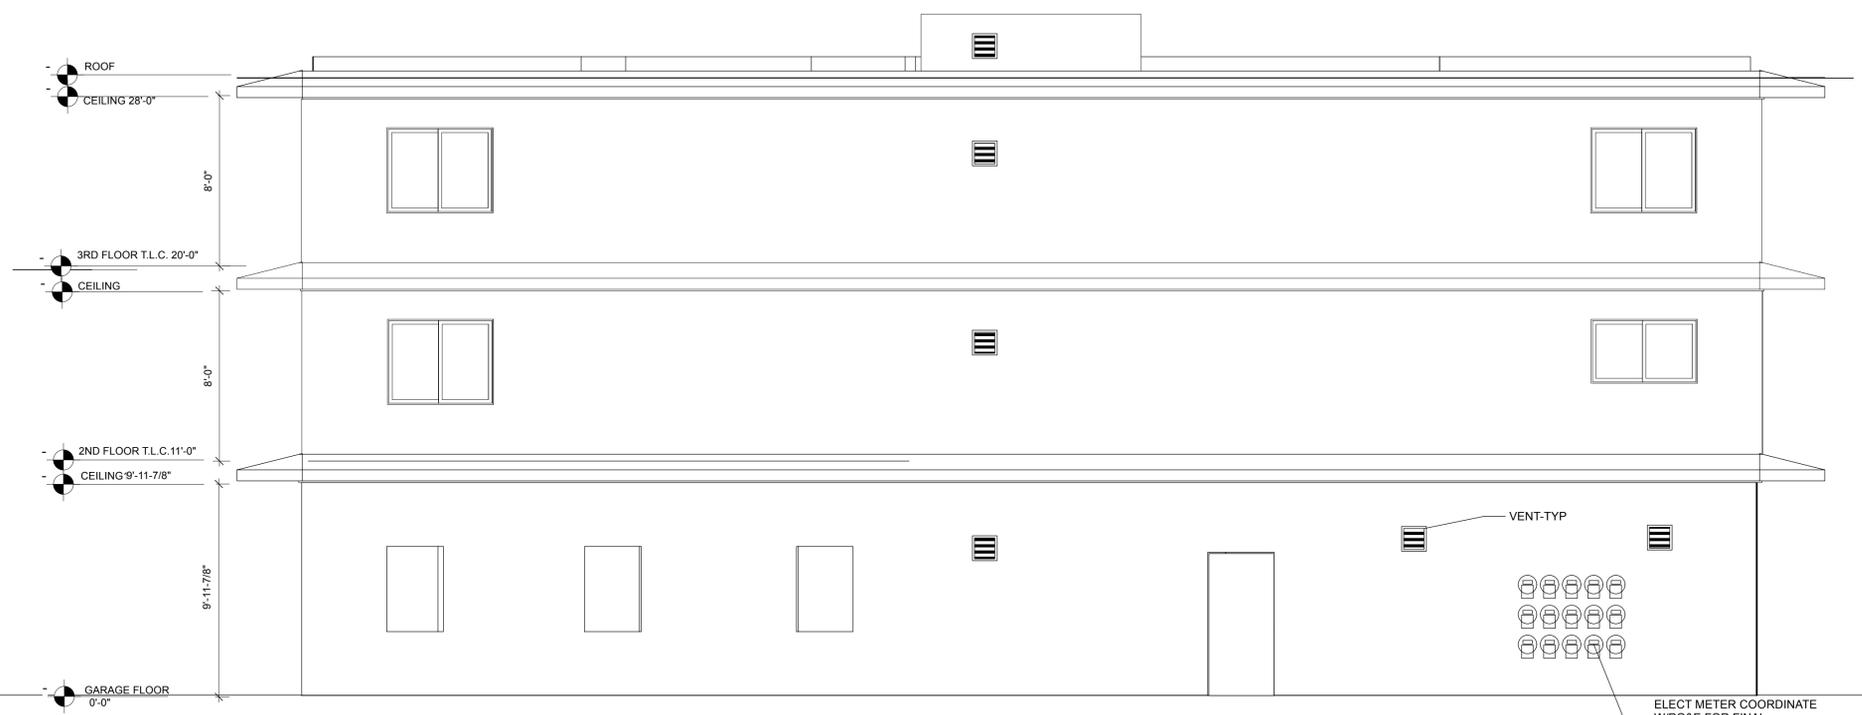
**2 LEFT ELEVATION**  
 Scale: 1/4" = 1'-0"

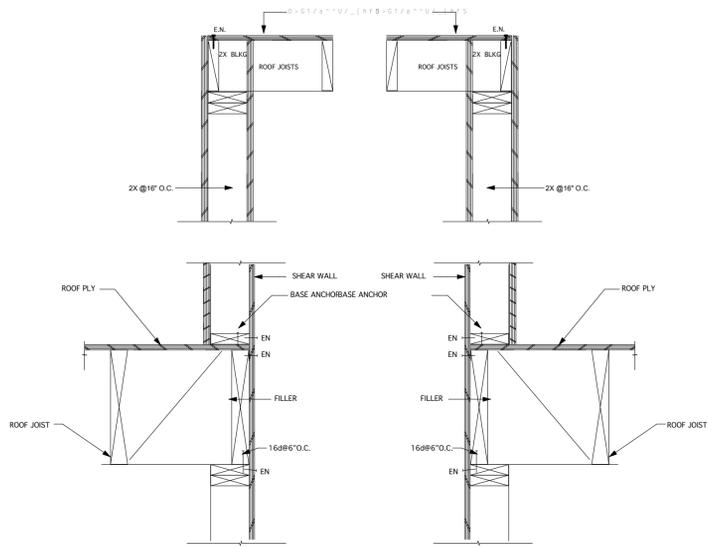
**ELEVATOR SHAFT ROOF TOP DETAIL**  
SCALE: NTS

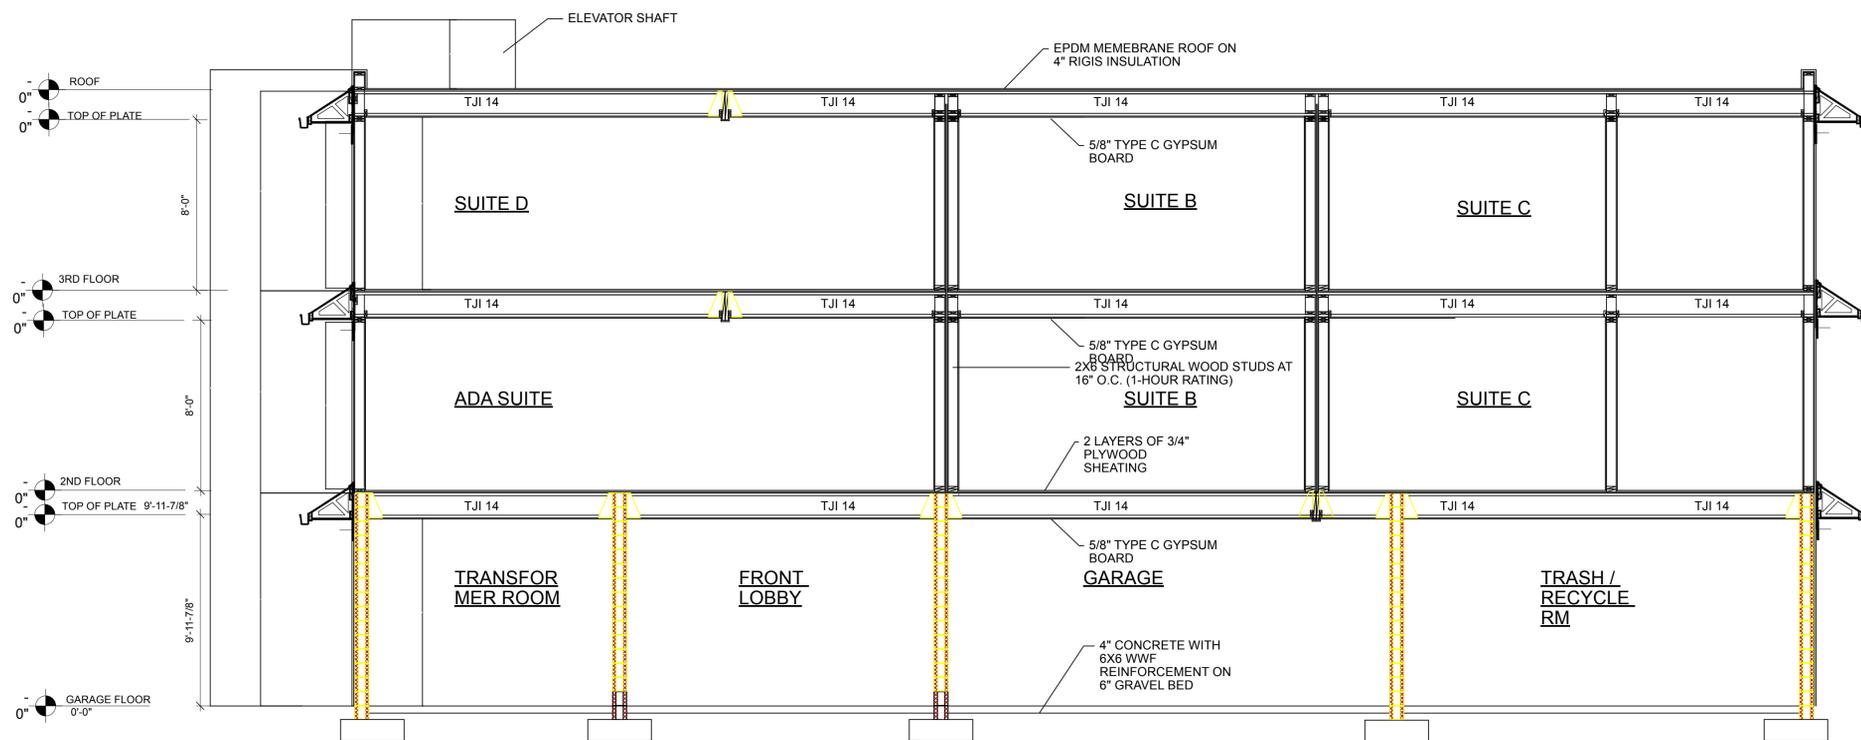
**1 BUILDING SECTION**  
Scale: 1/4" = 1'-0"

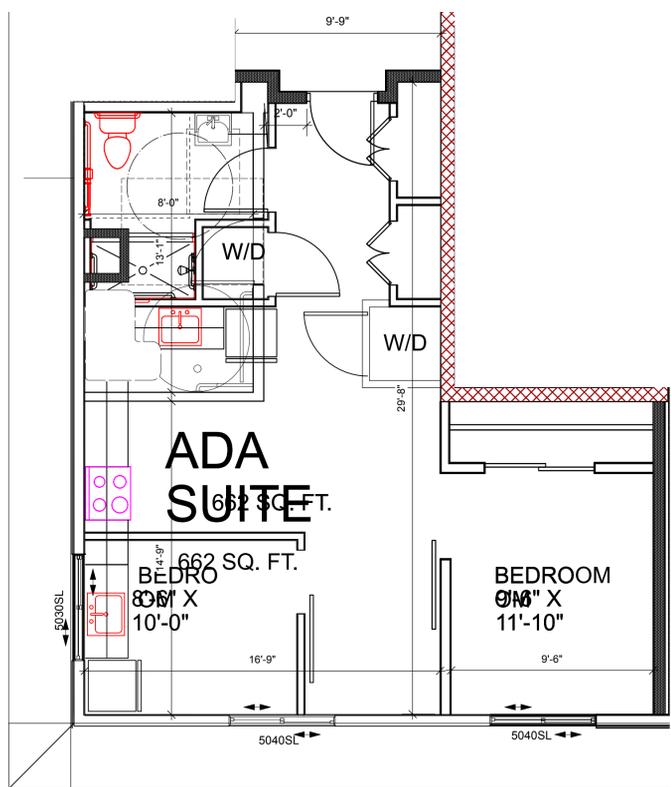
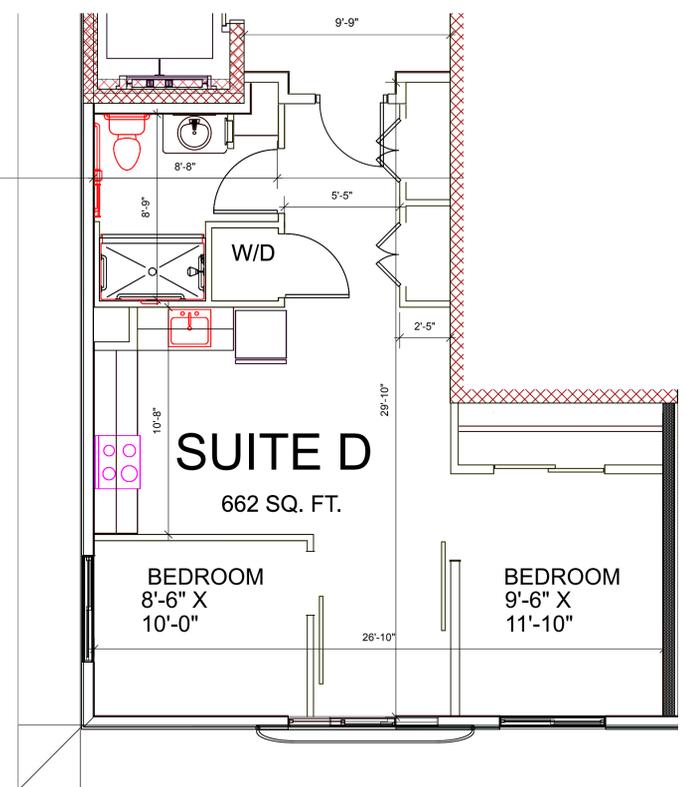
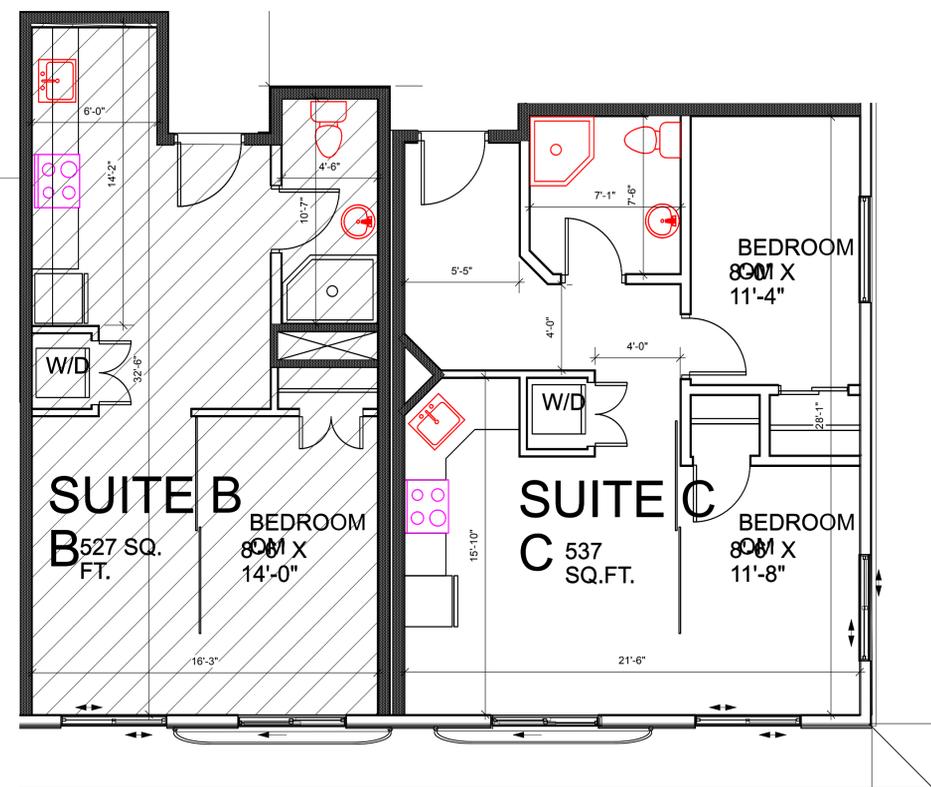
Sheet Title: TYPICAL UNIT PLAN

**CEILING HEIGHT**  
 BEDROOM 8'-0"  
 LIVING RM 8'-0"  
 DINING 8'-0"  
 TOILET 7'-0" MIN  
 HALL WAY 7'-0" MIN

1  
A6  
TYPICAL ONE BEDROOM UNIT  
1/4"=1'-0"

3  
A6  
ADA UNIT  
1/4"=1'-0"

2  
A6  
TYPICAL TWO BEDROOM UNIT 1/4"=1'-0"

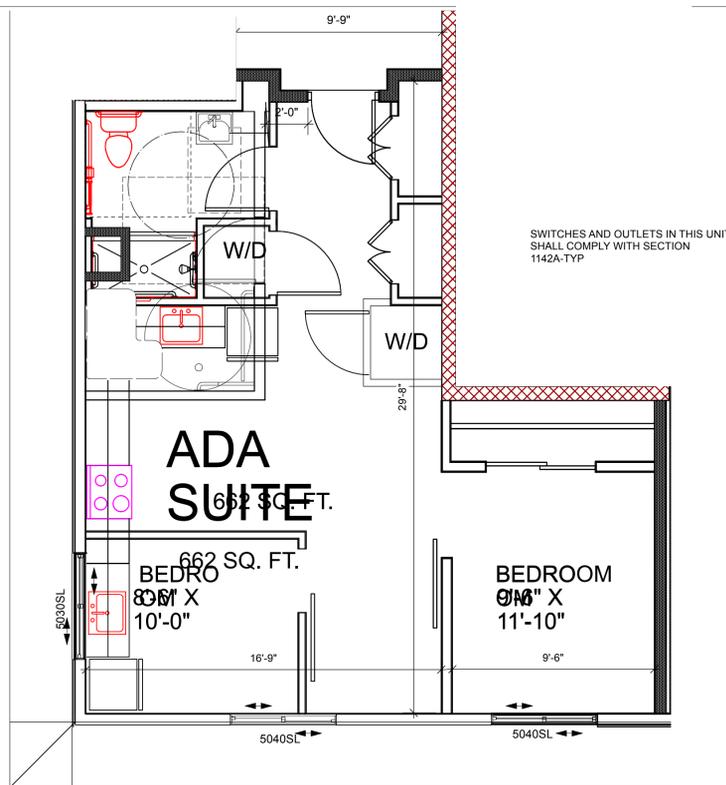
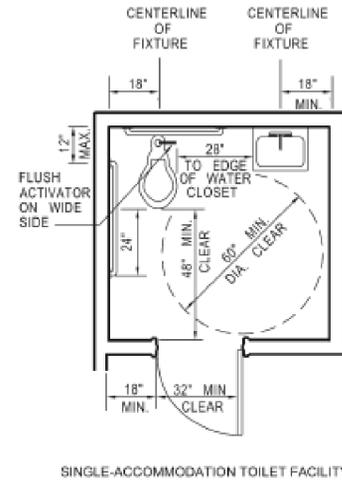
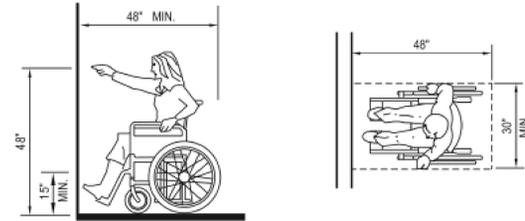
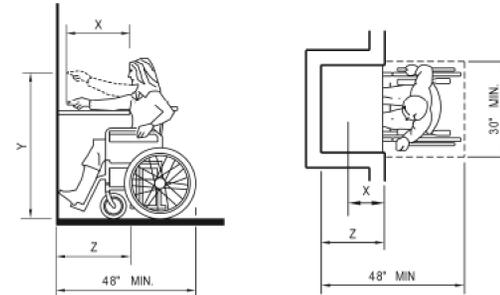
NOTE: X SHALL BE LESS THAN OR EQUAL TO 25 INCHES. Z SHALL BE GREATER THAN OR EQUAL TO X. WHEN X IS LESS THAN 20 INCHES, THEN Y SHALL BE 48 INCHES MAXIMUM. WHEN X IS 20 TO 25 INCHES, THEN Y SHALL BE 44 INCHES MAXIMUM.

1 PARTIAL PLAN ADA UNIT  
Scale: 1/4" = 1'-0"

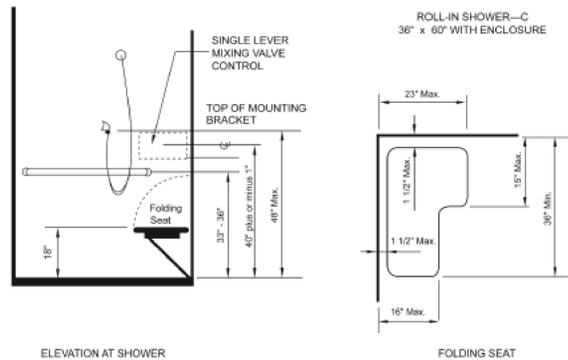
ROLL-IN SHOWER

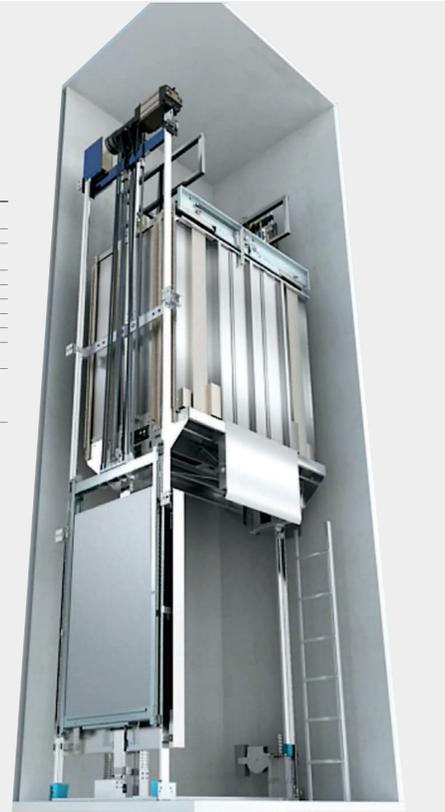
The design efficiencies of the Schindler 3100 MRL traction elevator reduce its overall space requirements by as much as 20%.

## Schindler 3100 MRL Traction Elevator General Purpose

Capacity 2,100 – 3,500 lbs.  
Passengers 13 – 21  
Speed 100 fpm  
Travel height Up to 56'<sup>7</sup>  
Openings 3 front, 3 rear  
Cab height 7'-9"<sup>4</sup>  
Door height 7'<sup>1</sup>

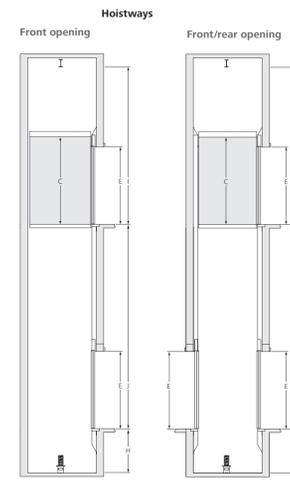
**Abbreviations:**  
A Cab width  
B Cab depth  
C Cab height<sup>1</sup>  
D Door width  
E Door height  
F Hoistway width  
G Hoistway depth  
H Pit depth  
I Clear overhead  
SSCO Single speed center opening door  
2SSO Two speed side opening door<sup>1</sup>

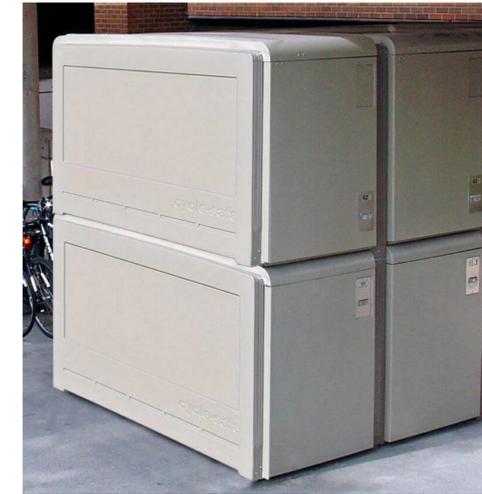
LONG TERM BICYCLE STORAGE
