May 18, 2023

Subject: Hayward Geologic Hazard Abatement District
Hideaway (formerly Ersted Property) Development
Hayward, California

**GEOLOGIC HAZARD ABATEMENT DISTRICT (GHAD)
PLAN OF CONTROL TRANSFER INSPECTION**

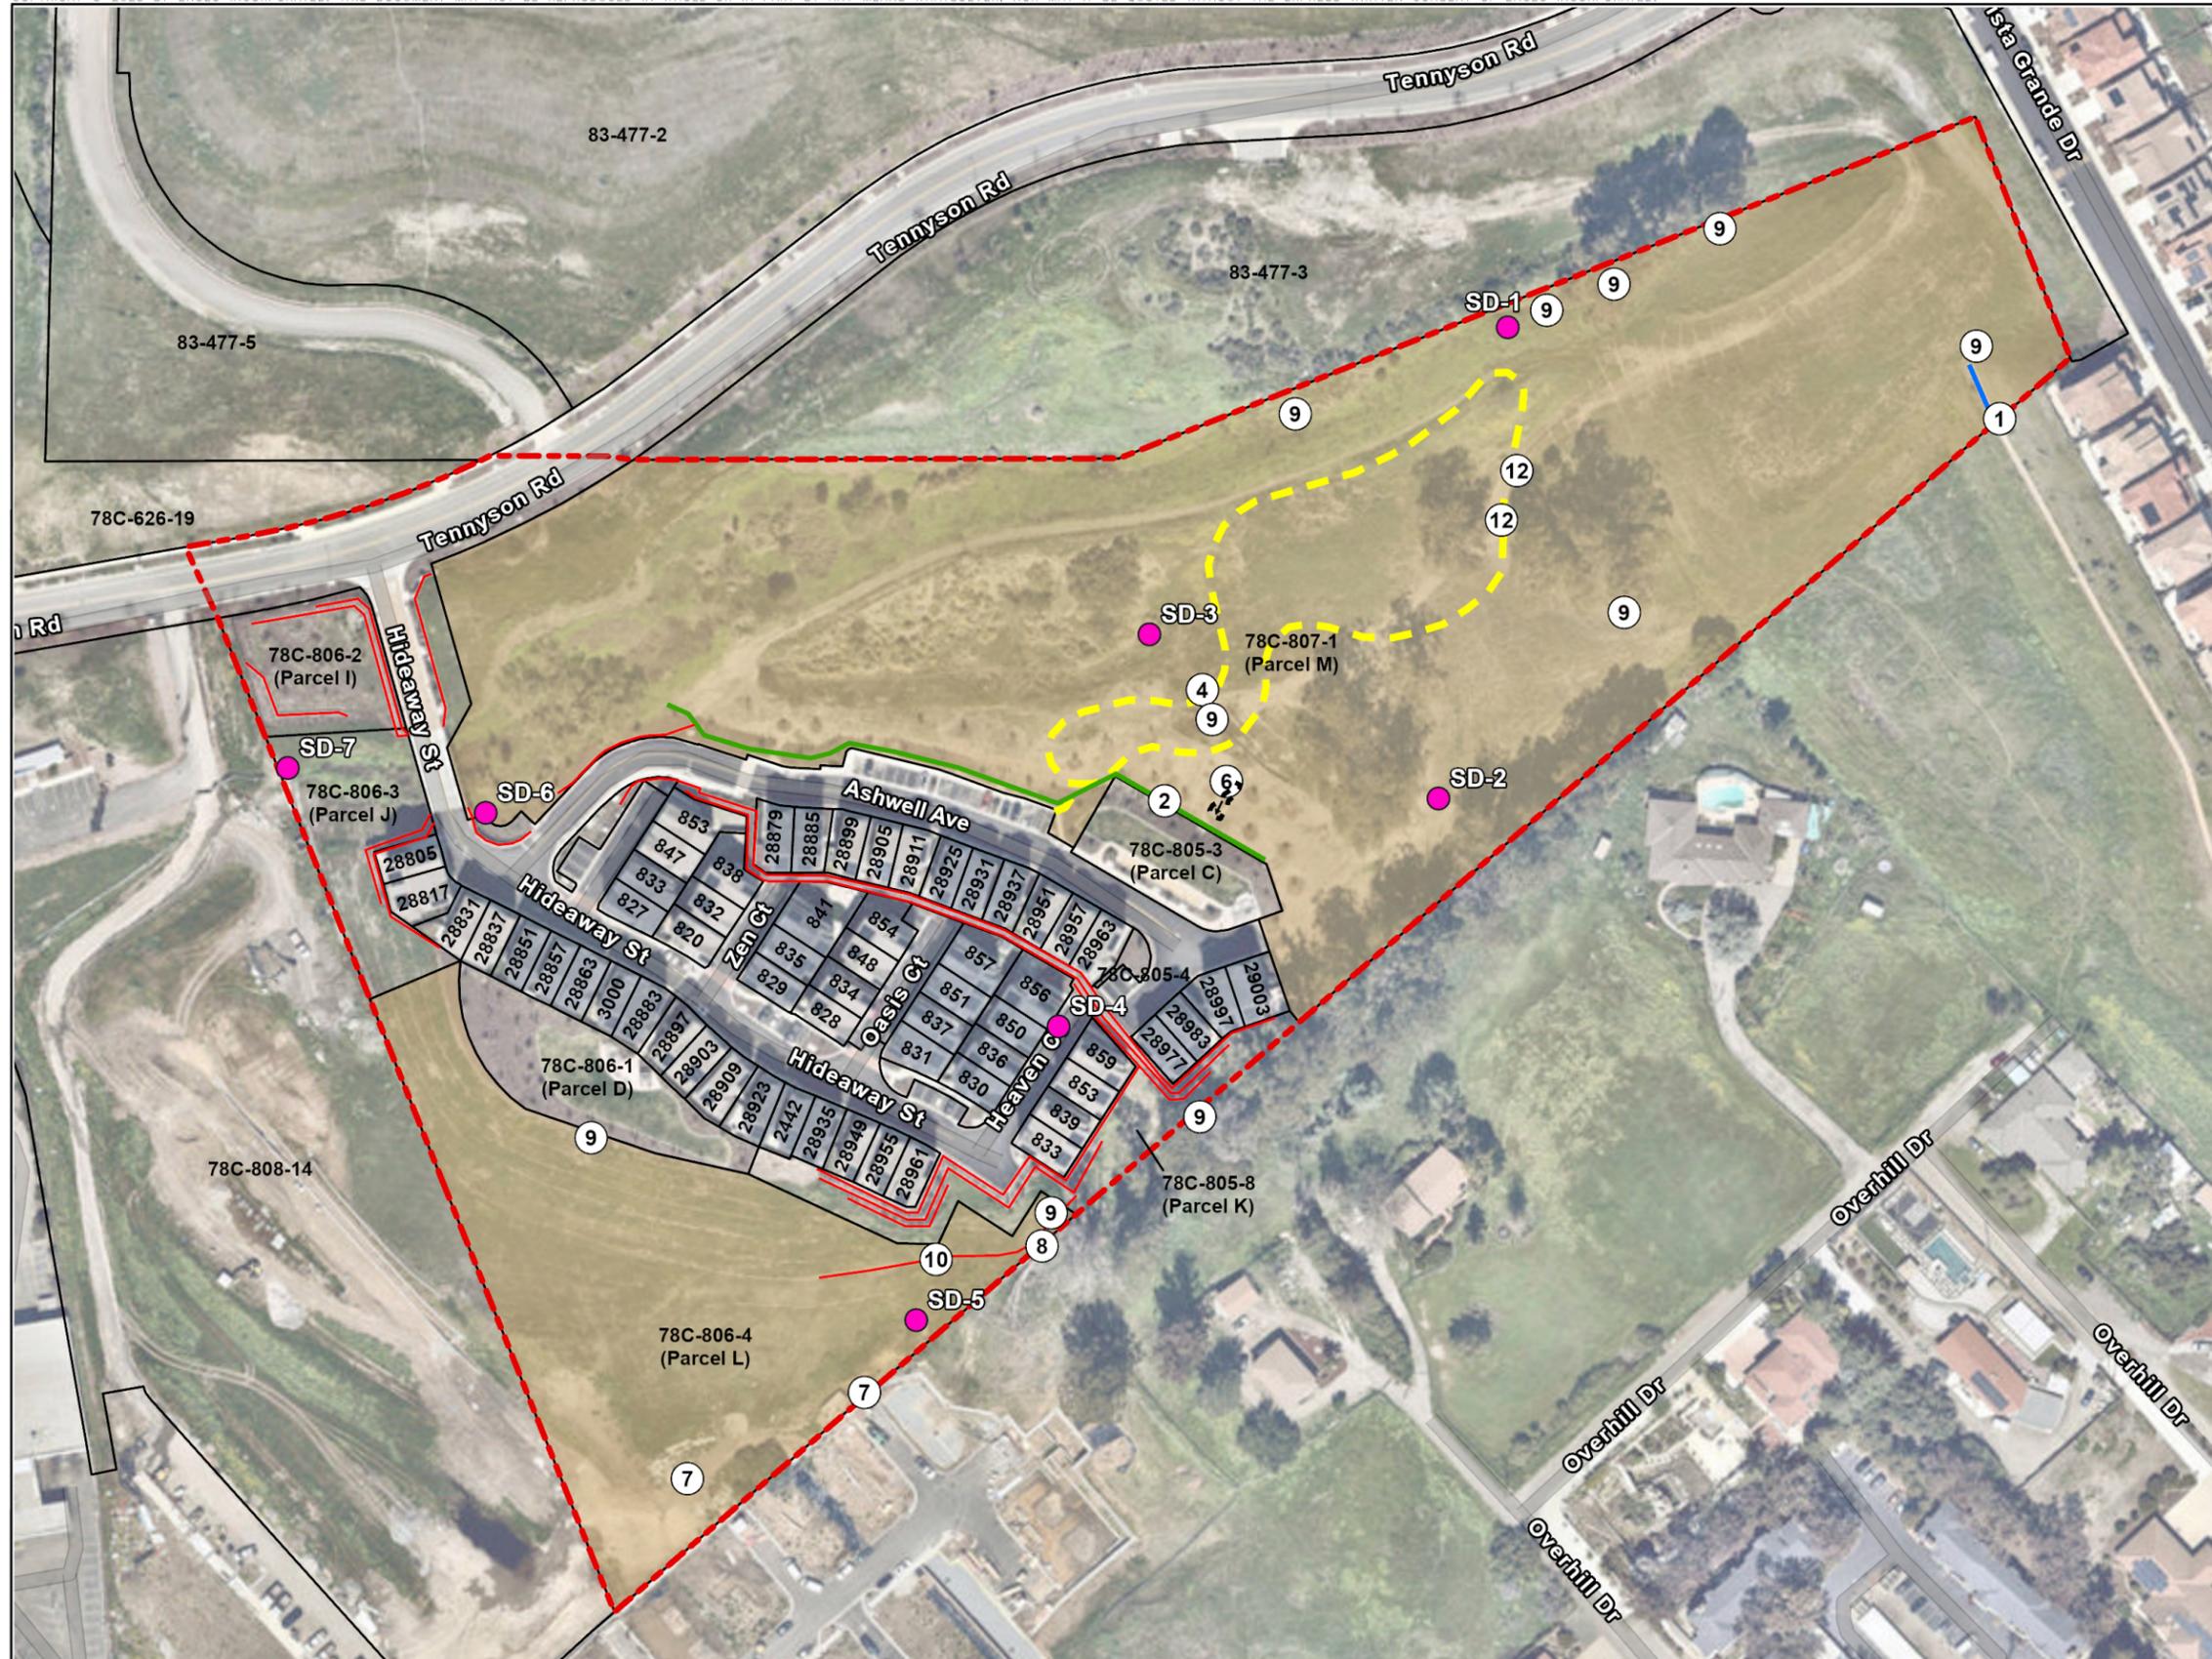
SITE PLAN
 HAYWARD GHAD- HIDEAWAY DEVELOPMENT
 HAYWARD, CALIFORNIA

1. A segment of concrete-lined drainage ditch is located on Parcel M and will be maintained by the GHAD (Figure 1). The concrete-lined drainage ditch was observed for accumulation of debris and sediment and for obvious distress such as cracking or shifting of the concrete. In general, the concrete-lined drainage ditch located on Parcel M was in good condition. Routine maintenance shall be performed and include removal of accumulated vegetation, vegetative debris, and soil. Vegetative debris shall be cut and removed from within the ditch and for a minimum of 12 inches on both sides of the ditch. Vegetation overhanging the ditch shall also be removed.

2. A drainage swale is located on Parcel M and will be maintained by the GHAD (Figure 1). The drainage swale was observed for proper shape, profile, and overall condition. At the time of our site visit, it appeared that the drainage swale was not constructed based on City-approved as-built improvement plans (Reference 4). The drainage swale should be constructed according to the approved improvement plans.

3. Along the property fence east of Lot 59 on Parcel M (APN 78C-807-1), there appears to be a riprap-lined drainage swale (Figure 1). Based on review of the City-approved as-built improvement plans, there does not appear to be mention or detail provided for the riprap-lined drainage swale. The GHAD requests an updated plan or detail for the existence of the riprap-lined drainage swale.

4. Subdrain outlets within the Transfer Areas were observed for condition and flow (Figure 1). Additional comments for observed subdrain outlets within the Transfer Areas are listed in Table 2.

LABEL	COMMENTS
SD-1	Unable to locate.
SD-2	Unable to locate.
SD-3	Unable to locate. Possible location near or in white, 6" diameter perforated PVC stick up. Confirm outlet detail and location.
SD-4	Unable to locate. No accessible storm drain inlet or manhole near outlet location.
SD-5	Open and clear. No flow at time of visit.
SD-6	Unable to locate.
SD-7	Unable to locate.

6. There is a minor landslide on the slope above the Homeowners Association's landscaped common space, east of the parking stalls on Ashwell Avenue, on Parcel M (Figure 1). This landslide should be repaired prior to acceptance by the GHAD.

7. On Parcel L, it appears that the neighboring development is undergoing active construction and has used the southern corner portion of Parcel L as storage for construction materials and soil stockpiles (Figure 1). The construction materials and soil stockpiles should be removed and slope grades should be reestablished prior to acceptance by the GHAD.

8. Along the eastern edge of Parcel L, a large tree has fallen and has uprooted subsurface soil (Figure 1). The tree should be removed and properly disposed of off site, and slope grades should be reestablished prior to acceptance by the GHAD.

9. All litter and debris, including remaining construction materials, shall be removed from the open space parcels and banks of the creeks and wetland areas. Several observable locations with significant debris within the open space parcels are noted in Figure 1.

12. There is a pedestrian walking trail located on Parcel M that will be maintained by the GHAD (Figure 1). At the time of our site visit, there were minor erosion rills, straw waddles, and overgrown vegetation within the trail. The erosion rills should be repaired, and the straw waddles and overgrown vegetation should be removed prior to acceptance by the GHAD. Additional improvement details related to the trail should be provided to the GHAD, if available.
